# CITY OF NEW ORLEANS STORMWATER DRAINAGE SYSTEM ROOT CAUSE ANALYSIS FINAL REPORT

Contract: K18-111

ROOT CAUSE ANALYSIS

FINAL REPORT

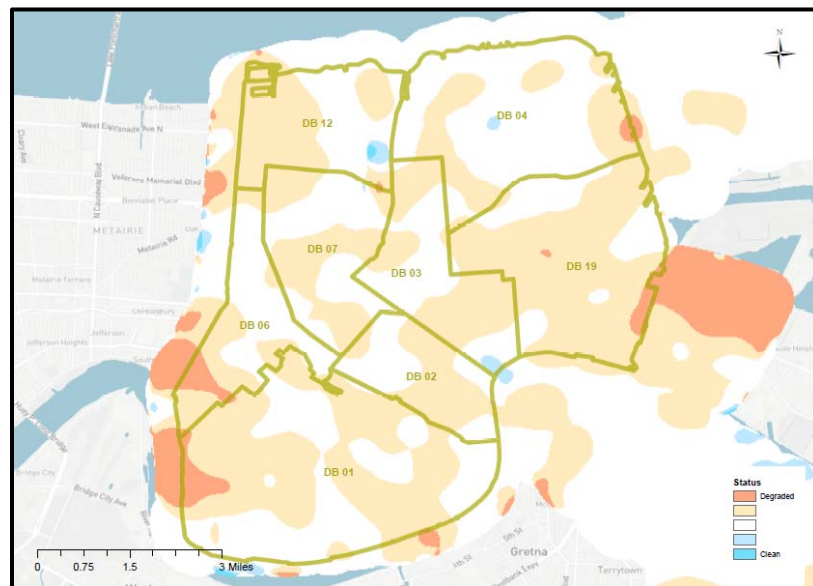
**Figure 6 Catch Basin Clogging**

Figure 6 indicates distribution of clogged catch basins in the Old City. Figure 7, provided by DPW, shows the condition status of catch basins at the time of flooding on August 5.

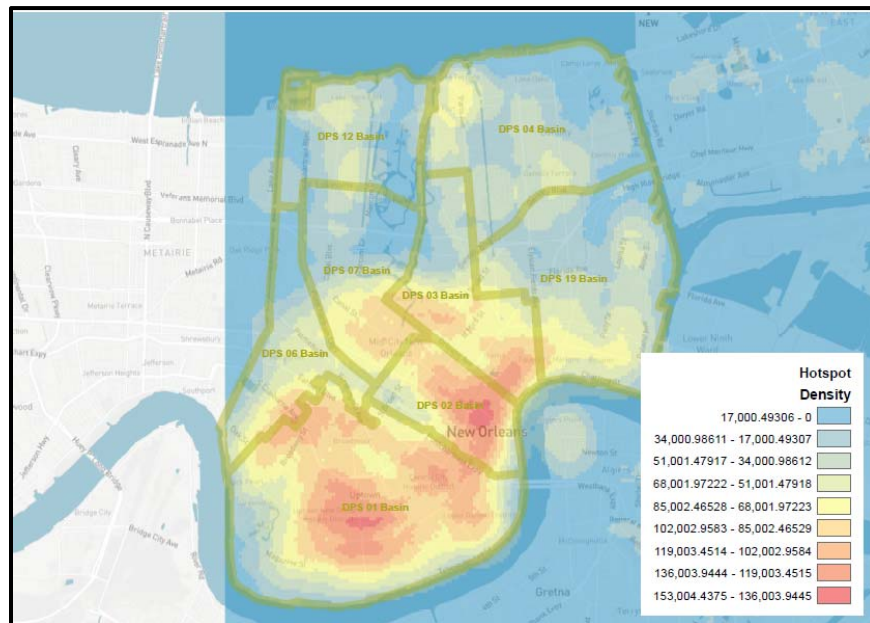
**Figure 9 "Hotspot" Density (<15-in Diameter Pipes) in the Old City**

Figure 8 shows distribution of drainage pipe sizes in the Old City. Figure 9 provides a visualization of small pipe "hot spots" or areas where undersized drainage pipes (less than 15-in diameter) are concentrated. The Veolia Condition Assessment (2017-2018) estimated from a 1 percent sample that the pipe network had 27 percent diminished capacity.

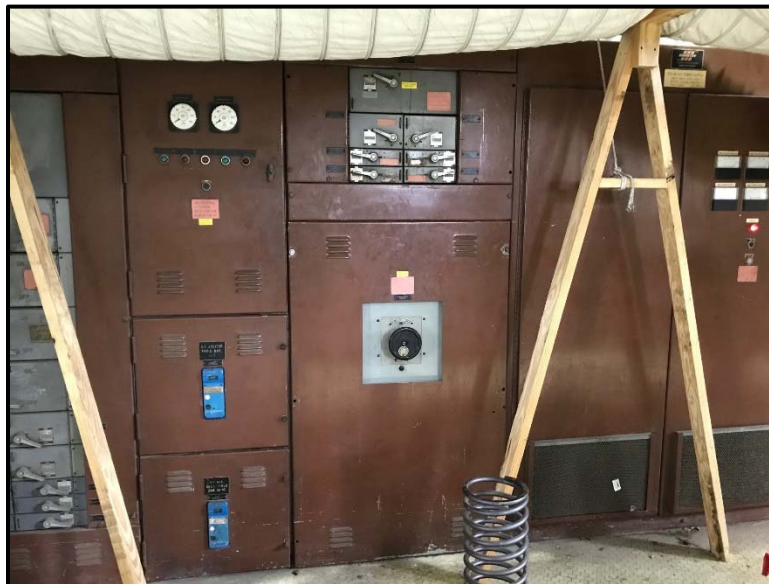
**Figure 15 Location of Field Rheostat**

The rheostat is located in the cabinet shown in Figure 15. Damage to the field rheostat is shown in Figure 16. Arcing at the contacts of the brushes on the end of the rotating arm resulted in the destruction of brushes, wiring and limit switches. Two areas of the G1- rheostat insulating board were burned at the end of the rheostat arm under the conducting brushes and at the connector strip near the F#1 and F#2 connection points.

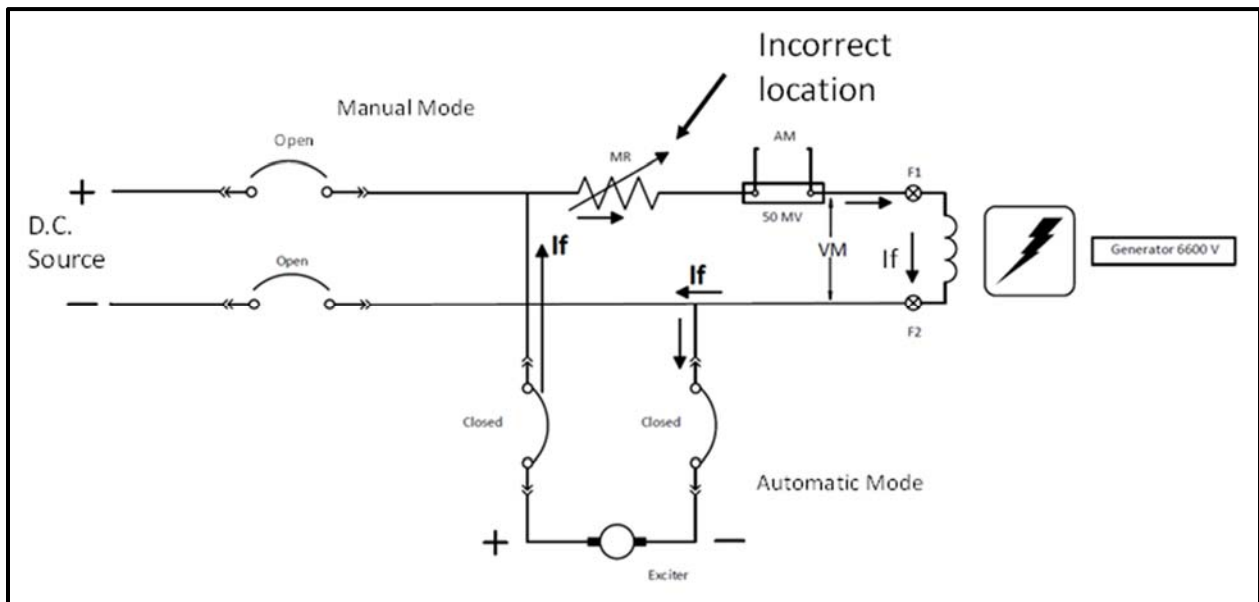
**Figure 18 One Line Diagram With Incorrect Wiring for Field Rheostat**

On May 17, 2018, a contractor from Industrial Electrical Services (IES) examined the rheostat along with S&WB electricians. They discovered that the rheostat had been wired incorrectly. The conductor for the manual mode rheostat was carrying full load current when the field exciter was in the automatic mode. The one-line diagram for the rheostat is shown in Figure 17 . Current would not normally be flowing through the manual rheostat in automatic mode because the breaker is opened and interlocked with the automatic mode breaker. Figure 18 shows the location of the rheostat connection in the mis-wired configuration.

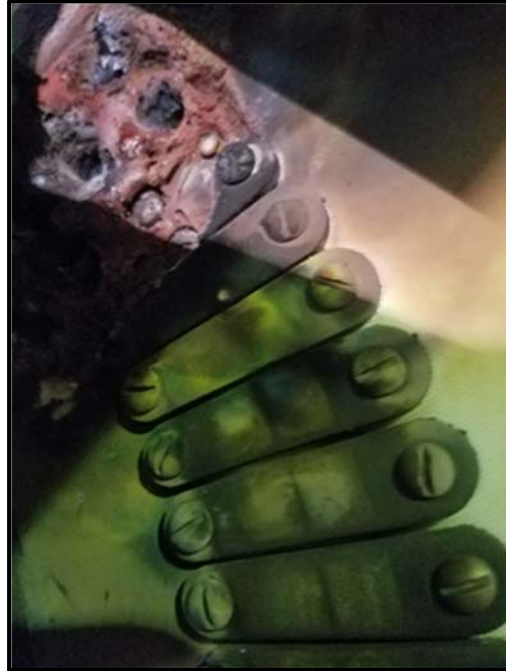
**Figure 19 Field Rheostat Damage August 9, 2017**

operated in both manual and automatic modes. This installation error should not have caused the rheostat to fail. Photos of the damage as from the failure on August 9, seen in Figure 19 show significant arcing at the end of the rotating arm. The arm contains brushes which conduct from the arm to the contact plates.

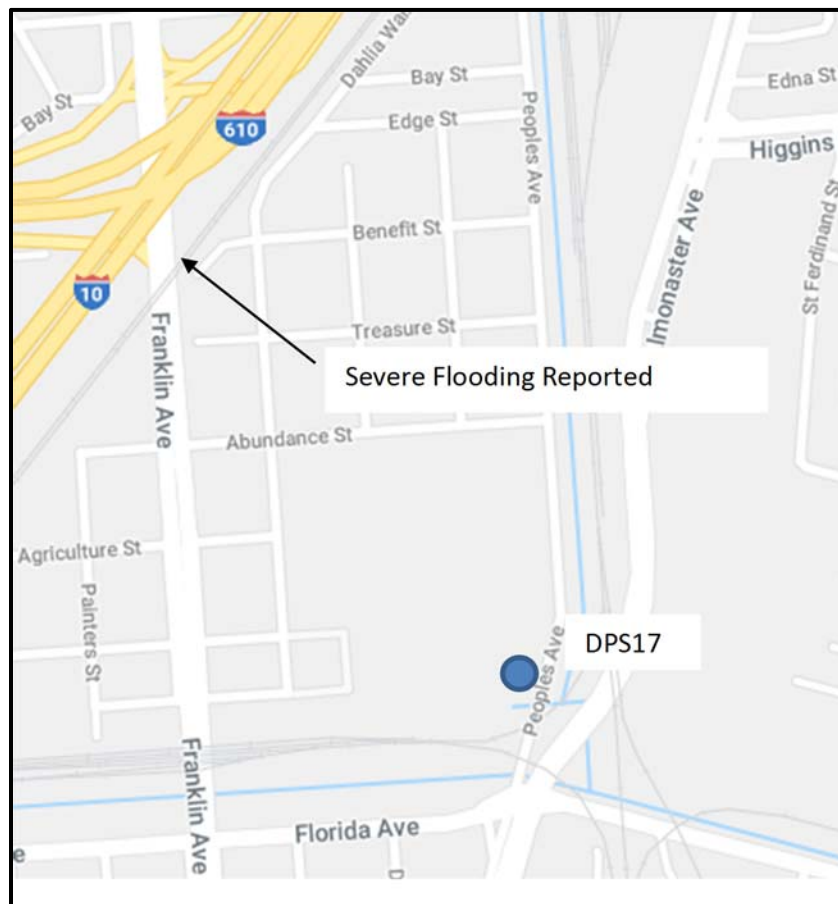
**Figure 26 Location of Flooding Near Peoples Avenue Canal**

Residents in DB 19 reported flooding in the vicinity of the Peoples Avenue Canal (or Peoples Canal) on August 5 and reported possible overflow from the canal and/or at a USACE construction site along the Canal. The Peoples Canal runs parallel to and east of Peoples Avenue from near Lake Pontchartrain toward Florida Avenue, transecting DB 4 and DB 19. Gentilly Boulevard (US Highway 90) follows Gentilly Ridge and is the boundary of DB 4 and DB 19; the Peoples Canal has a summit at Gentilly Boulevard and thus drains both north to DB 4 and south to DB 19. From south of Gentilly Boulevard to DPS 17, the Peoples Avenue Canal is an open and unlined drainage canal. From North of Gentilly Boulevard the canal is an underground culvert. Location of the most significant flooding is shown in Figure 26

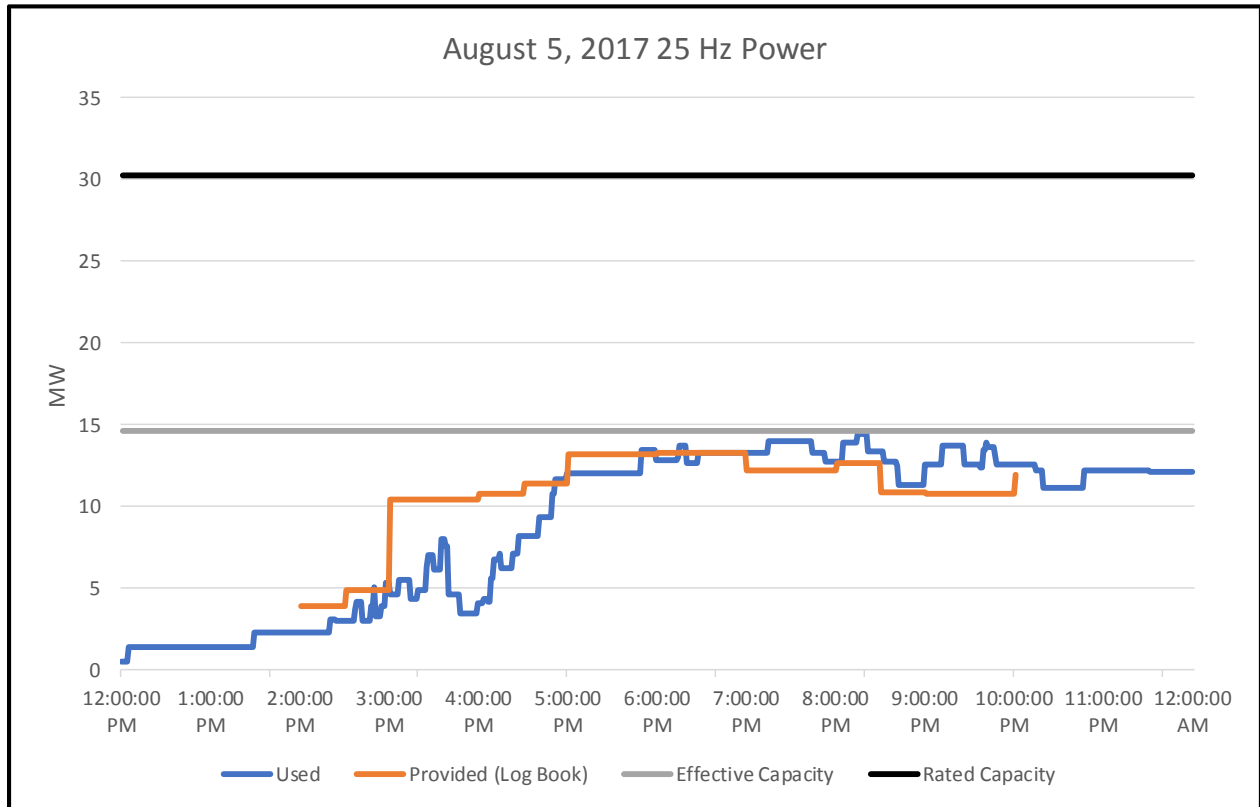
Figure 30 25 Hz Power Used by Pumps and Power Capacity on August 5, 2017

A similar analysis was prepared by the project team for this report using logbook information for generated power. Computed power used by pumps was also determined based on horsepower and operating status (off, lite, loaded). A time-history of power used, power generated and maximum power available in the system is shown in Figure 30. Figure 31 shows the power used by pumps and the power necessary to supply pumps which were requested but denied along with a total power needed. The denied power was assumed to persist until the log book indicated the pump was started. The analysis indicates the required power exceeded the available power by more than 30%.

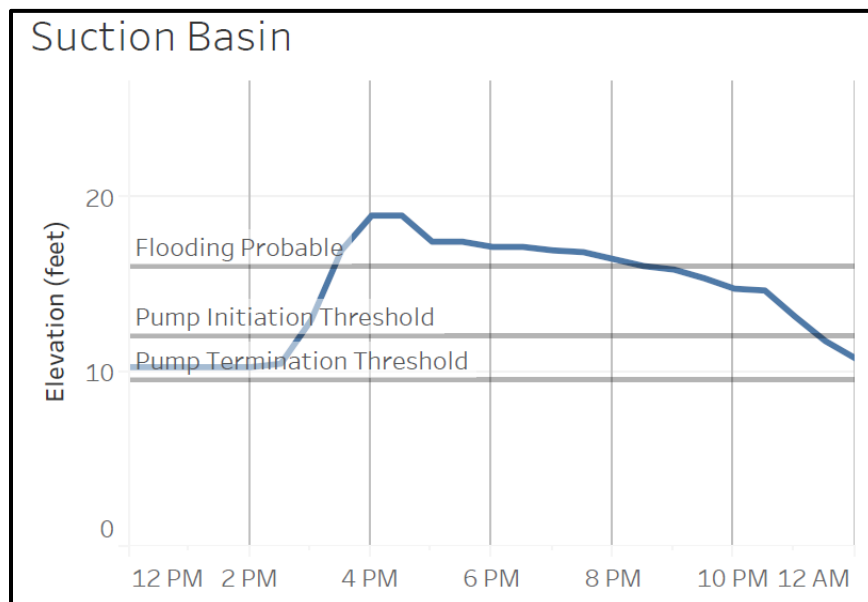
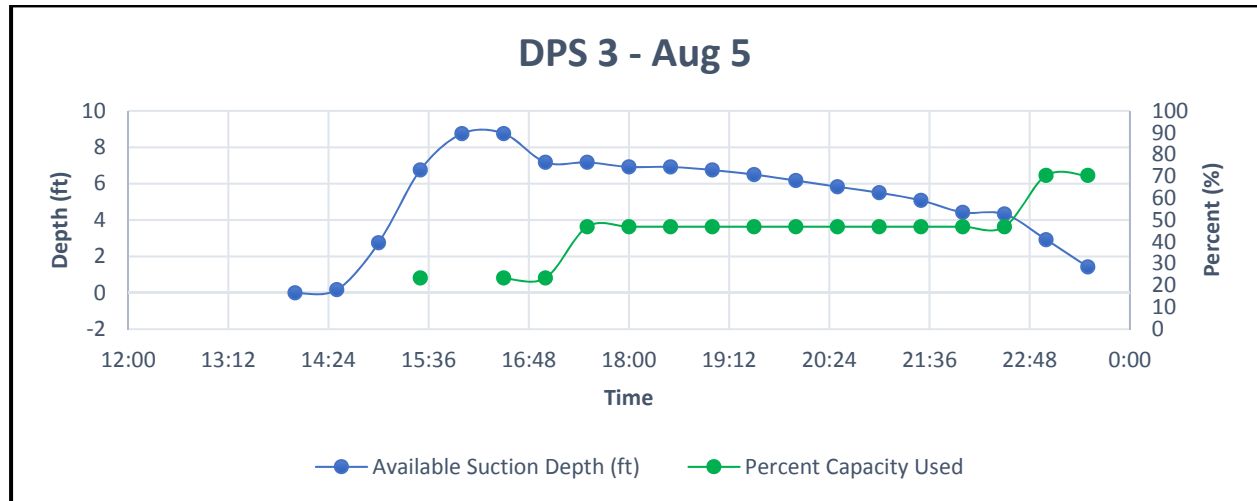
Figure 41 DPS 3 Suction Basin Levels August 5

**Conclusion.** Inability of DPS 3 to meet target pumping capacity through critical period of event was due to electrical issues (either system feeder supply problems or station feeder equipment issues). The electrical issues and difficulty in stopping pumps running in reverse quickly indicate that maintenance and repair were inadequate. While flooding would inevitably have occurred under such severe precipitation conditions, it is likely that flood depth and duration during the event could have been reduced if power supply to DPS 3 had been uninterrupted. It is also likely that flooding depth and duration would have been reduced if DPW drainage network cleaning, maintenance and repair had been accelerated.

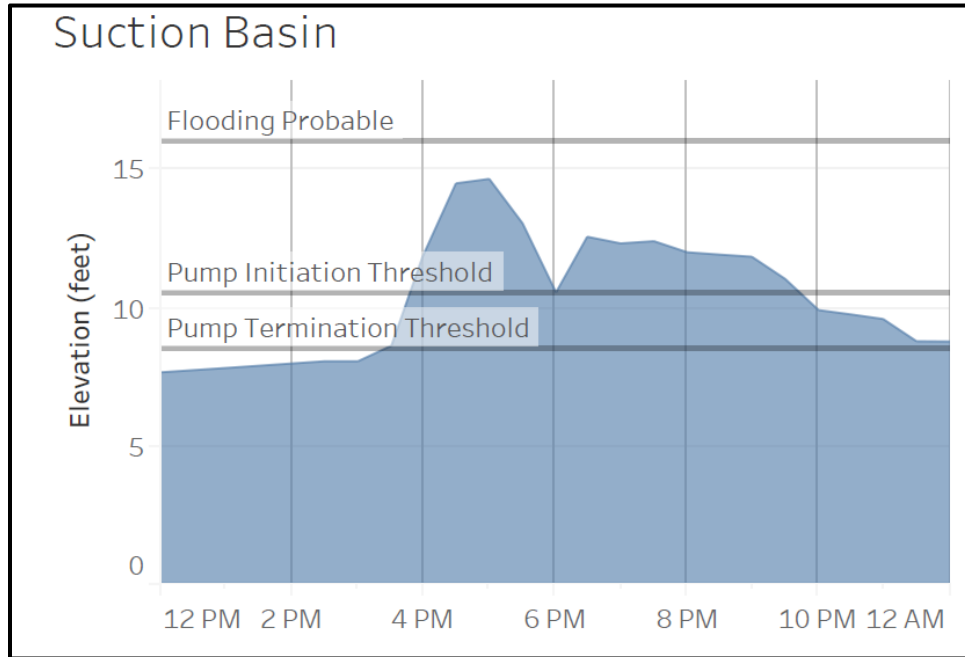
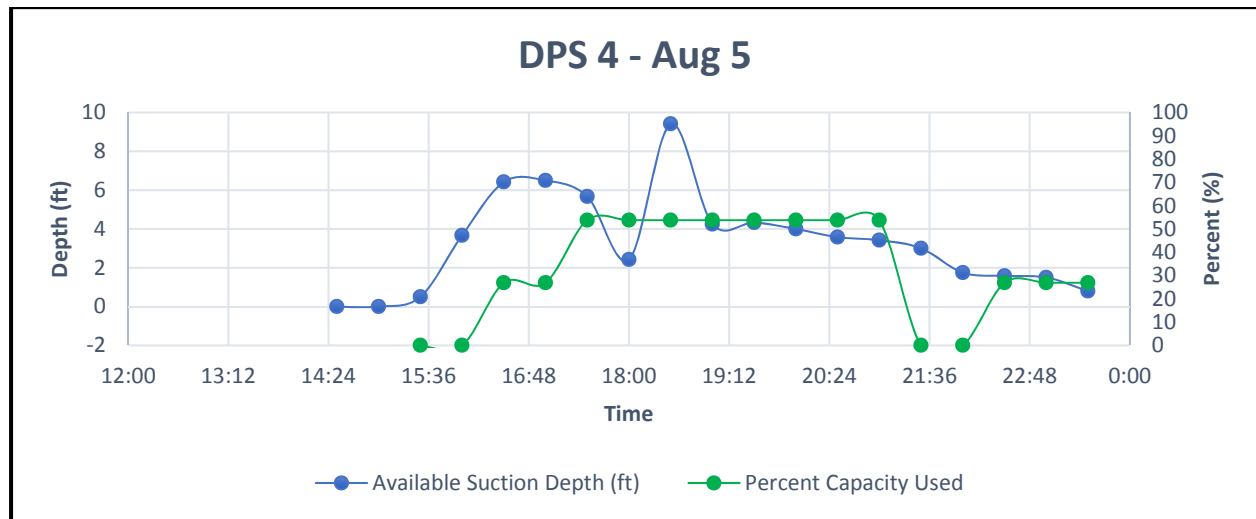
Figure 43 DPS 4 Suction Basin Levels August 5

**Conclusion.** Pump power request refusals prevented DPS 4 from attaining target pumping capacity throughout the event. It is likely that flooding during the event could have been reduced if sufficient power had been available to DPS 4 to operate an additional large drainage pump when requested.

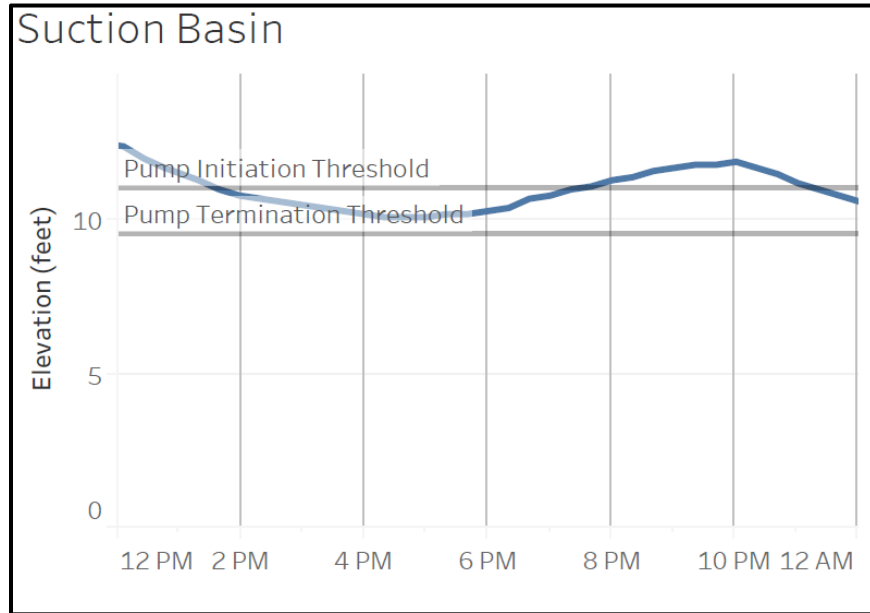
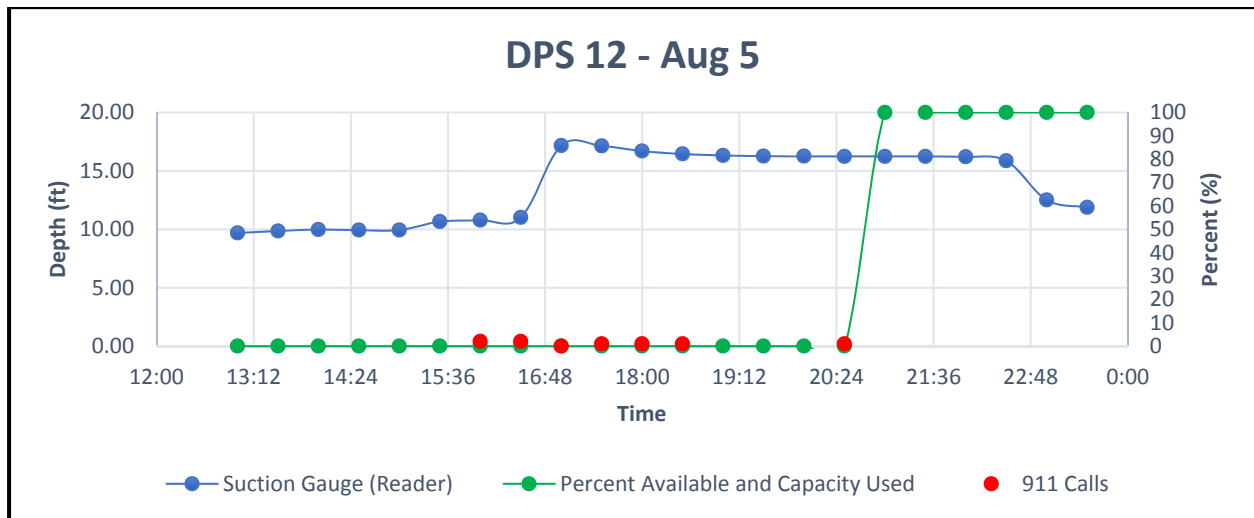
Figure 51 DPS 12 Suction Basin Levels August 5

**Conclusion.** Undoubtedly flood depth and duration in DB 12 would have been reduced had DPS 12 become operational at an earlier point in the event. As has been discussed previously, because 60 Hz I pump at DPS 6 was not in service, an operational decision was made to power 25 Hz G Pump at DPS 6 rather than 25 Hz D Pump at DPS 12, for a critical period of the event. DB 12 likely had runoff impact from DB 7, but there was also likely a miscalculation as to the drainage impact of DPS 6 within DB 12. In the event, DB 12 experienced significant flooding and DB 6 experienced less flooding.
