Sewerage and Water Board of New Orleans

Carrollton Water Treatment Plant

Water Quality Master Plan

July 2015

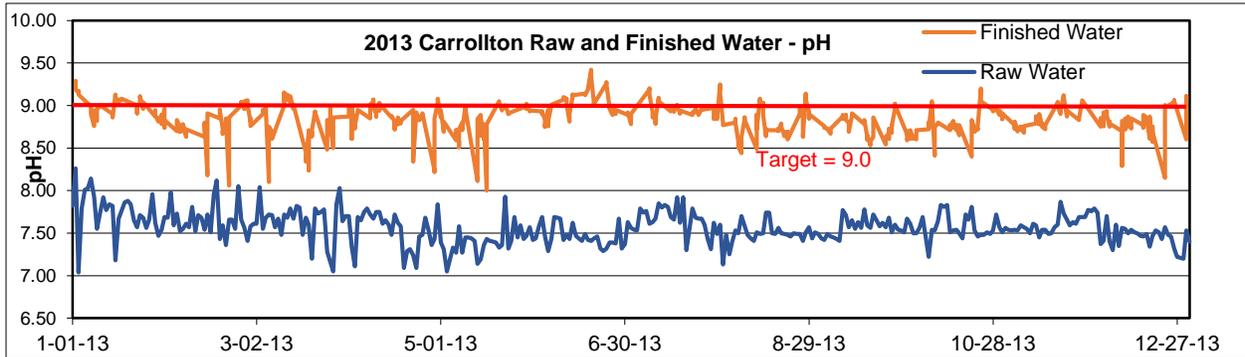
Figure 2-8: Raw and Finished Water pH

Plant staff has noted calcium precipitation in the C-Basins and filters when trying to meet the target pH of 9.0 for corrosion control in the summer. During these periods, the plant limits the

pH to about 8.7 to reduce the amount of precipitation that occurs. The plant also adds polyphosphate to help reduce precipitation on the filters. Figure 2-8 shows that the plant routinely operates at a pH below 9.0 to minimize precipitation issues. As seen in Figure 2-9, a noticeable increase in the Langlier Saturation Index (LSI) is observed in the summer months of the last four years, confirming that calcium carbonate precipitation is likely occurring as noted by plant staff.

Figure 2-8 shows that the plant cannot consistently meet the target pH of 9.0 primarily due to concerns associated with precipitation in the C Basins and filters. The target pH of 9.0 was established several years ago as the water quality goal needed for effective CCT. Although the plant is not meeting the target pH goal, the plant has consistently maintained lead and copper levels well below the action level, indicating that the current operating pH (about 8.7) is effective from a corrosion control treatment standpoint. It is recommended that the plant target a lower pH of about 8.7 throughout the year to minimize the precipitation that occurs in the C basins and filters. It is anticipated this target pH will be adequate to maintain continued compliance with the LCR. In addition, operation at the lower target pH will reduce the amount of lime addition required.

Alternatively, the SWBNO can consider eliminating pH adjustment through lime addition and convert to a phosphate-based corrosion inhibitor as a CCT strategy. This would allow for operation at a lower target pH approximately 7.3-7.8), further reducing the potential for precipitation. It should be noted that a change to a phosphate-based corrosion inhibitor would change the water chemistry in the distribution system and potentially result in potential unintended consequences (such as biological regrowth in the distribution system, increased phosphorus loadings to the wastewater treatment plant system, and increased disinfection byproduct (DBP) formation).

Given that the current strategy of adjusting pH has been very effective at meeting the LCR, it is recommended that the plant continue to use pH adjustment for CCT.

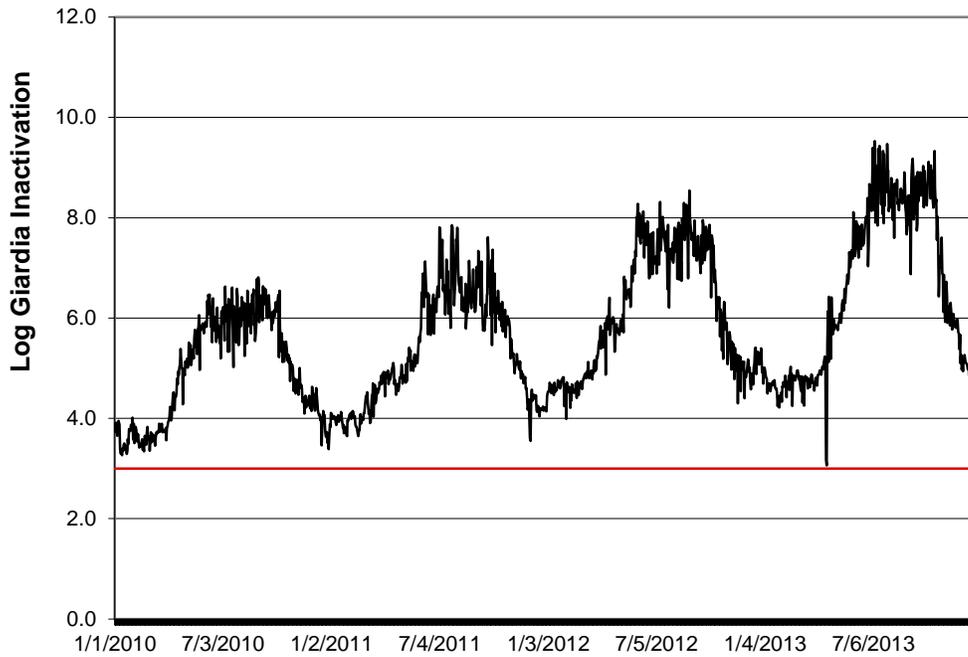
Figure 2-11: 2010-2013 CT Giardia Removal

Figures 2-10 and 2-11 show the CT for viruses and *Giardia* from 2010-2013 at the Carrollton WTP. As seen, the Carrollton WTP has consistently maintained a CT that exceeds the required log inactivation for both viruses and *Giardia*, meeting regulatory requirements.

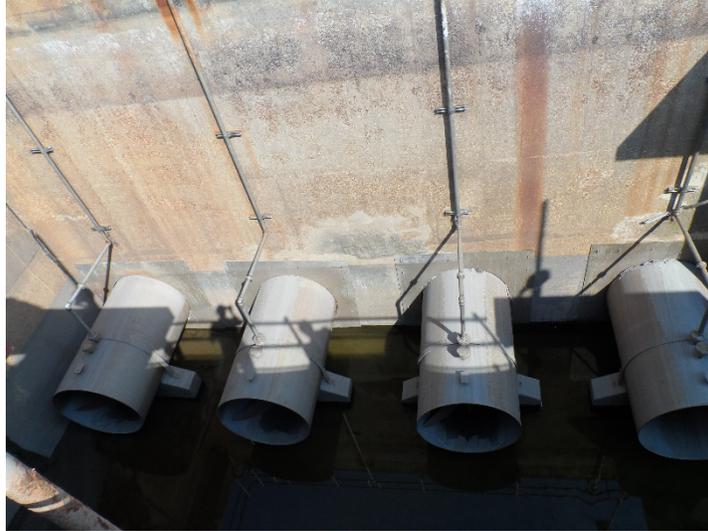
Figure 3-1: G Basin Static Mixers

Raw water enters the G Basins (G3 and G4) from a common raw water influent channel. This channel is supplied with water from three connections. These connections include two 48-inch diameter pipelines and an 84-inch diameter connection served by a 54-inch diameter pipeline. Raw water enters a G Basin through a set of three (4 ft by 4 ft) sluice gates. The water then flows through four static mixers (Figure 3-1). Currently, mechanical mixing equipment is not installed in any of the rapid mix basins. There are four mixing basins per treatment train for the G Basins for a total of 8 rapid mix basins. The dimensions of these rapid mix basins are 20' W x 120' L x 18' D with a total volume of 1,510 cubic feet (cf) and a hydraulic residence time of about 49 seconds per basin (based on a combined maximum hydraulic flow rate of 160 MGD for both basins). The calculated G value for the static mixers falls short of the recommended range. The recommended range is 600-1000 s⁻¹, currently with 4 mixers the G value is 120 s⁻¹. Optimization of the rapid mix for G Basins would require the installation of a new, low headloss mixing system. Ferric sulfate and polymer are added concurrently at the inlet of each static mixer.

- Reconfigure the rapid mix in the G-Basins to increase mixing intensity, this would include installing vertical mixers in place of the current static mixers, the addition of vertical mixers would decrease the chemical consumption of the plant and increase the G values in the mixers into the recommended range for a more effective coagulation.

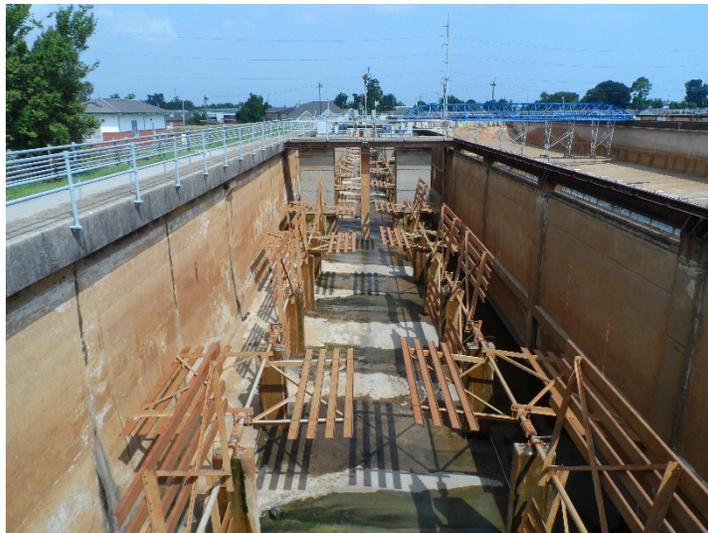
Figure 3-2: G Basin Flocculation Basin

Following ferric and polymer addition, water enters the flocculation area (Figure 3-2). Each flocculation basin is a single train with two rows of flocculators positioned in parallel to the water flow. Both rows are paddle-type flocculators mounted on horizontal drive shafts. The motors are constant speed and connected to the flocculator shafts by a drive chain. The flocculation area for both G-Basins have dimensions of 32' W x 480' L x 17'-6" D, providing a total volume of 268,800 cf and a hydraulic residence time of about 36 minutes per basin (based on a combined maximum hydraulic flow rate of 160 MGD). Each basin has adequate detention time for effective flocculation at average flow conditions. Mixing energies in the flocculators could be adjusted to promote better floc formation. This could result in improved turbidity reduction in the basins. The rotational speeds of the flocculators could be adjusted so that the G values in each stage fall within recommended ranges.

- Modify flocculator rpm in both G and L Basins, this would include installing variable frequency drives (VFDs) on the flocculators to bring the basins within the recommended G values.

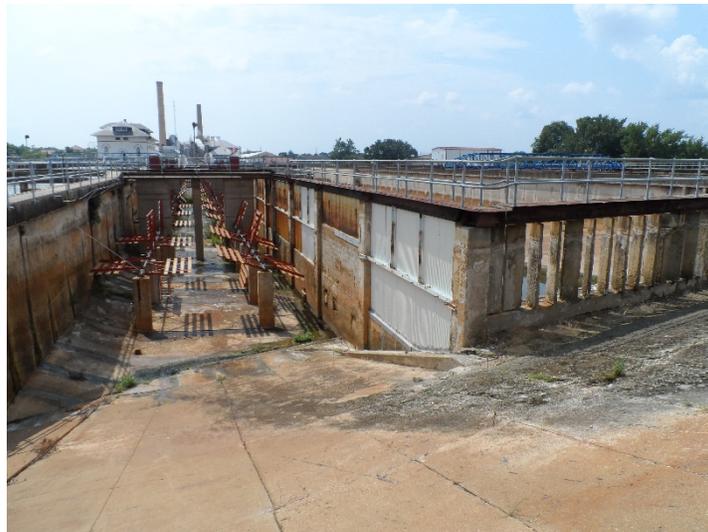
Figure 3-3: G Basin Sedimentation Basin

Flocculated water flows from the flocculation basins, around a sharp cornered turning area, through directional butterfly gates (which are currently inoperable), and into the G3 and G4 sedimentation basins (Figure 3-3). The G3 basin has a sedimentation volume of 938,875 cf. At a flow of 80 MGD, the surface overflow rate (SOR) is about 1,490 gallons per day per square foot (gpd/sf), and the detention time of 126 minutes, with a rise rate of 1.03 gallon per minute per square foot (gpm/sf). At a flow of 80 MGD, the G4 basin with a volume of 970,200 cf, operates at a SOR of 1,440 gpd/sf and theoretical detention time of 130 minutes, with a rise rate of 1.0 gpm/sf. The recommended SOR range for a conventional settling basin is between 700 to 1,000 gpd/sf with a typical value of approximately 850 gpd/sf. As seen, the SOR of the G Basins is approximately one and a half times higher than the maximum recommended SOR for effective clarification. Based on achieving a SOR of 1,000 gpd/sf, the maximum combined treatment capacity of G3 and G4 Basin is approximately 110 MGD.

The horizontal velocity through the basins is about 4.0 feet per minute (ft/min) and the weir loading rate is about 172,000 gpd/ft based on a combined maximum flow rate of 160 MGD. The recommended weir loading rate typically ranges between 17,300 – 26,000 gpd/ft. The weir loading rate for the G Basins is currently approximately ten times higher than recommended rates for sedimentation basins. The current sedimentation process in the G basins is limited due to the existing design configuration that leads to a SOR that is well above design standards.

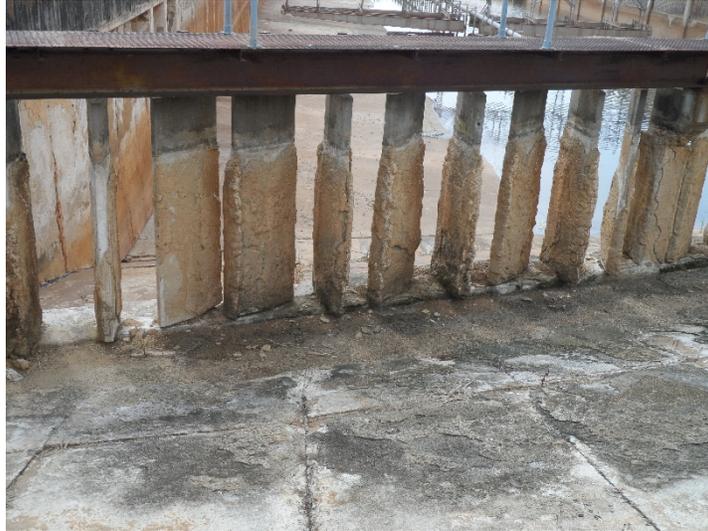
Figure 3-4: G Sedimentation Basin Inlet Butterfly Gates

The inlet butterfly gates of the G Basins are largely inoperable due to calcification and corrosion from past softening operations. The gates are positioned at various angles as seen in Figure 3-4, with some completely open and others completely closed. As a result, influent flow is likely preferentially channeled through the open gates resulting in an uneven flow distribution into the basins and reduce the effective settling area of the basins by the formation of dead spots.

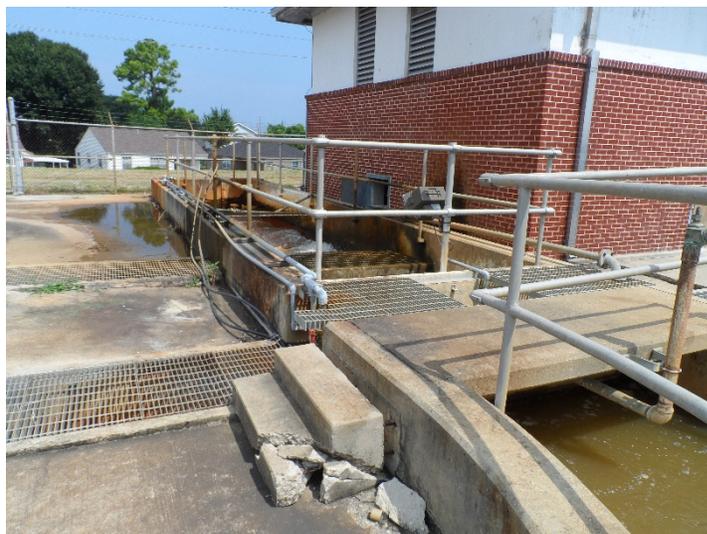
Figure 3-5: L Basin Static Mixers

A single 48-inch diameter pipeline supplies raw water to each of the two L Basins (L3 and L4). The influent passage into each basin is an eight-foot wide channel. Downstream of the influent channel, the raw water flows over an inlet weir and splits between either of two flocculation basins. A single static mixer in each L Basin provides the required hydraulic mixing of the coagulant and polymer. The G value for the static mixer (Figure 3-5) operates within the recommended range of 600-1000 s⁻¹, currently the L Basin has a G value of 728 s⁻¹, as evidenced by significant turbulence observed within the rapid mix channel.

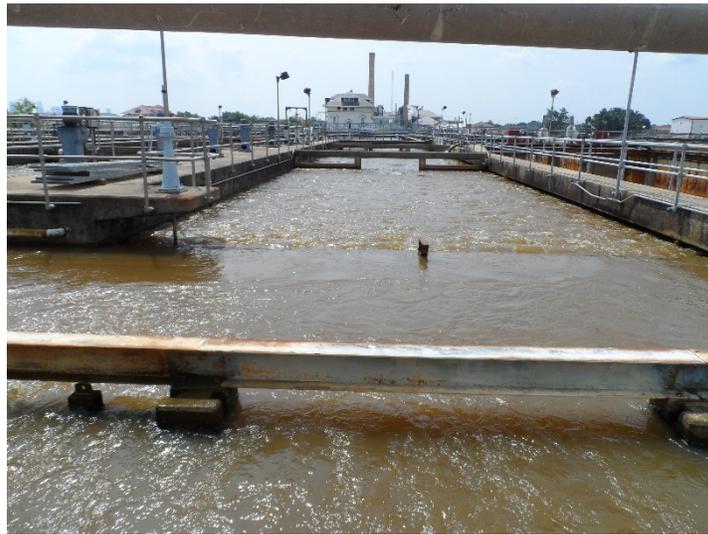
Figure 3-6: L Basin Flocculation Basin

Following ferric sulfate and polymer addition, water enters the flocculation basins (Figure 3-6). Each flocculation basin is divided into two parallel trains with ten rows of flocculators positioned perpendicular to the water flow. The individual rows include three, paddle-type flocculators mounted on a horizontal drive shaft. A single motor located between the two parallel basins operates two adjacent drive shafts (Figure 3-7 and 3-8). There are four flocculation basins with dimensions of 32' W x 150' L x 17'-6" D, with a volume of 84,000 cf and hydraulic residence time of 45 minutes (at a combined flow rate of 80 MGD). The flocculators are paddle-type (4 paddles per mixer), there are 10 rows with 3 mixers per row. The L-Basin flocculators have constant speed motors, which limits the manipulation of the flocculation process. This may inhibit optimization of the flocculation and coagulation process.

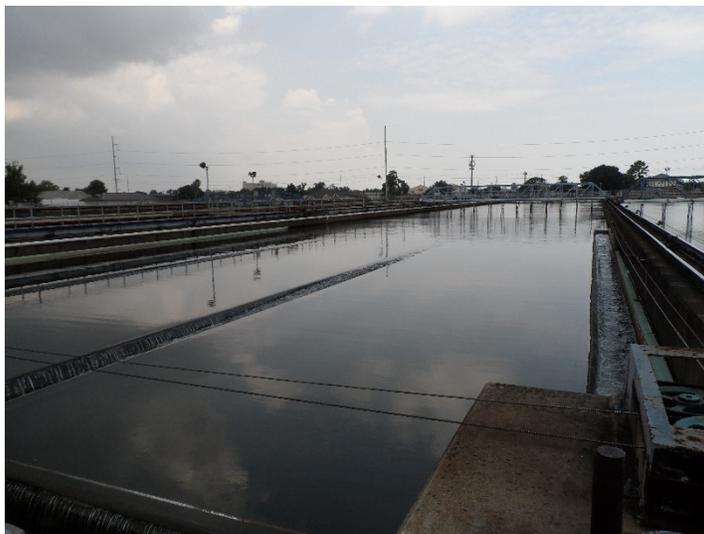
Figure 3-9: L Basin Sedimentation Basin

Flocculated water enters each sedimentation basin (Figure 3-9) through a fiberglass, ported baffle wall. There are two sedimentation basins (L3 and L4) with a volume of 402,000 cf and average depth of 14 ft. At a flow of 40 MGD through each L basin, the SOR is about 1,390 gpd/sf, and the detention time is about 108 minutes, this is less than the 240 minutes (4 hours) detention time that Ten States Standard recommends. The recommended SOR of a conventional settling basin is 700 to 1000 gpd/sf with a typical value of approximately 850 gpd/sf. As seen, the SOR of the L basins is approximately 1.4 times higher than the maximum recommended SOR for effective clarification. Based on achieving a SOR of 1,000 gpd/sf, the maximum combined treatment capacity of the L3 and L4 Basins of approximately 58 MGD.

The horizontal velocity through the basins is about 3.8 feet/minute and the weir loading rate is about 62,000 gpd/feet based on a combined maximum flow rate of 80 MGD. The recommended weir loading rate typically ranges between 17,300 – 26,000 gpd/sf, as such, the weir loading rate for the L Basins is approximately three times higher than the recommended rates for sedimentation basins.

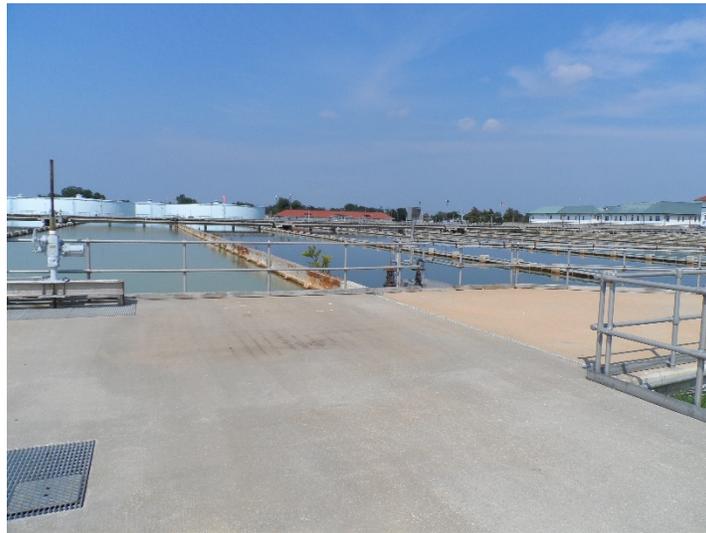
Figure 3-10: C Basins

Settled water from the G and L Basins is combined and routed to the C Basins (Figure 3-10), which provide additional clarification and primary disinfection contact time. Chlorine and ammonia are added at the inlet to the C Basins to form chloramines for primary disinfection. Lime and polyphosphate are also added at the inlet of the C Basins to adjust pH for corrosion control. There are three C basins (C1/2, C3/4 and C5/6). C1-C4 provide a combined surface area and average depth of 346,000 sq. ft and 12.7 ft, respectively; while Basins C5/6 provide a combined surface area and average depth of 262,000 sq. ft and 13.2 ft, respectively. The active C-Basins have a total volume of about 59 million gallons. At a design flow of 160 MGD, this volume provides about a 9 hour contact time.

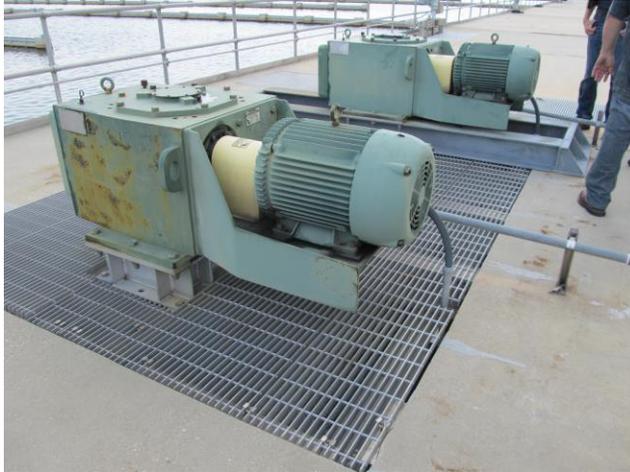
Figure 3-11: Flash Mixers (with redesigned base-back mixer)

The C basins have two 50 hp flash mixers (Figure 3-11) used for mixing the sodium hypochlorite solution prior to entering the C basins. The flash mixers were added shortly after 2000 and are in good condition. It was noted that one of the mixers had excessive flexing of the base support. To address this issue, the base has been redesigned and replaced with a longer base on the adjacent mixer. A longer base was onsite at the time of the inspection to replace the base on the remaining mixer.

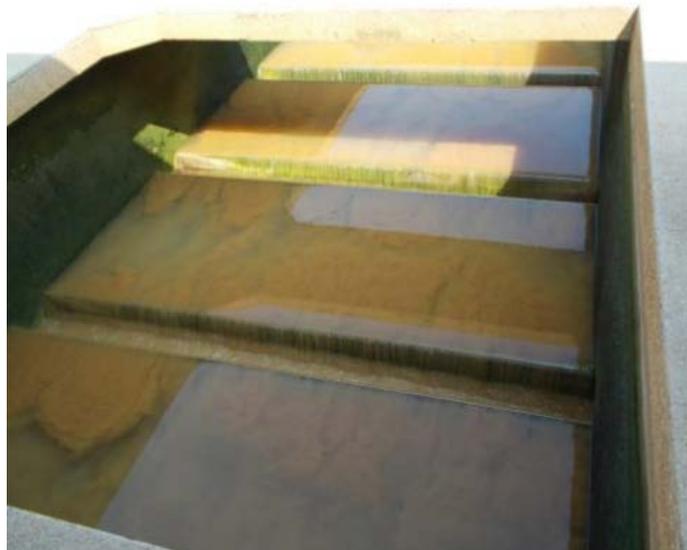
Figure 3-13: Example of Debris in Filter

- Media loss has led to a decreased level of anthracite. As little as 2 inches of anthracite is measureable in some filters.
- Debris and mudballs present in filters will lead to diminished run times and filter effluent quality, see Figure 3-13.

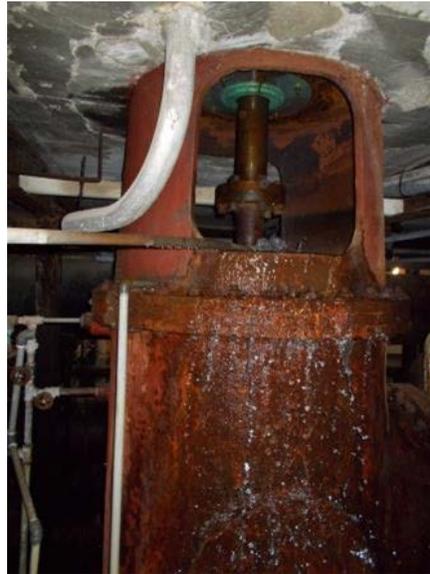
Figure 3-14: Existing Backwash Pump

of the inspection and ran smoothly. There was a considerable amount of water leaking through the stuffing box even when the pump was not running. The packing gland is located below the water level of the filter beds. The water from the leaking stuffing box drains to the sump pumps in the filter gallery. The plant operator stated that the machine shop has to regularly repack the shaft gland. Plant personnel indicated that there is a problem with the shaft or bearings requiring the constant repacking of the shaft gland.

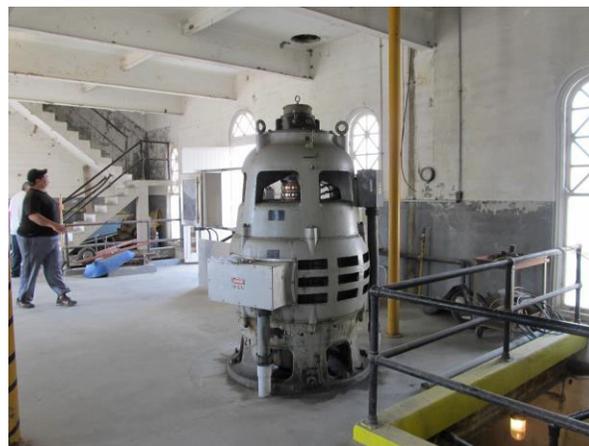
Figure 3-15: Backwash Pump

The Sycamore filters have a single backwash pump, which is estimated to be 70 to 80 years old. The backwash pump (Figure 3-14 and 3-15) is a vertical, direct-drive mix flow pump. The pump discharge is 36 inches in diameter. The drive is an electric motor rated for 200 hp at 450 revolutions per minute (rpm). The motor was converted from 25 hertz (Hz) to 60 Hz in 1983. There is no record of a comprehensive rebuild during the life of the pump, which is a long time for a pump to be in continuous service without a rebuild. The pump operated at the time

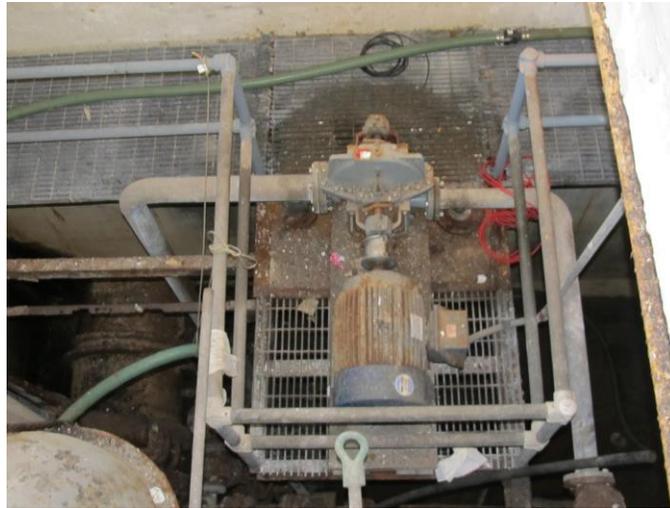
Figure 3-16: Booster Pump

There are two booster pumps (Figure 3-16). Many of the valves in the Sycamore Filter Gallery are hydraulically operated. The booster pumps are used to boost water pressure to a level needed to operate the hydraulically-operated valves. One booster pump is an in-line pump with a water line from the water distribution system and boosts the water pressure from approximately 60 to 65 pounds per square inch (psi). The second pump draws water from the clearwell at the filter complex and pumps it into the water line serving the hydraulic

system. The second pump is designed to provide operating pressure for the hydraulic system in the event of loss of pressure from the water distribution system, but it can also be used to boost water pressure by supplying additional water to the line operating the hydraulic system.

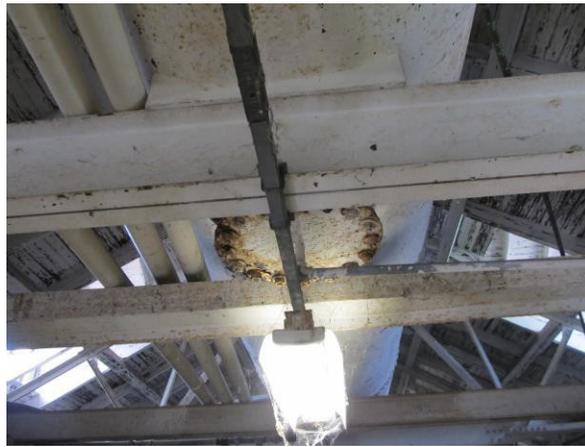
Figure 3-18: Air Receiver

The compressed air system at the Sycamore Facility consists of an Ingersoll Rand compressor (Figure 3-17) rated at 446 standard cubic feet per minute of air at 125 psi and an air receiver (Figure 3-18) with an estimated volume of 1,200 cf. Maximum compressor operating pressure is set between 85 to 90 psi. The air compressor was installed in 2004. The air tank is believed to date back to the earliest filters constructed around 1906. The compressor was operating at the time of the inspection and is in good condition. The air system has a cross connection to the 25-cycle power generator building air system for auxiliary compressed air. The compressor is also used as an auxiliary unit for the compressed air system at the power generation plant.

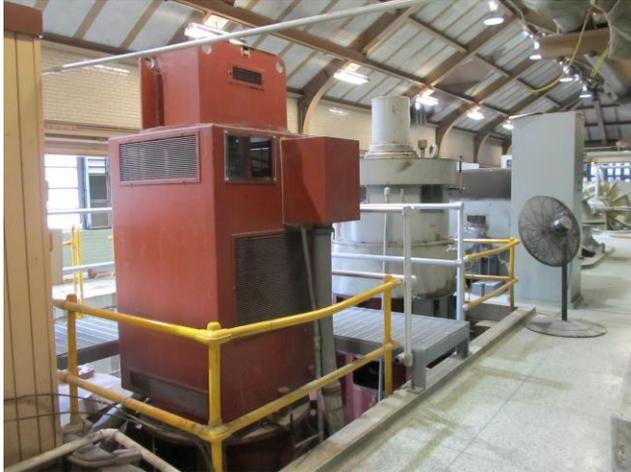
Figure 3-20: Storage Tank Pumps

There are two pumps (Figure 3-20) for pumping from the filters to the storage tanks. The pumps are driven by 350 hp motors. The pumps are located in a building housing pumps for the distribution system and controls for the Claiborne Filters. Both pumps are 48-inch mixed-flow pumps. The total dynamic head (TDH) for the pumps is estimated at 40 feet since the storage tanks tops out at 30 feet. Both pumps have 25 Hz motors. The newer pump has four speeds, from 265 rpm to 350 rpm. The older pump has 16 speeds. Both pumps are in good condition. The plant should continue to maintain these pumps in accordance with the manufacturer's recommended schedule.

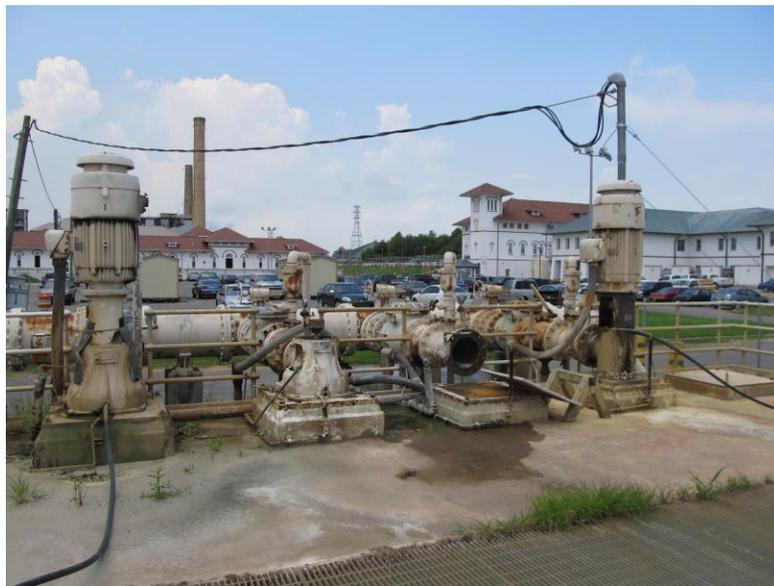
Figure 3-21: Recycle Pumps

There are four back wash water recycle pumps (Figure 3-21). The pumps are designed to transfer water from the Backwash Waste Equalization Basin to the G and L Basins for recycling of spent backwash water to the head of the plant. Two of the pumps are 75 hp units and two are 150 hp units. Presently, one of each of the 75 hp and 150 hp pumps is operating; the others have been removed. There is a spare mount for a fifth pump. Overall, the recycle pump facility is in poor condition with only two of the four pumps operable. The remaining pumps are operational but their life expectancy is limited. There is an ongoing contract to remove the two remaining pumps and replace them with new pumps.

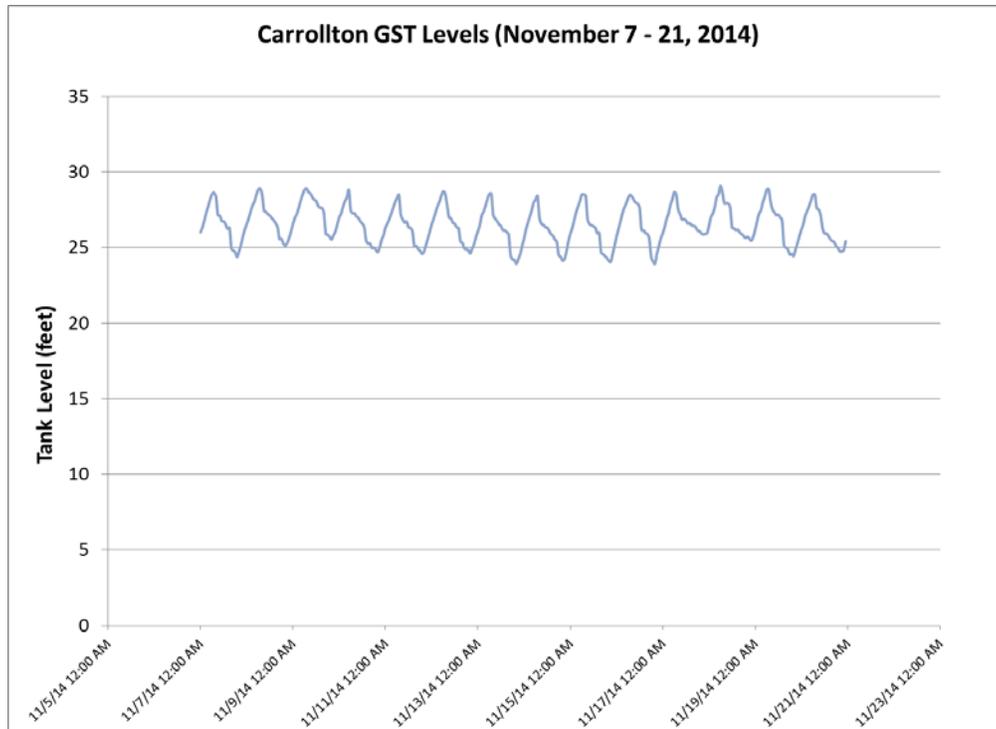
Figure 3-22: Carrollton Steel GST Levels (November 7-21, 2014)

The SWBNO provided GST level data for a two week period in November (Figure 3-22). Based on the data provided, the tanks do have regular daily fill and draw patterns. The most significant observation regarding the tank level data is the amount of turnover. There is approximately 5 feet of draw down in the tank on a daily basis – or roughly 15 percent of the tank volume (5 feet divided by 30 feet total depth). More turnover would help to better maintain water quality within the tanks. Regarding the fill and draw cycles, for the period evaluated, the tank is filled over a roughly 12-hour period and drains over a 12-hour period. Generally speaking, this is a nearly ideal situation as it maximizes mixing during both the fill and draw cycles. However, further evaluation is needed to assess mixing parameters such as inlet velocity to determine the effectiveness of the mixing.

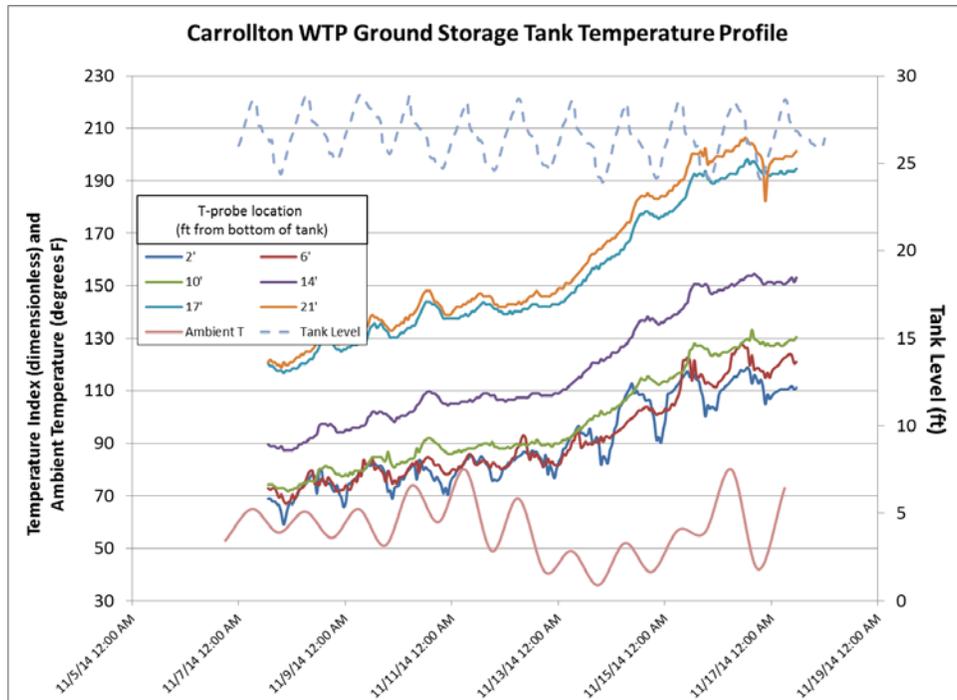
Figure 3-23: Carrollton GST Temperature Profile (November 15 – 19, 2014)*

Temperature probes were installed in one of the Carrollton steel GSTs for a period of approximately ten days in November 2014. Figure 3-23 shows the results of the temperature monitoring, as well as the tank level and ambient temperature during the monitoring period.

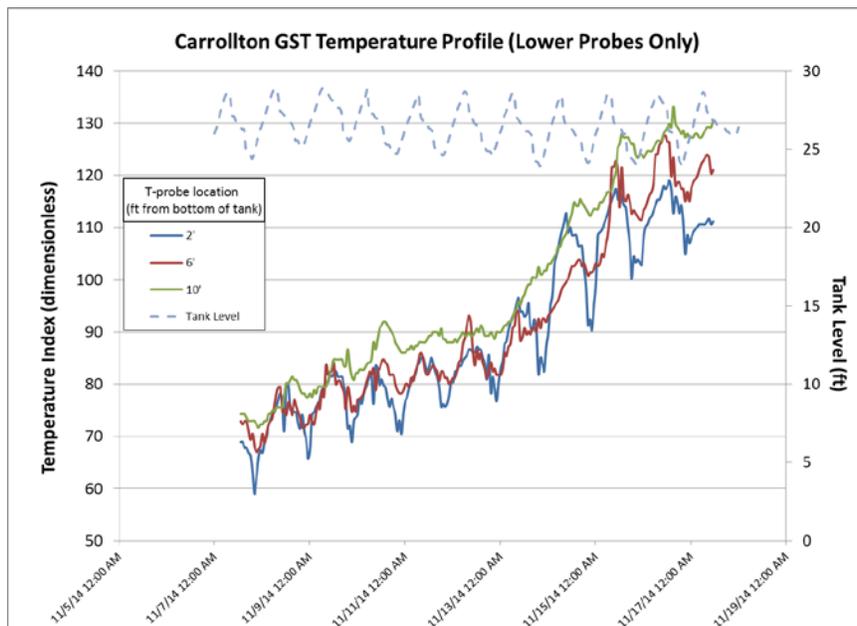
Figure 3-24: Carrollton GST Temperature Profile Lower Probes Only (November 15 – 19, 2014)*

probes begins to diverge indicating thermal stratification. However, the temperature indices of these three probes converge during the fill cycle, indicating that at least the bottom third of this tank is mixing (at least in the vicinity of the temperature probes which were installed in the general vicinity of the inlet pipe). Unfortunately, due to the quality of the data no further conclusions can be drawn regarding the mixing efficacy of the tank.

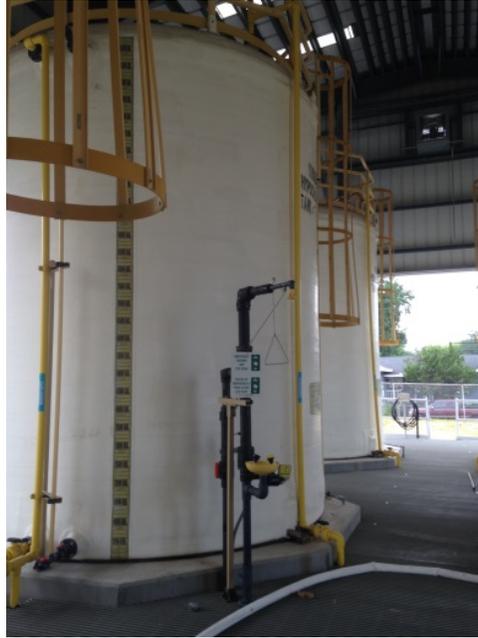
Figure 3-25: NaOCl Storage Area Personnel Washdown Area

The sodium hypochlorite storage and feed system at the Carrollton WTP is the newest system at the plant, having been placed in operation within the past two years. This is a liquid system providing the chlorine as sodium hypochlorite. Sodium hypochlorite (NaOCl) is stored in fiberglass reinforced plastic (FRP) storage tanks, located in a covered containment area (see Figures 3-25 and 3-26). A corrosion resistant coating covers the containment area. While the storage area has a personnel wash down station (Figure 3-25), the area does not have a dedicated potable water supplied wash down station. To wash down the area, plant personnel must utilize hose laid across the decking from the G-Basin area, creating a tripping hazard.

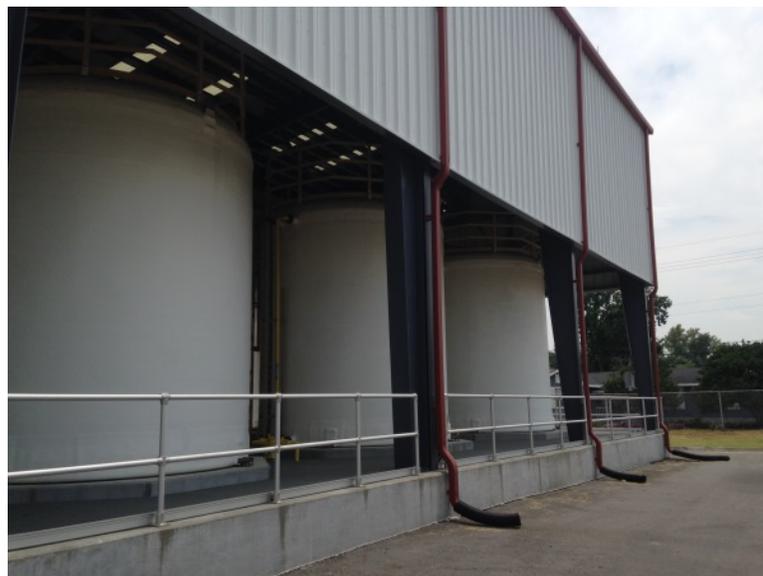
Figure 3-26: NaOCl Storage Area

. There are 8 bulk storage tanks that each hold 15,000 gallons, for a total storage capacity of 120,000 gallons. Approximately 6,000 gallons of hypochlorite are used on a daily basis. The plant currently only uses one side of storage tanks (60,000 gallons of storage) to reduce the amount of chemical stored to minimize the degradation of the hypochlorite. The current sodium hypochlorite dosage is 5.6 mg/L which results in a usage of about 6,700 gallons per day

assuming a flow of 144 mgd. The storage currently utilized provides about 10 days of storage at this feed rate and flow.

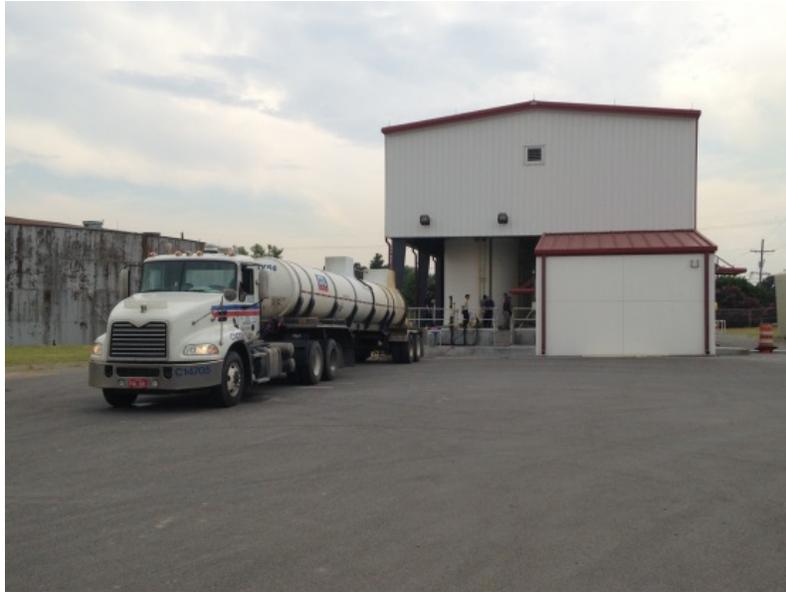
Figure 3-27: NaOCl Unloading

NaOCl is delivered to the plant in trucks and unloaded at an access point outside the containment area towards the southwest corner of the plant site. Figure 3-27 shows a delivery truck unloading NaOCl. Figure 3-28 shows the piping used in the delivery of NaOCl.

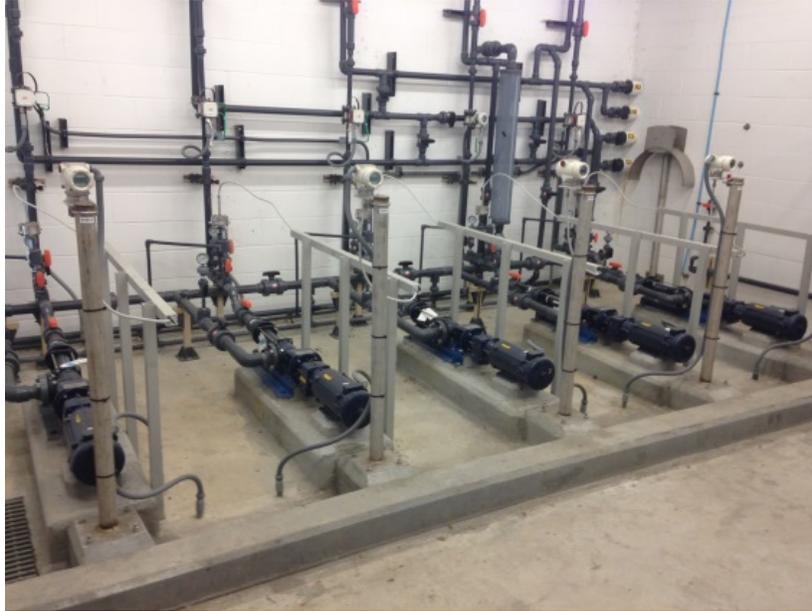
Figure 3-29: NaOCl Feed Pumps

of this containment area. The raised, reinforced concrete pump bases are not coated with a corrosion resistant coating. There are five 1.5 hp Seepex feed pumps. The pumps appear in good condition and plant staff noted that the pumps work well. All hypochlorite is currently added before the C Basins.

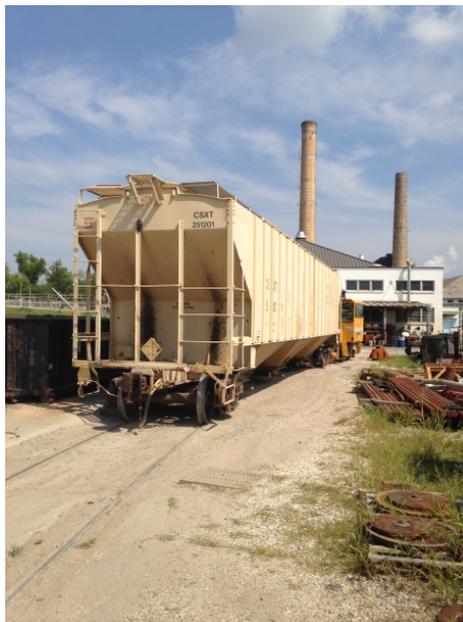
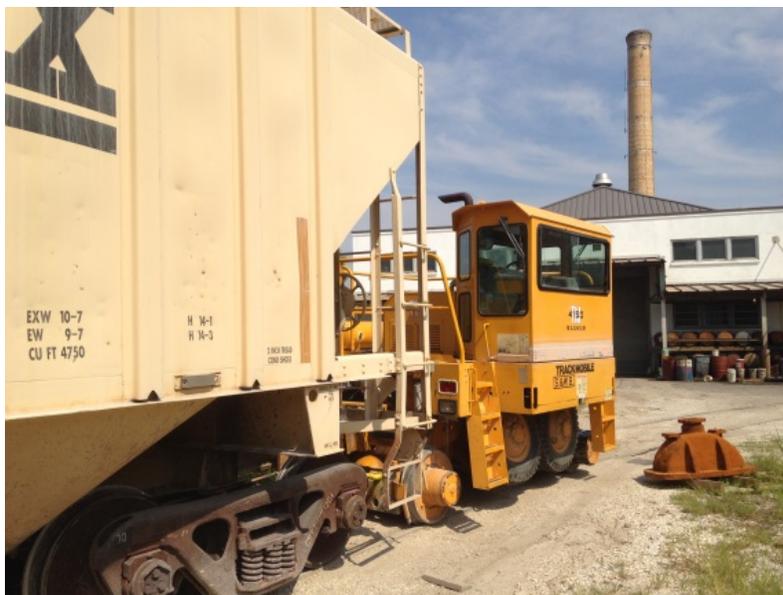
Figure 3-31: Lime Rail Car and Tug

The Carrollton WTP lime storage and feed system is a challenge with respect to maintenance and safety. Overall, the lime handling, storage, slaking, and feed components have exceeded their useful service life. The system is old and requires labor intensive measures to keep operational. The system is in need of replacement to ensure continued reliable and safe operation. Prior to replacing the existing lime system, the use of lime and alternatives to a “slaked lime” should be examined and evaluated, including the elimination of lime altogether and changing the corrosion control strategy for the Carrollton WTP.

A yellow “tug” is used to move the lime hopper car from the railroad drop-off point, down a residential street into the Carrollton WTP and to the unloading area next to the Chemical Building (see Figures 3-31 and 3-32). After unloading the lime, plant personnel must return the empty hopper cars to the railroad “drop-off” point for pick up by the railroad. The street along which the hopper rail car must be moved is of typical residential street width with rails installed down the center. To ensure adequate safety clearances plant personnel must contact residents along the street to advise them of the operation and to request they move any cars parked along the street. Unmoved cars can delay this operation for hours. Rail car operations are now accomplished by plant operations personnel as an additional duty. Thus, when a rail car is moved, other plant duties are postponed.

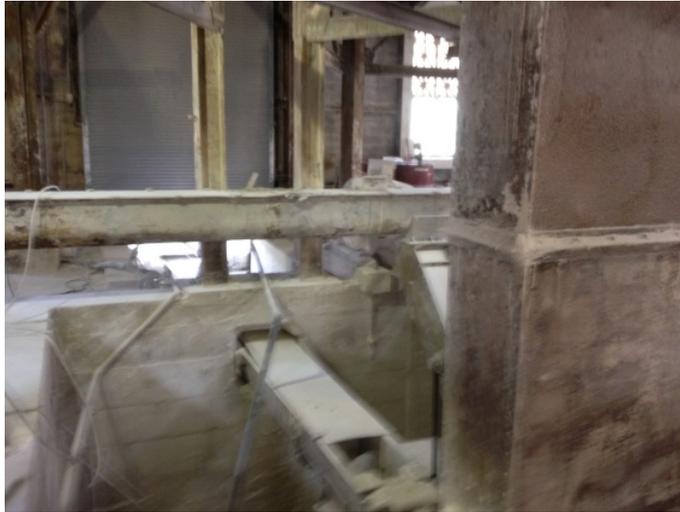
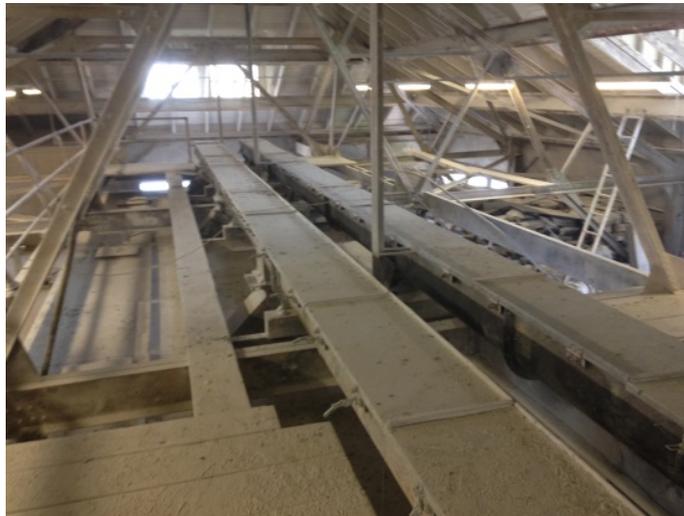
Figure 3-33: Lime Unloading Conveyor Receiving Lime from Rail Car – Ground Floor

Lime drops from the bottom of the rail hopper car into a pit outside the Chemical Building, where it is moved by a conveyor into a hopper within the building, see Figures 3-33 and 3-34. At an average lime dosage of 22 mg/L and average flow rate of 144 mgd, approximately 10 tons per day of lime are used. Each of the eight bulk storage tanks provides about 100 tons of storage, resulting in a total storage time of about 80 days. The average feed rate for lime is 26,400 lb/d. Each of the three lime slakers has a capacity of 4,000 lb/hr which provides a total slaking capacity of 288,000 lb/d. Each of the five lime feed pumps has a capacity of 100 gpm which provides adequate capacity to meet required feed rates.

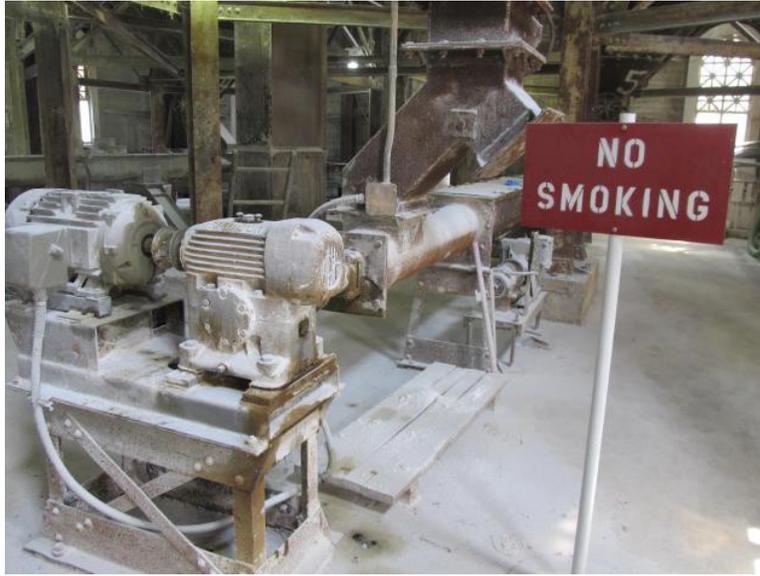
Figure 3-35: Lime Screw Conveyor

A vertical conveyor system (Figure 3-35) is used to transport lime from the rail cars to overhead storage bins. From the overhead storage, the lime is fed to one of two operable slakers on the second floor of the Chemical Building. The slakers process the raw lime to a liquid form for pumping by the lime pumps located on the bottom floor. There are eight screw conveyors, each operated by a 5 hp motor through a worm gear reduction. Only one screw conveyor was operating at the time of the inspection. The conveyor operated as intended with no reported problems. The backup to this system is truck delivery of lime. The delivery trucks are equipped with a pneumatic system which delivers the lime directly to the overhead storage bins.

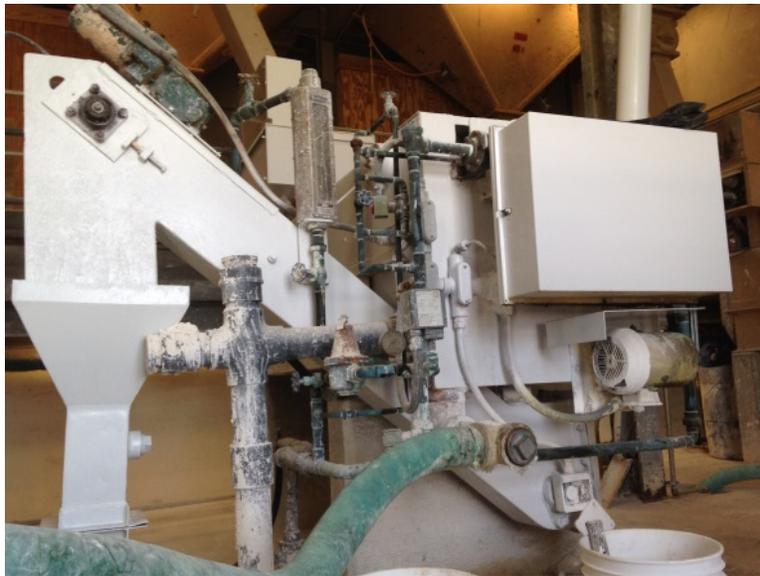
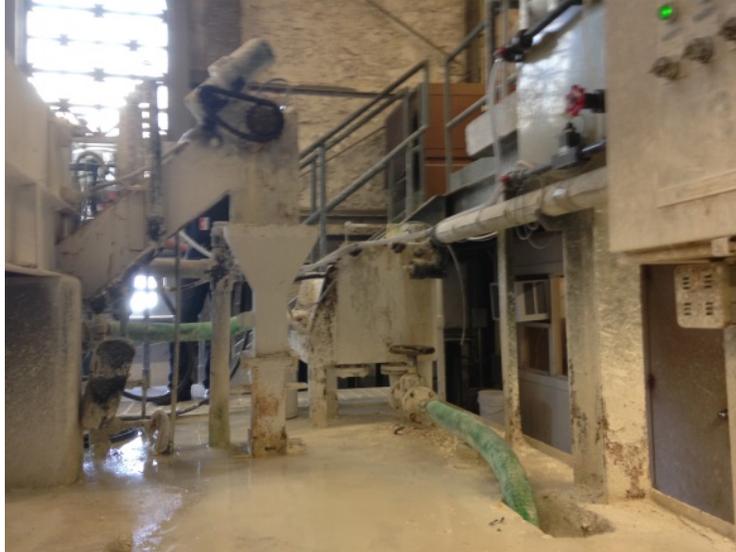
Figure 3-36: Lime Slaker

The lime slakers (Figure 3-36 and 3-37) have exceeded their expected useful service lives. Plant operators reported that the slakers require extensive, almost continual maintenance. Personnel often use salvage parts from an inoperable unit to repair other units.

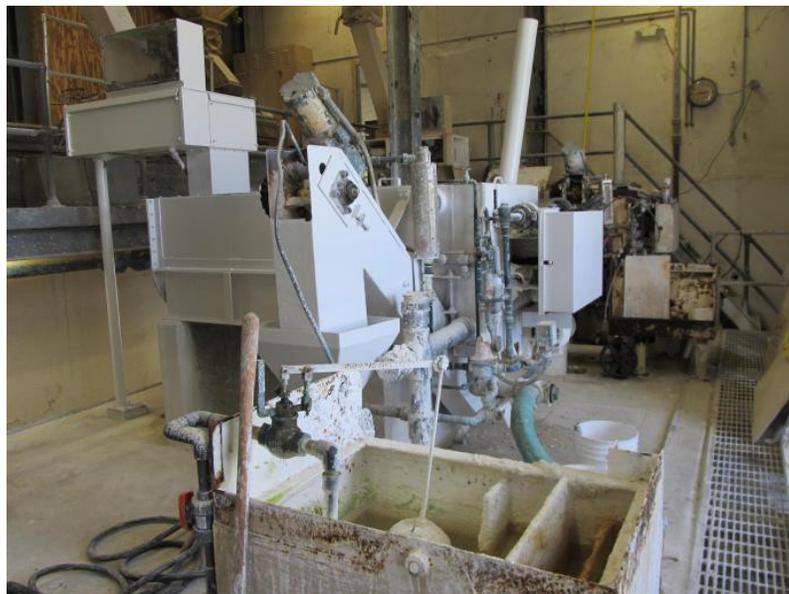
Figure 3-38: Lime Slaker

There are three lime slakers (Figure 3-38) manufactured by Wallace & Tiernan. Two of the slakers are operable while the third is used for spare parts. The slakers are over 20 years old and should be replaced with newer more efficient models currently available. Each slaker has a maximum capacity of 4,000 pounds per hour (lbs/hr), with one slaker typically used at a time. Current lime use is approximately 28,000 pounds per day (lbs/day).

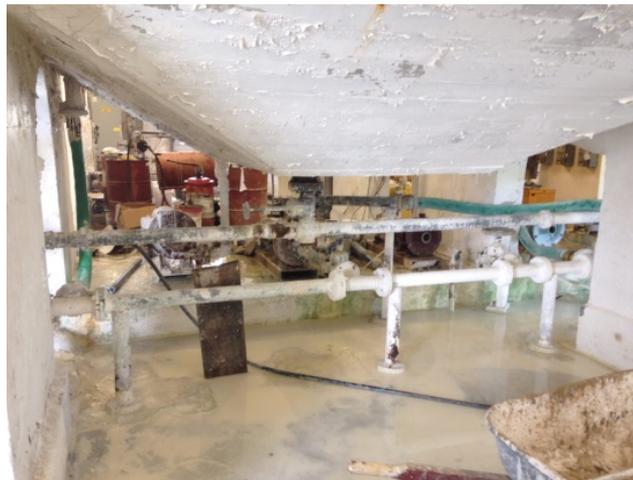
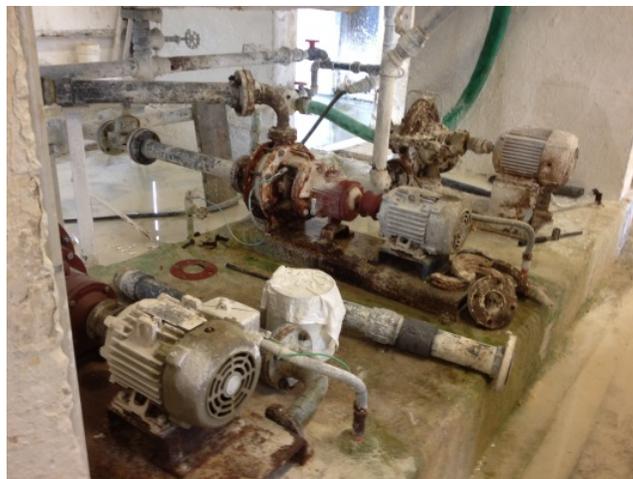
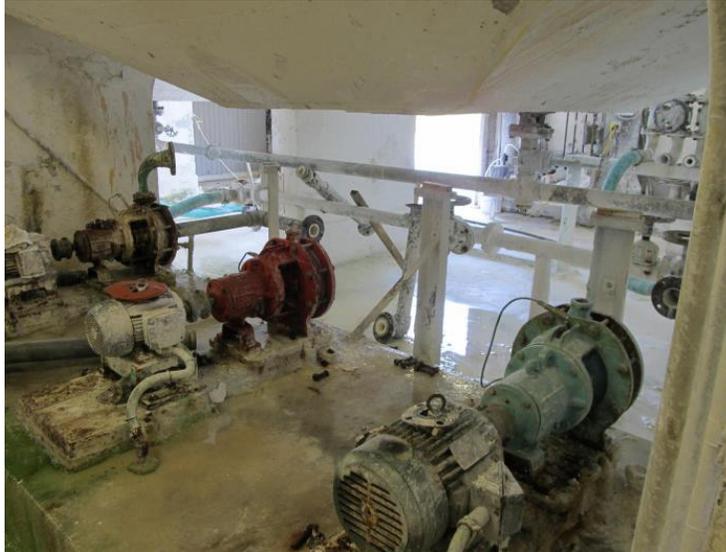
Figure 3-39: Lime Feed Pump Area

There are five lime pumps (Figure 3-39, 3-40 and 3-41) used to feed lime upstream of the C-Basins. The pumps are direct-drive and powered by a 5 hp motor operating at 1,750 rpm. The

pumps are manufactured by Durco and are Model MK3 STD. Only one pump is typically needed to meet feed requirements. Because of the nature of pumping lime solution, the pumps require frequent disassembling for cleaning and clearing of blockages. When a pump is removed from service for maintenance, another is placed in service to maintain continuity of operation.

The lime pumps are connected to suction and discharge manifolds by rubber hoses. This permits changing quickly from pump to pump. Upon disconnecting a pump from service, the lime solution discharges from the hoses requiring a wash down of the area. Since there are no retaining walls to contain the liquid lime in the hoses, the entire pump area requires hosing after each pump change.

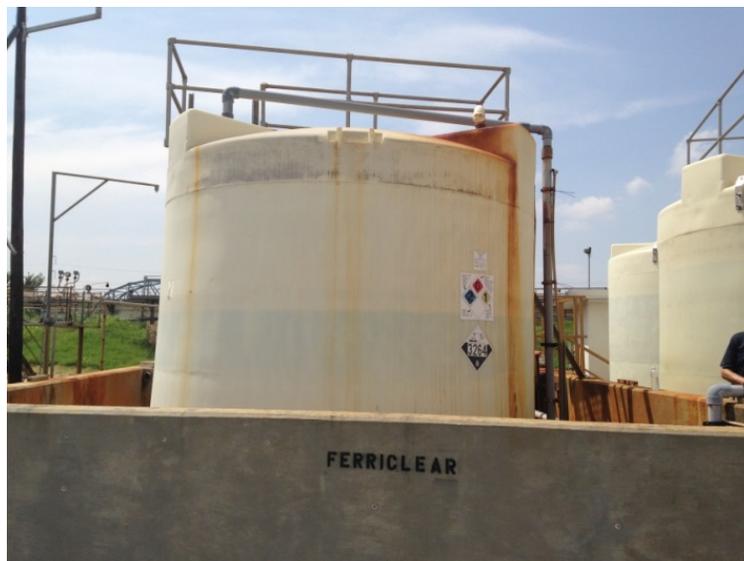
Figure 3-42: Ferric Sulfate Storage

Ferric sulfate is delivered to the Carrollton WTP in trucks and stored in two 8,000 gallon fiberglass reinforced plastic (FRP) storage tanks, Figure 3-42. Each tank is located in a separate uncoated, reinforced, concrete containment area. A pipe wall penetration in the common wall between the two tanks interconnects the tanks. Each tank is equipped with a galvanized steel ladder providing access to the tank top. Safety handrails are installed on the top of these tanks. Tank level measurement is a visual system, as the liquid level in the tank can be seen through the opaque tank wall.
