Sewerage and Water Board of New Orleans

Carrollton Water Treatment Plant

Water Quality Master Plan

July 2015

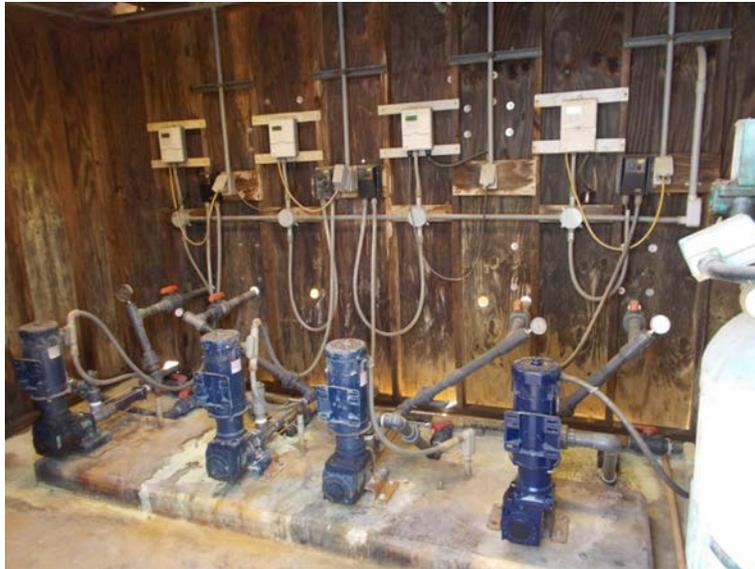
Figure 3-43: Ferric Sulfate Feed Pumps

There are four Seepex ferric sulfate feed pumps (Figure 3-43) which are housed inside a building located in a containment area adjacent to the ferric sulfate storage area. All of the feed pumps are installed on an uncoated reinforced concrete pump base. The pump building does not have a containment system around the pumps. Chemical feed pump areas should be located in a curbed spill and/or leak containment area and a chemically resistant coating be applied to the area. The current feed pumps are adequately sized to meet current dosage requirements.

As with other chemical systems at the Carrollton Plant, there is no wash down station inside the pump building. Thus any chemical spillage cannot be washed away.

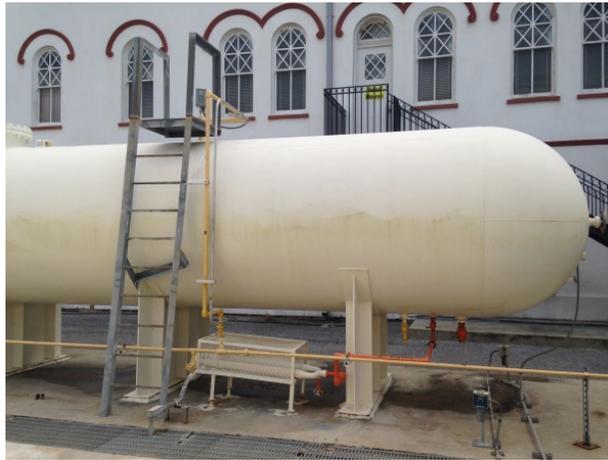
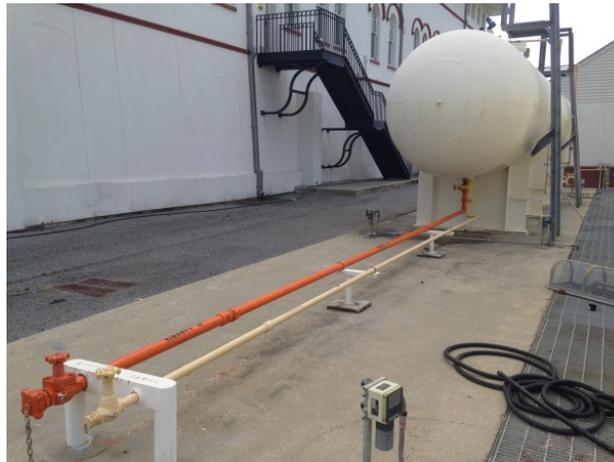
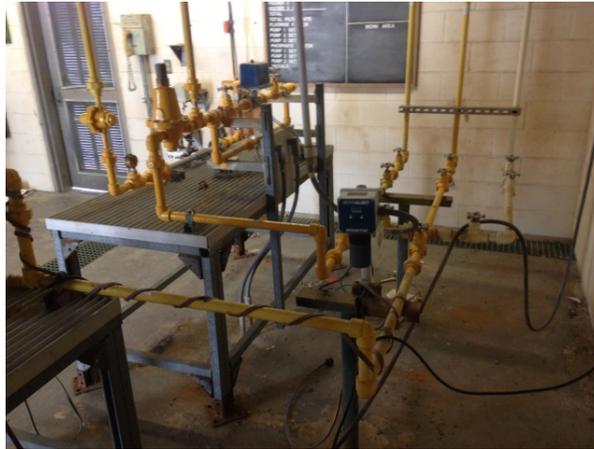
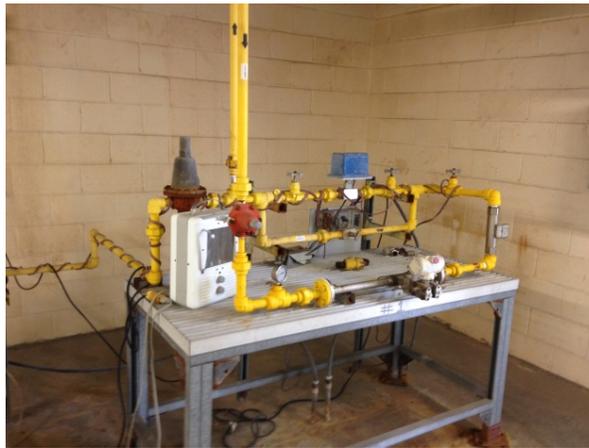
Figure 3-44: Ammonia Storage Tank

The ammonia storage system at the Carrolton WTP consists of one 10,000 gallon fixed steel pressure tank located outside adjacent to the Administration Building. The ammonia feed system (Figures 3-44 thru 3-47) employs the storage tank pressure as the prime driver to move the ammonia gas to the injection points. This is typical of ammonia feed systems. The ammonia feed system consists of two direct feed ammoniators, each with a feed capacity of 3,000 lb/d. The ammoniators each include a pressure reducing valve and flowmeter. Ammonia is currently

added downstream of the hypochlorite application points before entering the C-Basins. There is capability to add ammonia downstream of the C-Basins; however, this feed point has not been used. The average ammonia dosage is 1.0 mg/L, with a typical target application ratio of chlorine to ammonia ranging between 3:1 and 5:1. Based on a 1.0 mg/L dosage and average flow of 144 mgd, the existing bulk storage tank provides approximately 25 days of storage capacity. The existing 3,000 lb/d feed units have adequate capacity to meet daily demands and a peak flow of 240 mgd and dosage of 1.0 mg/L.

Pressurized feed piping, while adequately supported, is not anchored to pipe supports completely.

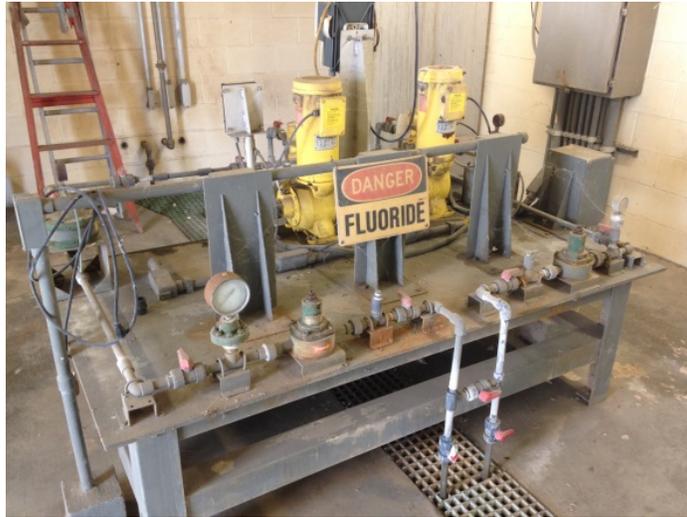
Figure 3-48: Fluoride Feed Pumps

Fluoride is added to the treated water to prevent dental caries. Fluoride (fluorosilicic acid) is added prior to filtration in the effluent channel of the C-Basins. Fluoride is stored in a single double-walled 10,000 gallon FRP storage tank located near the ammonia storage tank. The tank is labeled by name and has the CAS number and hazards signs placed in clear view. Two metering pumps located inside the combination fluoride-ammonia feed building (Figure 3-48 and 3-49), are fed from the bulk storage tank. Under an average flow of 144 mgd and an average dosage of 0.28 mg/L as F⁻, the bulk storage tank can provide approximately 30 days of storage. The feed pumps are adequately sized to meet the dosage requirement at the design flow. No flow pacing or automatic adjustment of the fluoride feed system is provided.

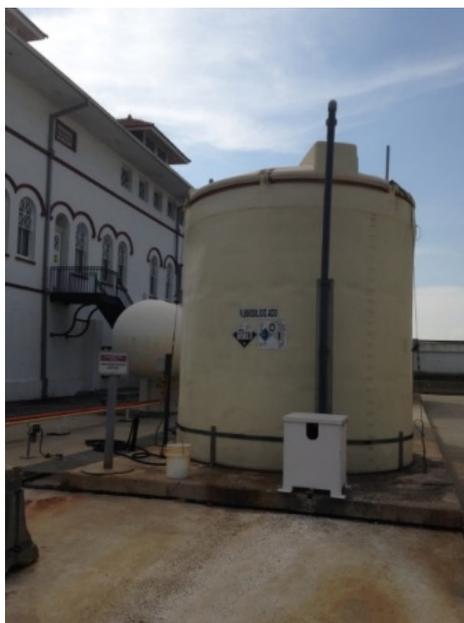
Figure 3-50: Fluoride Storage Tank

The fluoride storage tank is mounted directly on a raised concrete foundation/base. Wire strapping is used to secure the tank in addition to a metal strap and anchor system (Figure 3-50).

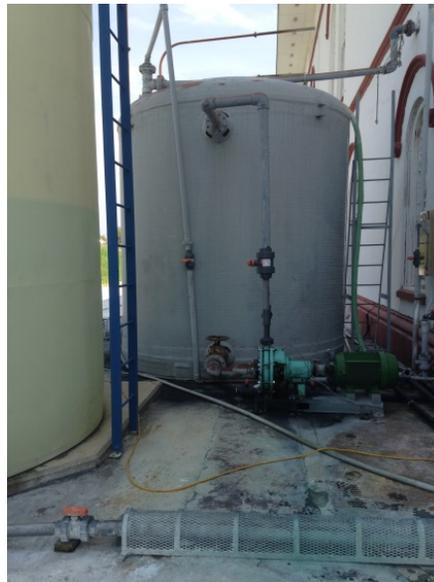
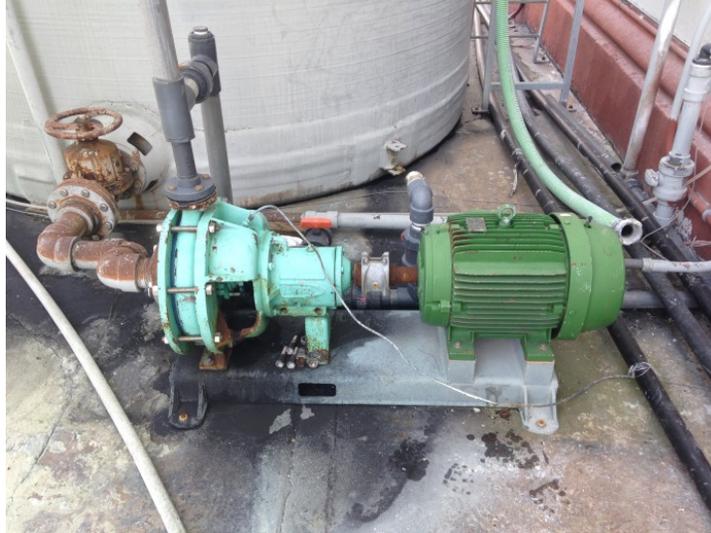
The PAC storage system is comprised of a 5,000 gallon FRP storage tank (Figure 3-51), recirculation pump (Figure 3-52), and associated piping and appurtenances. Both the FRP storage tank and recirculation pump are located outside the Chemical Building along the southward-facing wall. There are two feed pumps housed within the Chemical Building. Plant staff noted that the feed pump capacity is typically insufficient to reliably feed enough PAC to address taste and odor events (the maximum dosage they can meet is about 1 mg/L). Overall, the storage system is constructed of primarily corrosion resistant materials. Only minimal corrosion was noted during the inspection. The FRP storage tank exterior exhibited some UV degradation and is cracked and leaking.

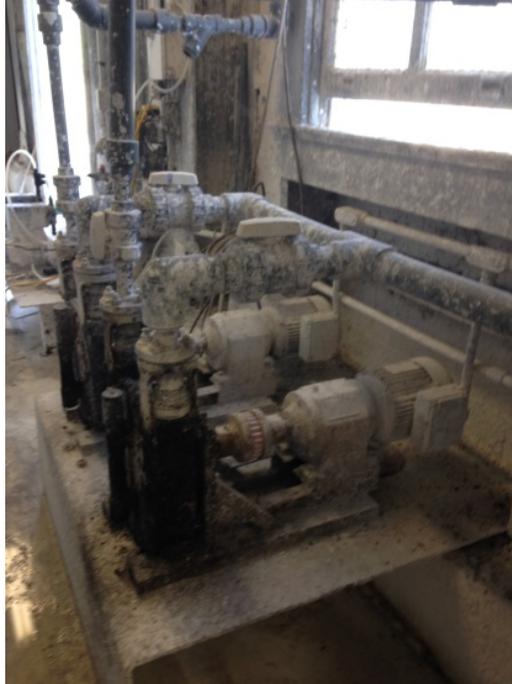
Figure 3-53: PAC Feed Pumps

The PAC pumps appeared to be operational, however, some general housekeeping is needed in the area. No nearby wash down station was noted to aid in maintaining the area. Typically, the PAC feed dosage control is manual, with no requirement for instrumentation signal on pumping dosage being relayed to a plant central monitoring station.

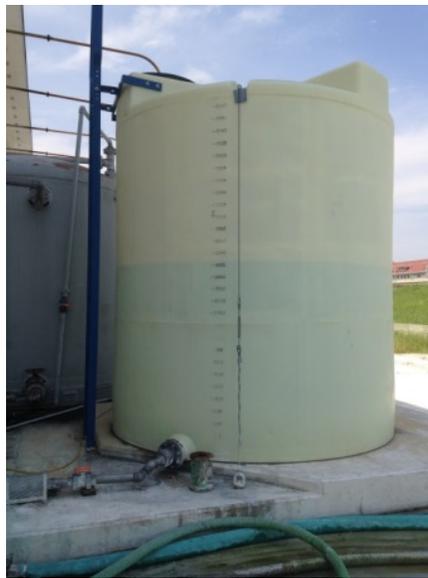
Figure 3-54: Polyphosphate Storage Tank

This tank’s exterior exhibits minor UV degradation. But no evidence of fatal tank damage or impending failure was noted.

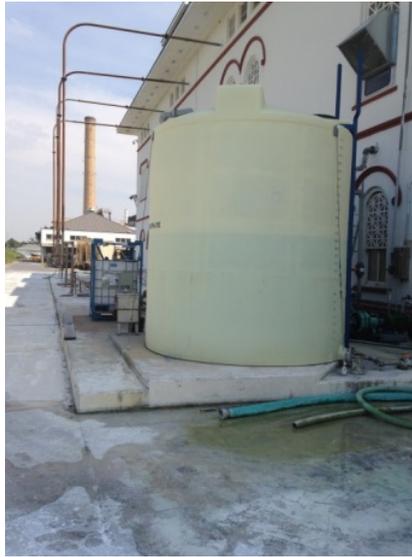
Figure 3-55: Polyphosphate Storage Tank

Polyphosphate is stored in a 6,000 gallon FRP storage tank (Figures 3-54 and 3-55) located on the south side of the Chemical Building adjacent to the PAC bulk storage tank. This tank is mounted on a raised reinforced concrete base and secured by wire straps equipped with turnbuckles. The feed system consists of two metering PulsaFeeder pumps located inside the Chemical Building. Typical dosages range between 0.5 to 1.5 mg/L. Plant staff noted the existing system can meet typical dosage requirements.

Located inside the Chemical Building, the polyphosphate feed system, is coated with lime (in addition to its own chemical). This system is constructed of primarily corrosion-resistant materials. However, due to the extensive lime coating the equipment, determining the true condition of the system was difficult. Since lime cannot be practically cleaned from equipment and piping, a complete system replacement (and relocation outside the lime contaminated area that is the interior of the Chemical Building) is recommended.

Containment areas with controlled means of drainage are recommended for most liquid storage systems.

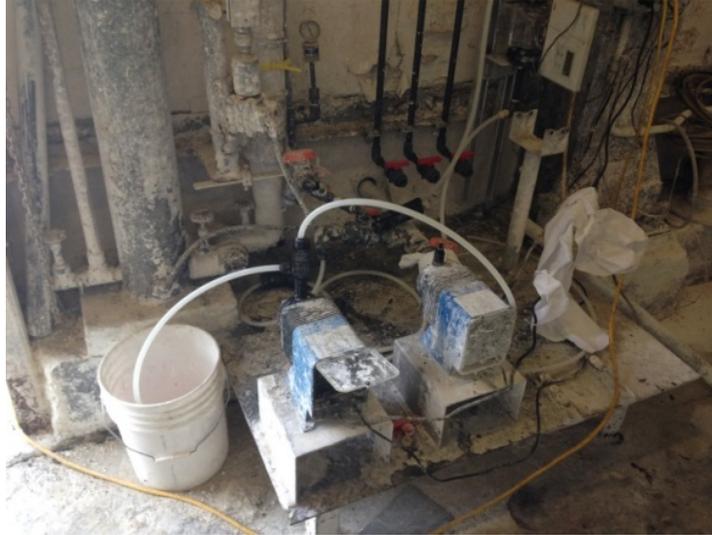
Figure 3-56: Polyphosphate Feed Pumps

Feed pumps (Figure 3-56) in this system are from the Pulsatron series of PalsaFeeder diaphragm pumps. This model of PalsaFeeder pump utilizes 110 voltage through a standard 110 volt convenience outlet and has a capacity of 240 gpd. The pump controls are located on the face of the pump. Both features make replacing these pumps relatively easy since no specialized skills or licenses are usually required.

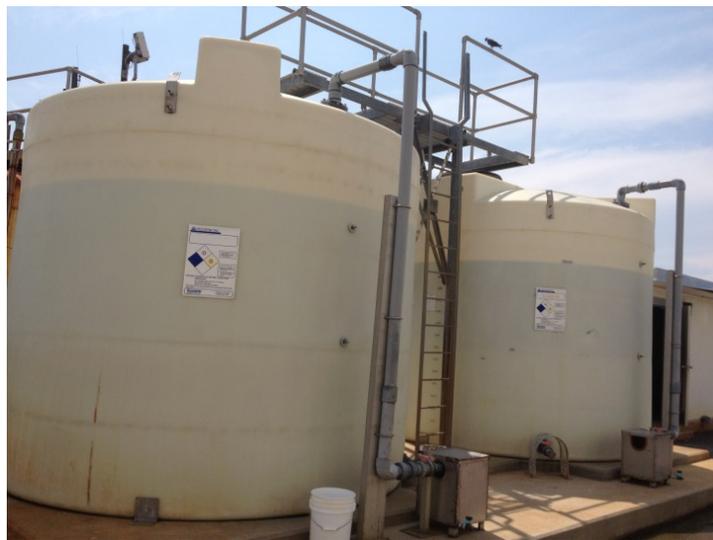
Figure 3-57: Polymer Storage Tanks

The polymer system consist of two 8,000 gallon FRP storage tanks providing a total storage volume of about 16,000 gallons (Figure 3-57). The feed system consists of four metering pumps

The tanks are bolted to raised foundation reinforced concrete pads. The tank tops are equipped with galvanized steel anchor straps. A single, vertical ladder provides access to an elevated platform spanning the top hatches of each tank. The loading stations for each tank are stainless steel top hinged boxes, which inside contain a quick-disconnect hose coupling. Chemical is delivered to the plant via commercial tank truck, which provides its own pressure differential to unload the polymer. The tank is filled from the top. A wire mesh guard is installed over the drain valve in each tank. Those drain valves are Schedule 80 PVC with a capped quick connect hose fitting installed.

Based on an average flow of 144 MGD and average dosage of 4.5 mg/L, the bulk storage tanks provide approximately 3 days of storage, which is well below the 30 days of storage recommended by Ten States Standards. The four existing pumps have a capacity of 10 gallons per hour (gph) each and meet dosage requirements under average operating conditions.

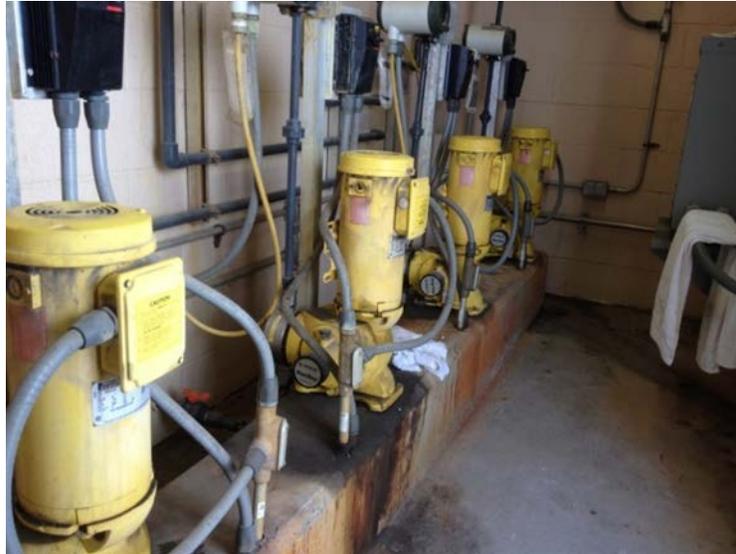
Figure 3-58: Polymer Feed Pumps

(two duty and two standby units). The polymer feed pumps (Figure 3-58) are housed inside a concrete block building adjacent to the polymer storage tanks.

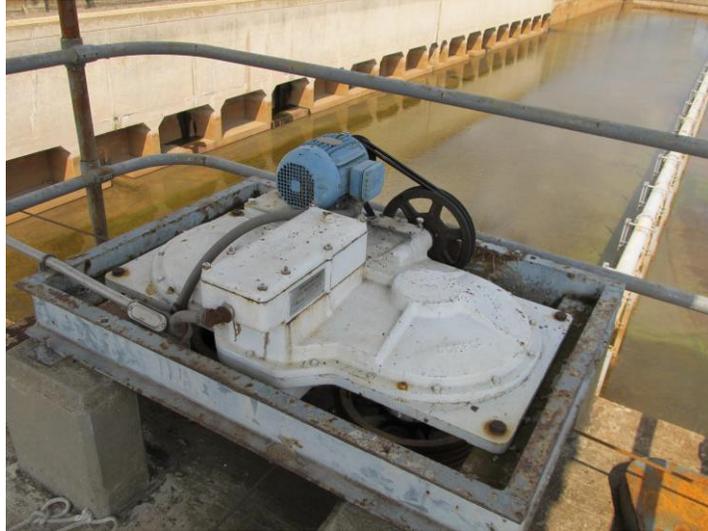
Figure 3-59: Rake Driver

The rake drivers are in good condition and are regularly repaired on site when needed. The machine shop has the capability of manufacturing any required part. Safety concerns exist from the lack of belt guards and lack of guards over the exposed wire rope within the handrails.

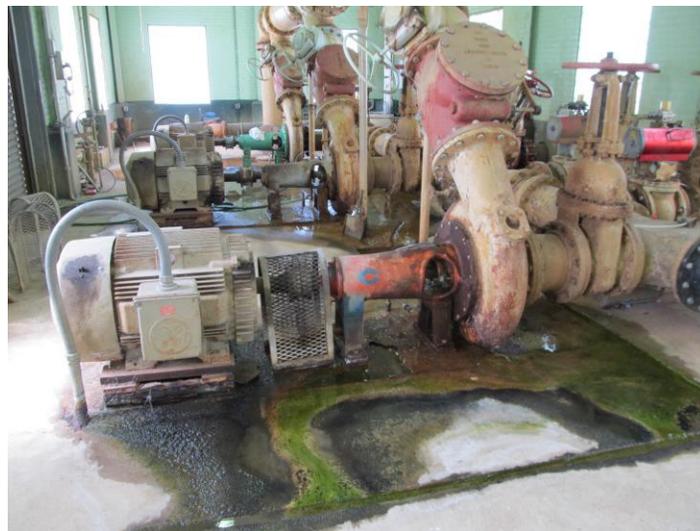
Figure 3-60: G-Basin Mud Pumps

With the exception of leaking stuffing boxes, the pumps were observed to be in good condition. Plant staff indicated that one pump is normally operated at a time, but it is possible to operate multiple pumps. The piping arrangement and sizes allow for this. The three pumps provide a high degree of redundancy.

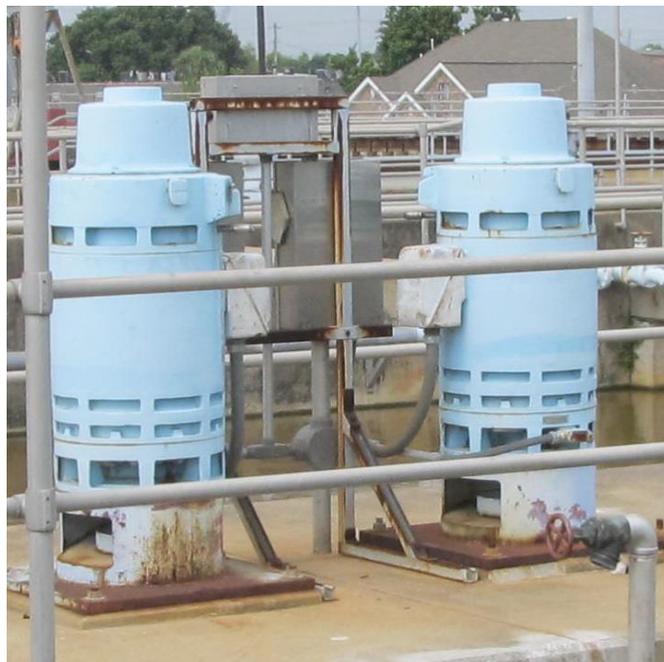
Figure 3-61: L-Basin Mud Pumps

Each of the L basins has two mud pumps (Figure 3-61). The pumps are vertical, direct drive centrifugal pumps. The motor for the pump is located on the deck level of the basins and a shaft extends to the machinery galley floor level where the pumps are located. The motors are 60 hp operating at 1175 rpm. The pumps were installed in the 1970s. At the time of the inspection, the pumps were not in operation, but it was reported that they are operable and in good condition. It is noted that the pumps cannot not be operated in conjunction with the newer C basins pumps because the C basin pumps, when operating, produce a higher head condition which cannot be overcome by the L basins pumps. As a result, the L basin pumps have, on several occasions, flooded the machinery galleries in the L basins.

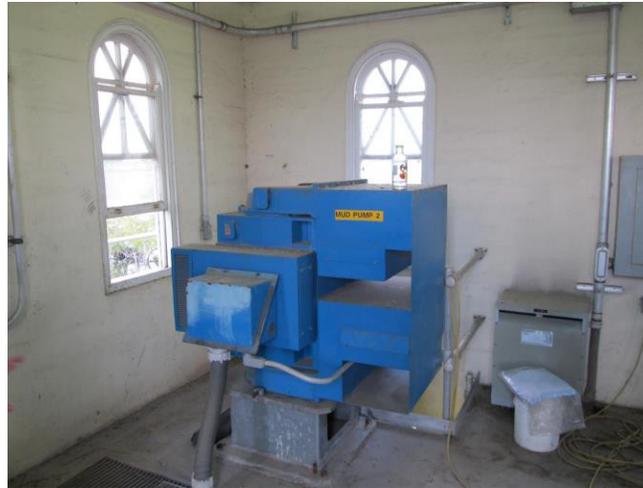
Figure 3-62 C Basin Mud Pump

appeared to be in good condition. The plant operator stated that both pumps were operational and there have not been any problems with their operation, except as noted previously when operating with the L and G basins pumps.

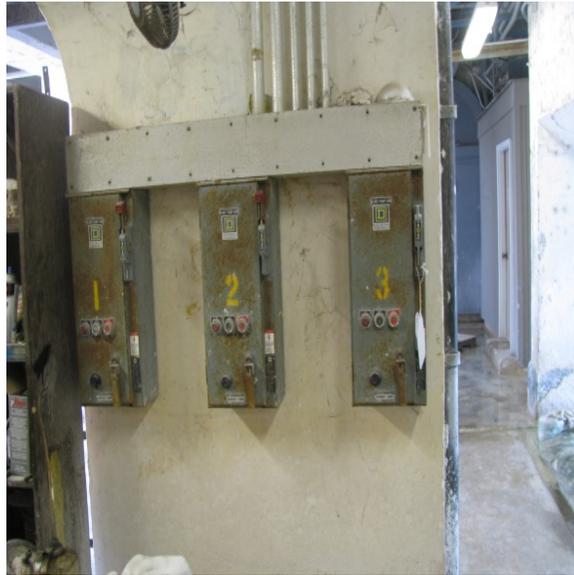
Figure 4-6: Deteriorated Motor Starters

- Rusted and deteriorated Lime Pump combination motor starters.

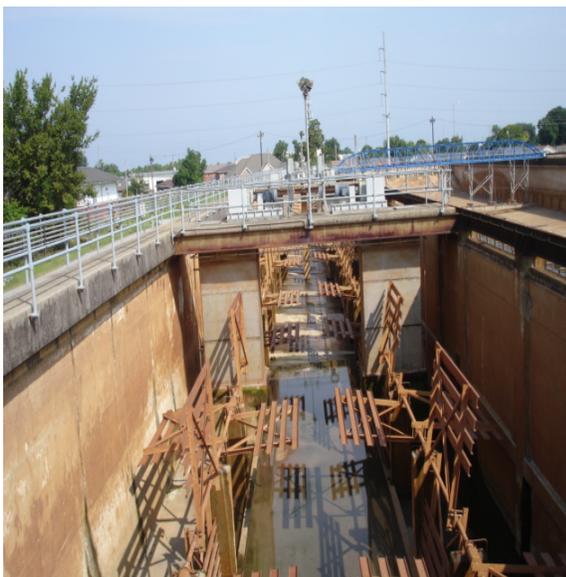
Figure 5-1: Dewatered G3 Basin with Flocculators

The slabs and walls for the G3 and G4 basins are constructed with reinforced concrete, and supported on a foundation of timber piles. Combined dimensions of these two structures are 550 feet to 632 feet in length and 280 feet in width. The structures are approximately 18 feet from top of slab to top of walls. Timber piles are spaced generally on an 8 foot by 8.5 foot grid. The flocculation and sedimentation basins are constructed integral with each other, with G3 and G4 being integral. Flocculation basins have flocculators supported on concrete pedestals (Figure 5-1).

Original plans for G3 and G4 date back to the early 1900s. There were major modifications to the structures in 1953. In this modification, walls and pedestals were added, a new reinforced slab concrete was constructed over the existing slab, sumps were added, 0.75 inch diameter “T” anchors were installed in the timber piles, and 103 relief check valves with under-slab gravel drains installed. It should be noted that the “T” bars were driven just eight inches into the piles.

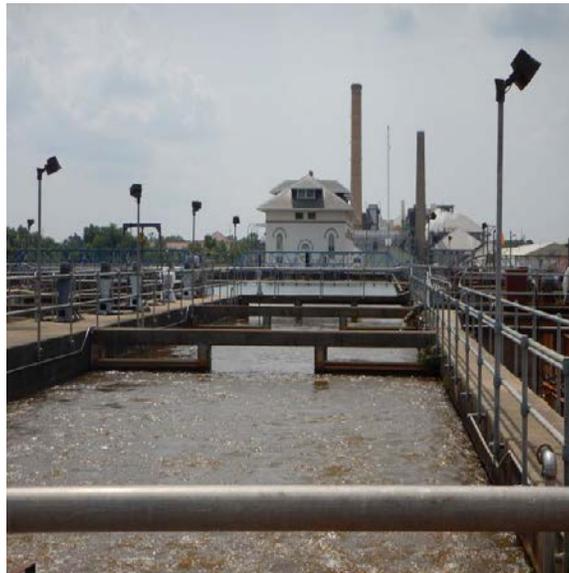
Figure 5-3: L3 Basin

top of slab to top of walls. Timber piles are spaced generally on a 6.5 foot by 7.0 foot grid. Basins L3 (Figure 5-3) and L4 are a continuous concrete structure. This structure was in operation at the time and only the portions of the structure above the water level could be observed.

The inspection revealed the following issues: the soil-supported slab at the western end of the basins is experiencing settlement, walkways had some minor cracks, and rust on the steel machinery supports, handrails, manhole covers, and sluice gates. None of these issues affect the structural integrity of the structure.

The recommendations are to install a piezometer to monitor groundwater elevations during dewatering, sand blast and paint exposed steel and provide cover protection over exposed cable drives.

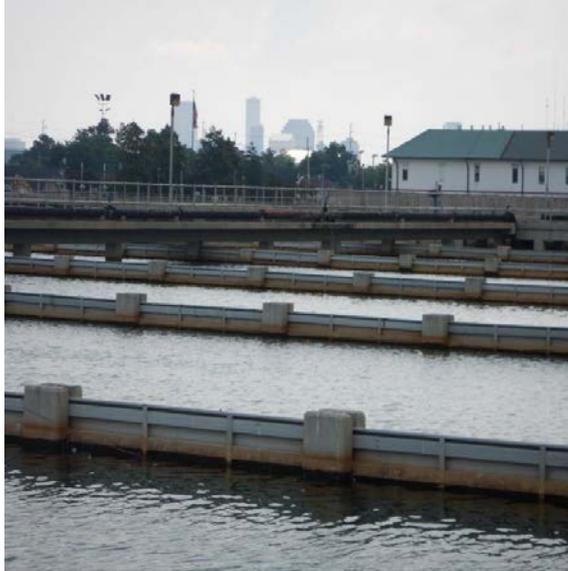
Figure 5-4: C Basins at Carrollton WTP

The C Basins (Figure 5-4) were online during the site visit, so only the components above the water line were inspected. The concrete observed above the water level was in good condition. The walls for these basins are pile-founded, inverted “T” walls. Slabs are 6-inch thick reinforced concrete, soil-founded and reinforced with wire mesh. Dimensions for the basins are 500 feet in width, 706 feet in length and 14 feet in height.

One solution for fixing the uplift problem for these slabs is to anchor them down by the installation of micro piles. This fix would also require the placement of a new slab overlay. This modification would be at a significant cost.

The recommendation is to install piezometers to monitor groundwater elevations during any dewatering or partial dewatering of these basins. It is recommended that a study be conducted to assess mitigation strategies of current infiltration and leaks from the G, L and C basins. This study should also evaluate current flooding between basins L4 and C5.

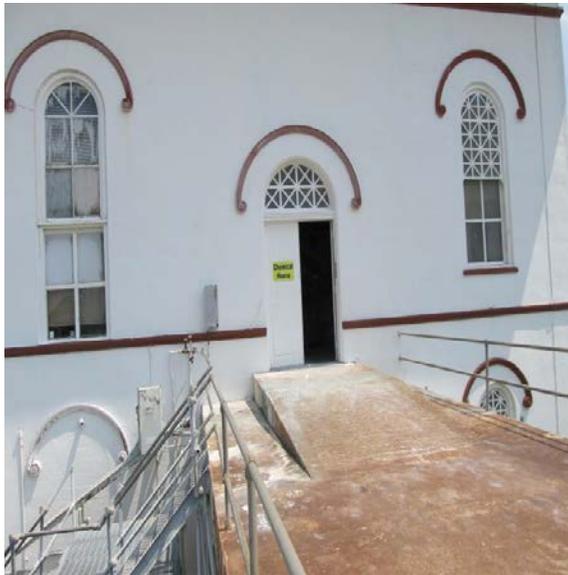
Figure 5-5: Chemical Building at Carrollton WTP

There were no structural issues revealed in the inspection of the Chemical Building (Figure 5-5).

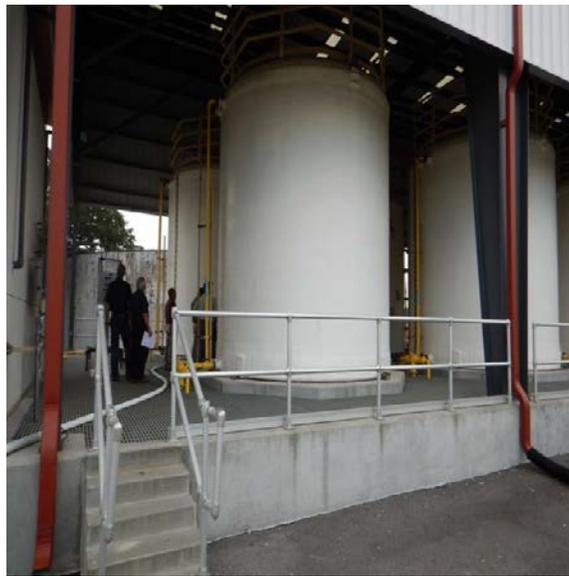
Figure 5-6: Sodium Hypochlorite Facility at Carrollton WTP

This is a new, pre-engineered steel frame building with open sides (Figure 5-6). Essentially, it provides cover for the hypochlorite tanks. There were no structural issues with this building with the exception of 3-inch diameter plastic pipe lines that run vertically to the top of the tanks with an unsupported length of approximately 12 feet; this could pose a problem in hurricane wind velocities.

It is recommended that lateral supports be provided at the vertical mid-span of the pipe.

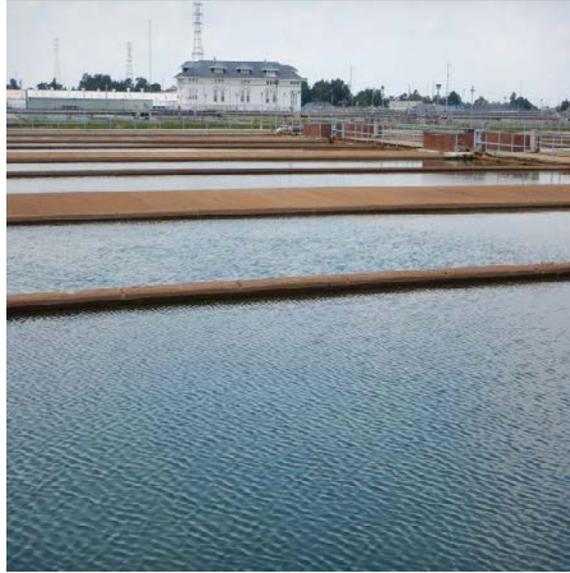
Figure 5-8: Claiborne Filter Gallery at the Carrollton WTP

The Claiborne Filter Gallery was constructed circa 1960. It was in operation at the time of the inspection and appeared to be performing well (Figure 5-8). Concrete for the filter structures and the building's steel rigid frame and walls were in good structural condition.

The following issues were observed during the inspection: rust and corrosion on the exterior equipment under the steel hatch (a minor maintenance problem). The south exterior wall of the filter structure had water leaking at some of the vertical construction joints (Figure 5-9).

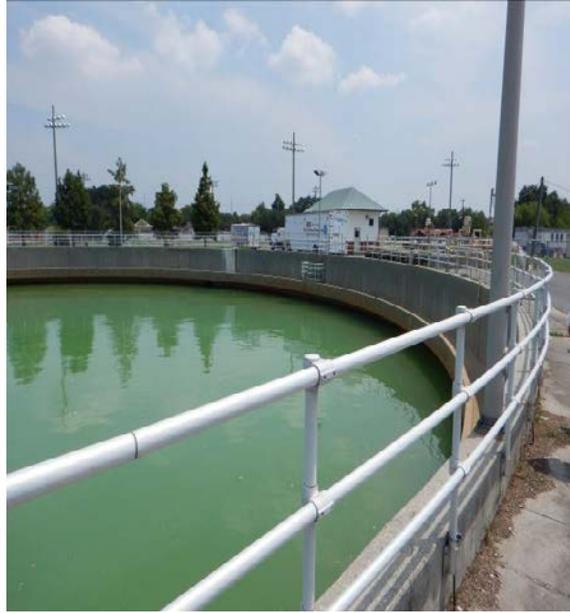
Figure 5-10: Backwash Waste Holding Tank at the Carrollton WTP

The backwash waste holding tank (Figure 5-10) is a concrete in-ground tank that is 220 feet in diameter with the top of slab at elevation 12.1 feet, and the top of wall at elevation 30.1 feet (the elevations are referenced to Board Datum). It is pile-supported on concrete piles which are anchored into the 12-inch slab. This tank was not dewatered at the time of the inspection, so only the concrete above the water line was inspected. Concrete above the water line, in the circular walls, looked very good.

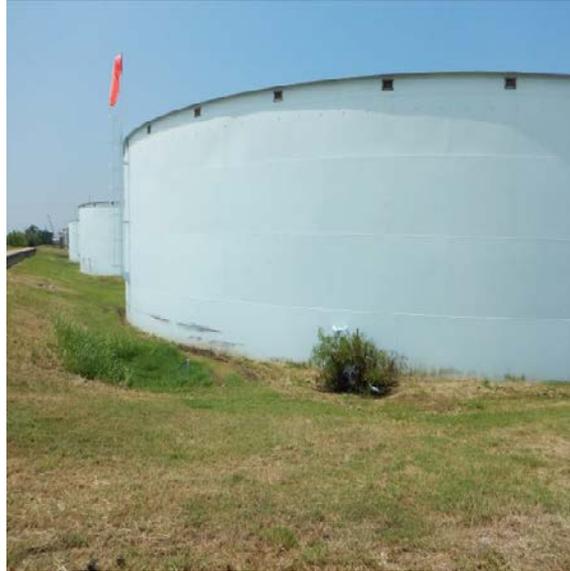
Figure 5-13: Ground Water Storage Tanks at the Carrollton WTP

The ten ground storage tanks (Figure 5-13) near South Claiborne Avenue were inspected. Since the tanks were in service, only a visual inspection was performed on the tank exteriors. There are six steel tanks and four concrete tanks. Both steel and concrete tanks appeared from the outside to be in good condition. The paint system on the steel tanks was good; for aesthetic reasons, the concrete tanks need to be painted.

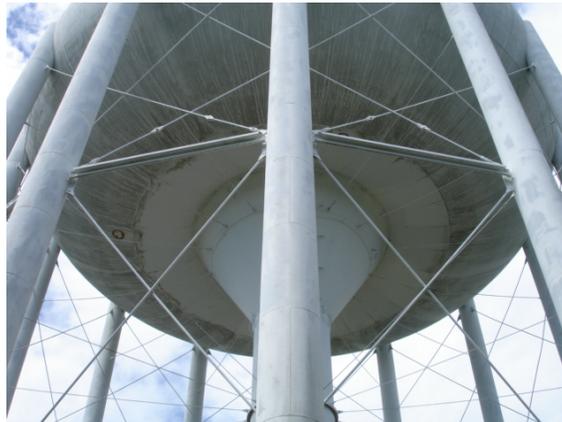
Figure 5-14: Elevated Storage Tank

The New Orleans East Elevated Storage Tank is over 125 feet high, with a diameter of 105 feet and a capacity of 2 million gallons, see Figure 5-14. A 2009 inspection revealed that the storage tank had numerous corrosion holes both in the roof and sides, see Figure 5-15. The roof was open, the previous inspection stated that a roof hatch was missing, the interior stiffener plates were badly corroded.

The tank is in poor condition and several improvements would need to be implemented to rehabilitate the tank and place it back in service. The tank has been offline since 2009 and plant staff has noted that the tank will not be needed to meet system demands or provide distribution system storage. As such, it is recommended that the tank not be placed back in service. Given the tank's poor condition, it is recommended that the tank be demolished and the area cleared.
