# CITY OF NEW ORLEANS STORMWATER DRAINAGE SYSTEM ROOT CAUSE ANALYSIS FINAL REPORT

Contract: K18-111

ROOT CAUSE ANALYSIS

FINAL REPORT

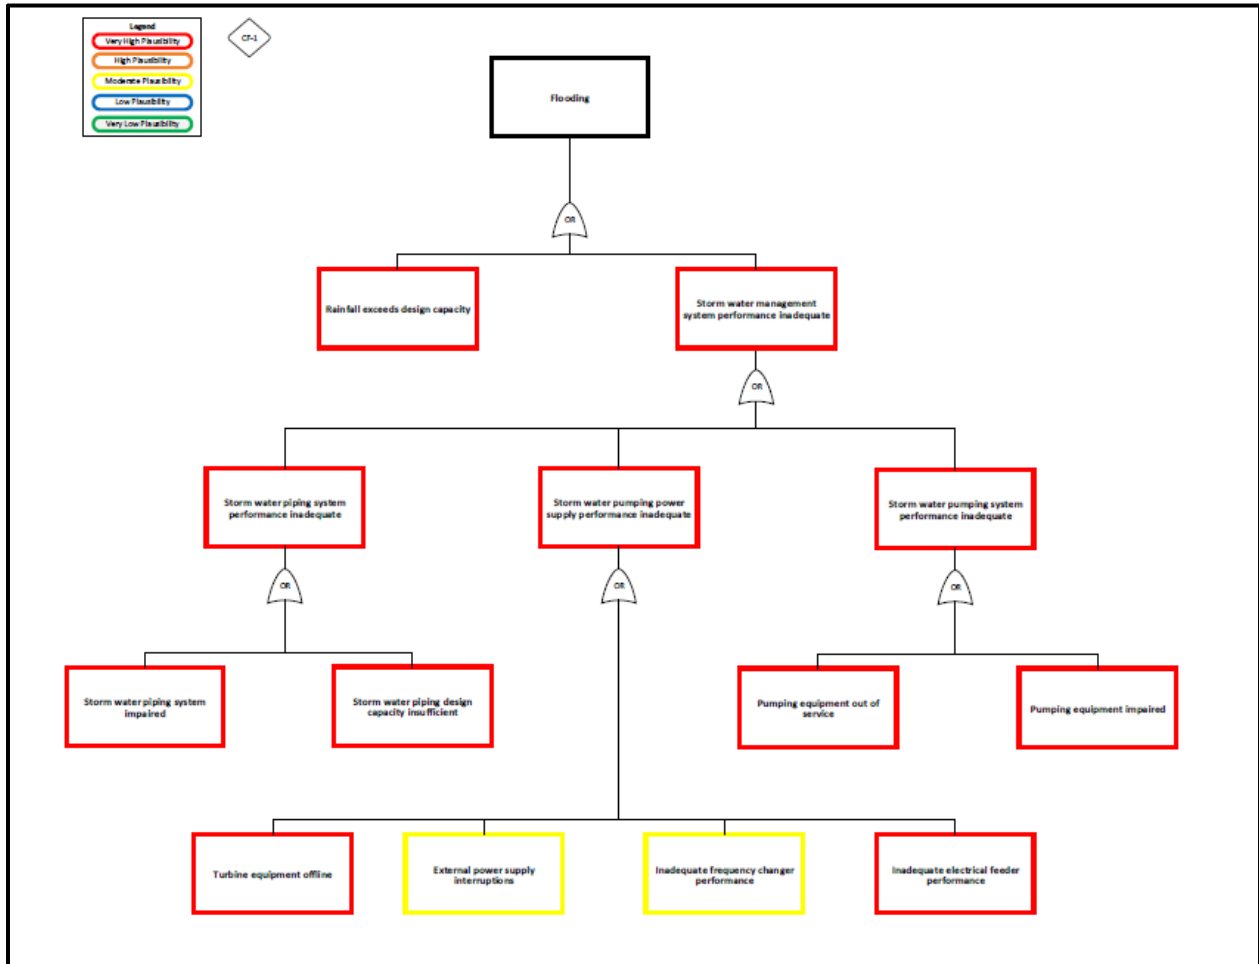
**Figure 2 High Level Cause and Effect Tree**

Any cause tied to an effect through an OR gates in the CAET must be mitigated to eliminate the effect. To eliminate flooding, both excessive rainfall and inadequate drainage system performance must be solved. Since control of rainfall is not possible, rainfall which exceeds the design basis storm will result in flooding. This risk must be accepted, or the design basis storm must be changed to a greater storm frequency and associated increased rain intensity. Improvements in the storm water drainage system will reduce but not eliminate flooding for the rainfall which occurred on August 5.

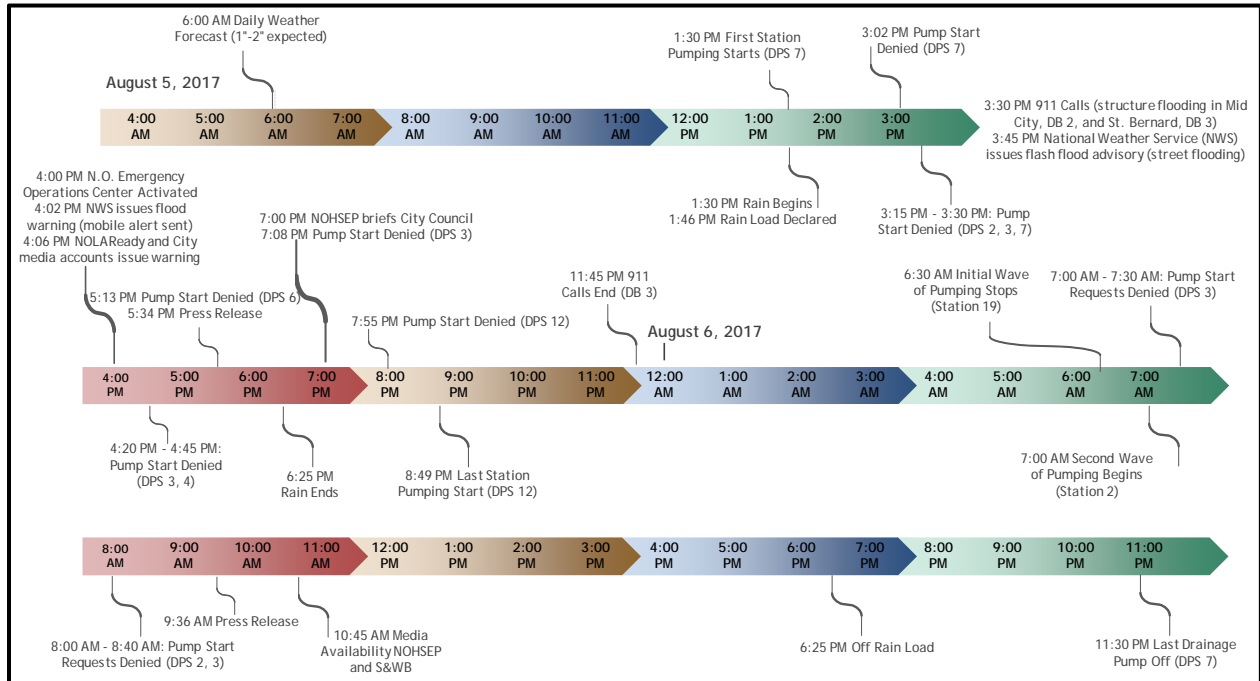
Figure 4 Timeline for August 5-6, 2017 Flooding

Timelines for the day of the loss events is shown in Appendix A.1 for July 22, August 5 and August 8. The August 5 timeline is shown in Figure 4. Additional timelines were also constructed to provide visibility to the events. The first was a macro timeline which identifies key events and actions occurring prior to the flooding which contribute to the loss. This timeline is found in Appendix A.2. It is helpful to show how decisions affect long term performance of systems and why it is critical to implement corrective actions to prevent future losses. As seen in the timeline in Appendix A.2, decisions 20 or more years ago contributed to the Loss Events in the summer of 2017.

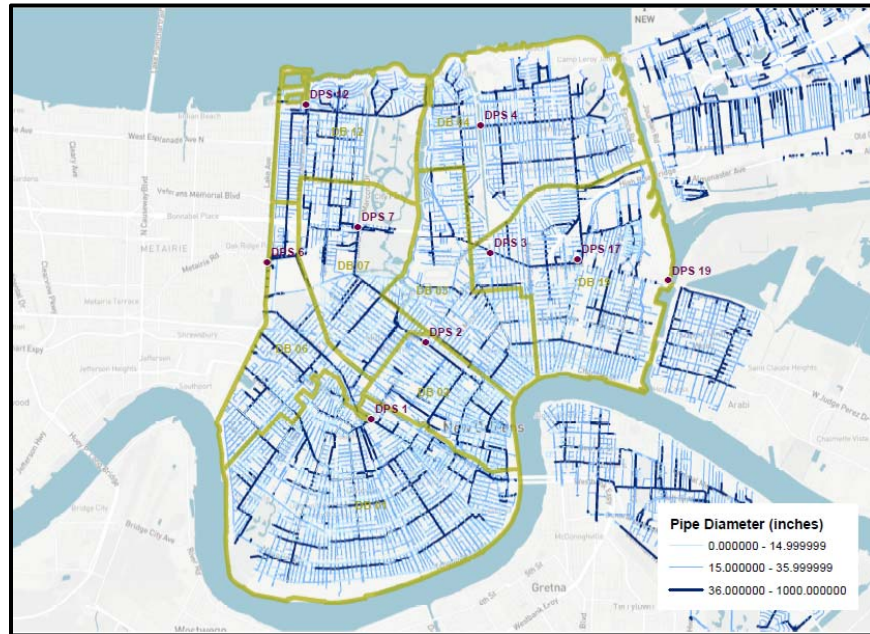
**Figure 8 DPW Drainage Network**

System design standard - Construction of the contemporary street drainage system in New Orleans began more than 100 years ago with engineering standards different than the present day. Many drain lines remain in place that are considered undersized under a current local "10-yr storm" level of service (LOS) expectation. In New Orleans, minimum street drainage design pipe size is now 15-in. As a consequence of historic development, much of the street drainage in the Old City is undersized. The proportion of undersized pipes corresponds approximately to the age of general development of the neighborhood.

Figure 8 shows distribution of drainage pipe sizes in the Old City. Figure 9 provides a visualization of small pipe "hot spots" or areas where undersized drainage pipes (less than 15-in diameter) are concentrated. The Veolia Condition Assessment (2017-2018) estimated from a 1 percent sample that the pipe network had 27 percent diminished capacity.

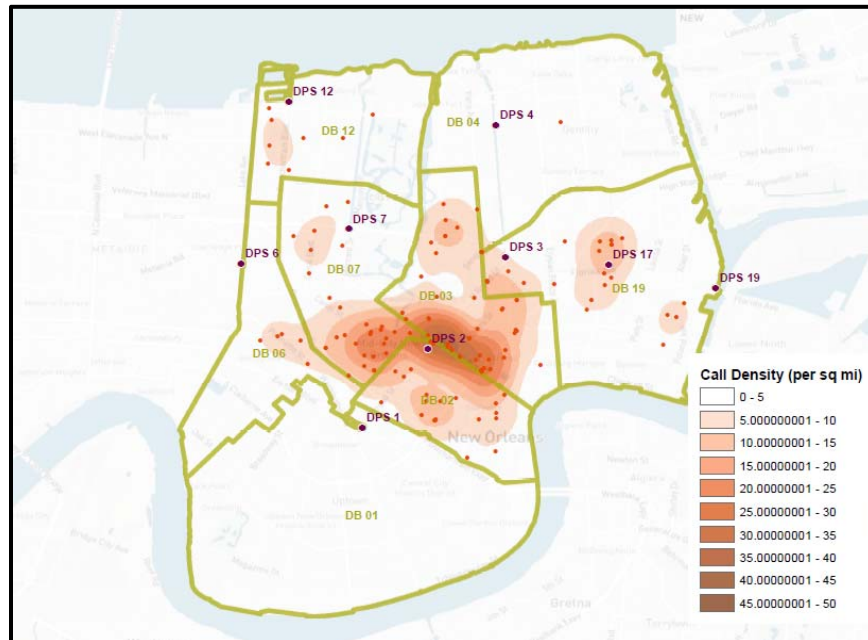
**Figure 13 911 Call Density Distribution**

- Damage, Claims, 911 Calls.
  - 911 calls- 140 non-underpass flood related calls, as seen in Table 7 below, were received on August 5, indicating a significant number of emergency situations caused by flooding not in underpass locations. These August 5 calls were predominantly from DB 2, DB 3, DB 7, DB 17 and DB 19. Distribution of 911 calls is provided in Figure 13.

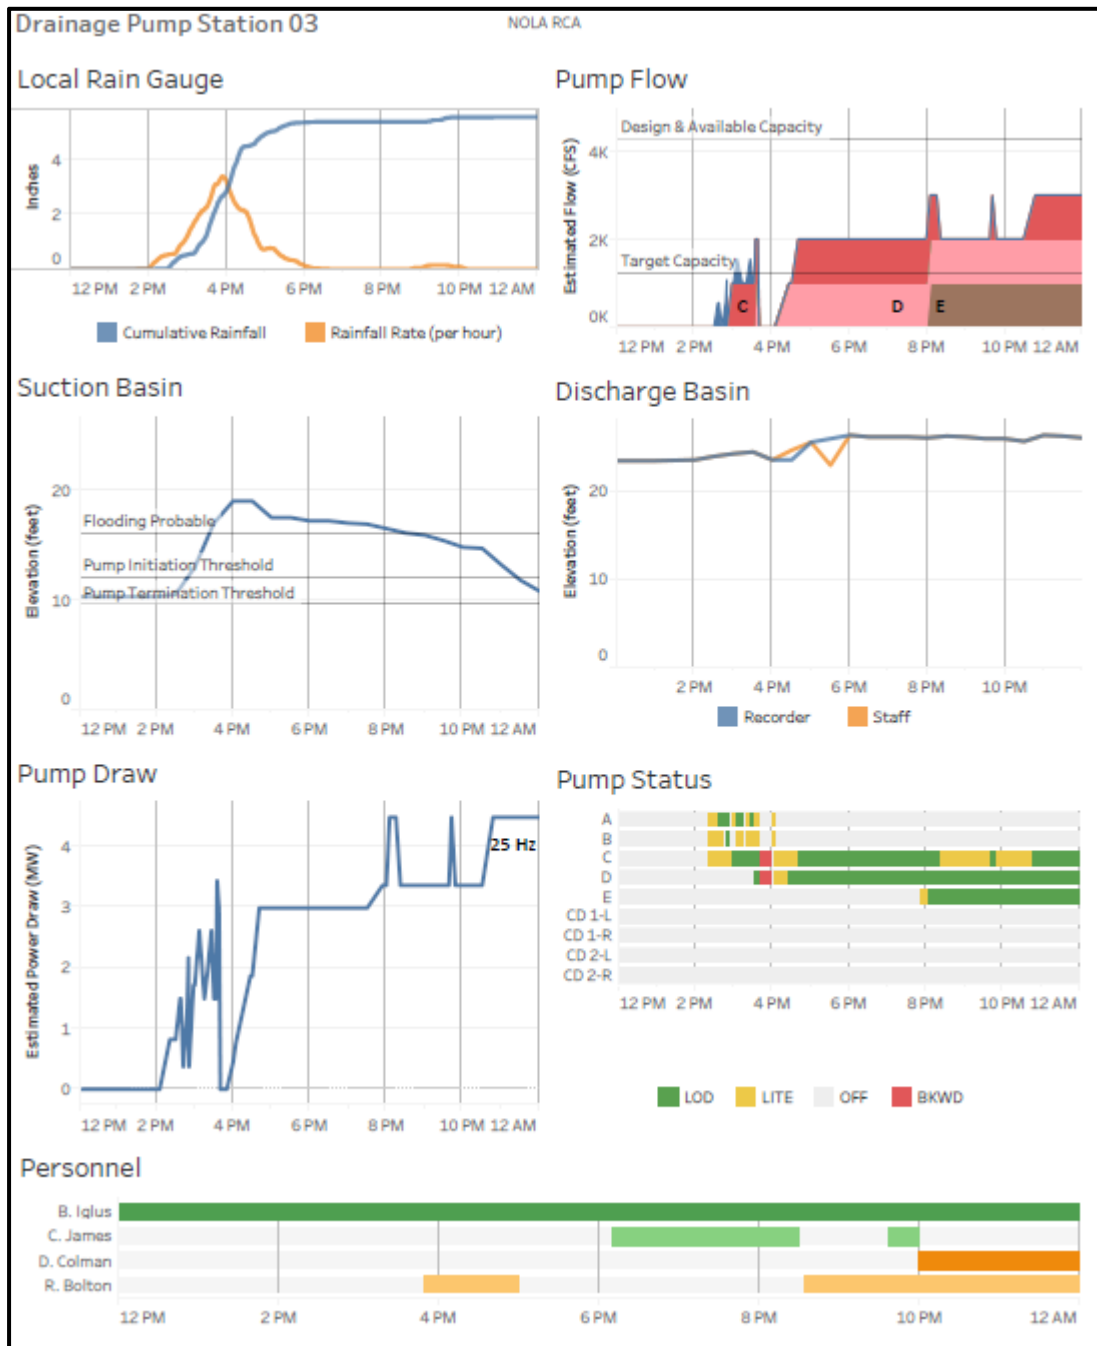
Figure 14 Drainage Pumping Station 3 Performance Timeline

A suction basin elevation of 16 ft is used by S&WB Drainage Operations staff as an approximate indicator of likely flooding in DB 1, DB 2, DB 3, DB 4, DB 6, DB7 and DB 12. On August 5, DPS 2, DPS 3, DPS 6, DPS 7 and DPS17 experienced suction basins rising to over 16 ft (Cairo Datum).

Pump run times and suction basin level response provide the metrics for analyzing pumping system performance during rainfall events. Graphical depictions of this data for DPS 3 is shown in Figure 14. Data for all pumping stations are presented in detail in Appendix F.

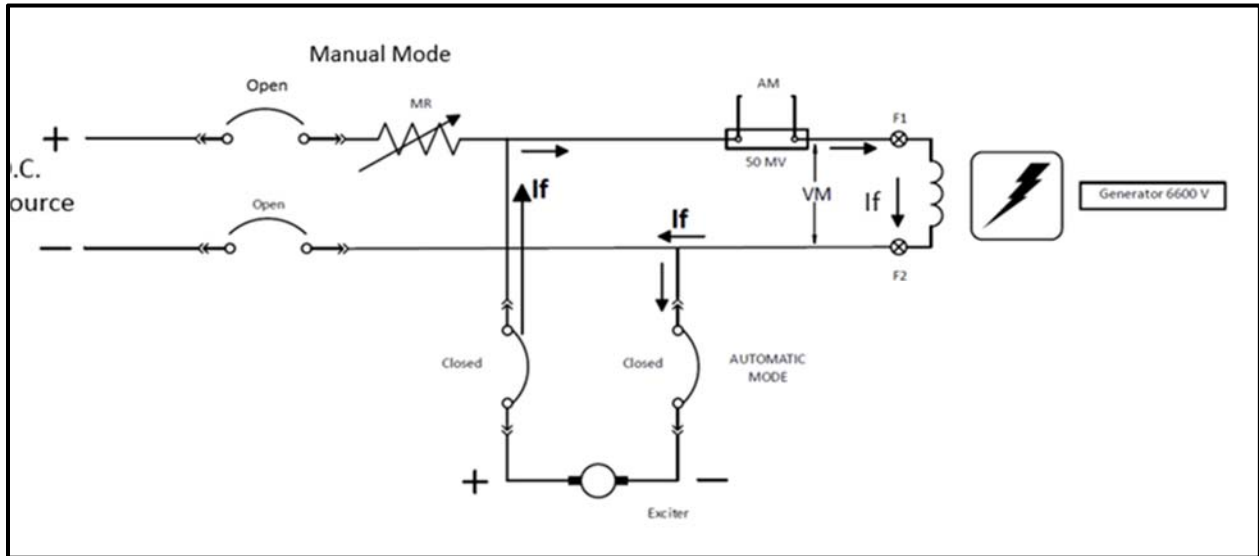
**Figure 17 One-Line Diagram for Field Rheostat**

On May 17, 2018, a contractor from Industrial Electrical Services (IES) examined the rheostat along with S&WB electricians. They discovered that the rheostat had been wired incorrectly. The conductor for the manual mode rheostat was carrying full load current when the field exciter was in the automatic mode. The one-line diagram for the rheostat is shown in Figure 17 . Current would not normally be flowing through the manual rheostat in automatic mode because the breaker is opened and interlocked with the automatic mode breaker. Figure 18 shows the location of the rheostat connection in the mis-wired configuration.

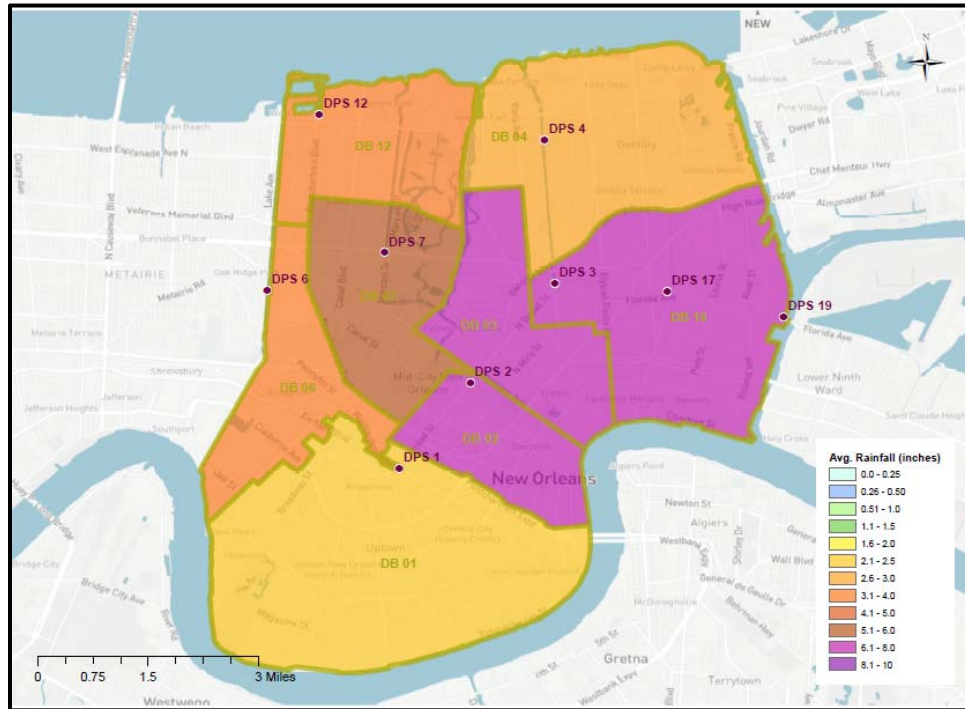
**Figure 20 Average Rainfall By Drainage Basin August 5**

Rainfall rates across individual drainage basins, rather than single-point data from DPS stations, better indicate drainage demand for the basins as a whole. Lincoln’s bias-corrected rainfall estimates <sup>7</sup> are shown in Table 15. Bracketing of the recurrence intervals are shown in Table 16. Recurrence intervals and PFE for August 5 event are shown in Table 17. Average rainfalls by basin is shown spatially in Figure 20. Average recurrence intervals for 3 hours bias-corrected storm for August 5 are shown in Figure 21.

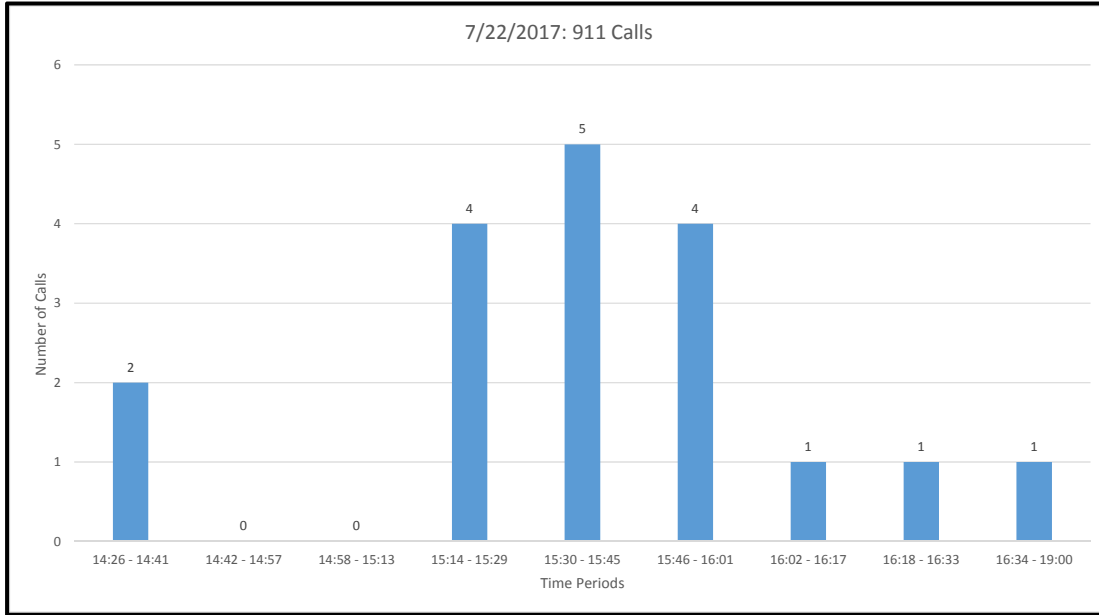
Figure 22 911 Calls July 22

911 calls are an important indicator of flooding. Many calls are related to rising water in underpasses. When these calls are taken out, a more accurate picture of flooding is available which can be used to alert the public of areas to avoid. Table 18 below provides the number of calls by drainage basin for each of the three Loss Event dates. Distribution of these calls over time is shown in Figure 22 and Figure 23.

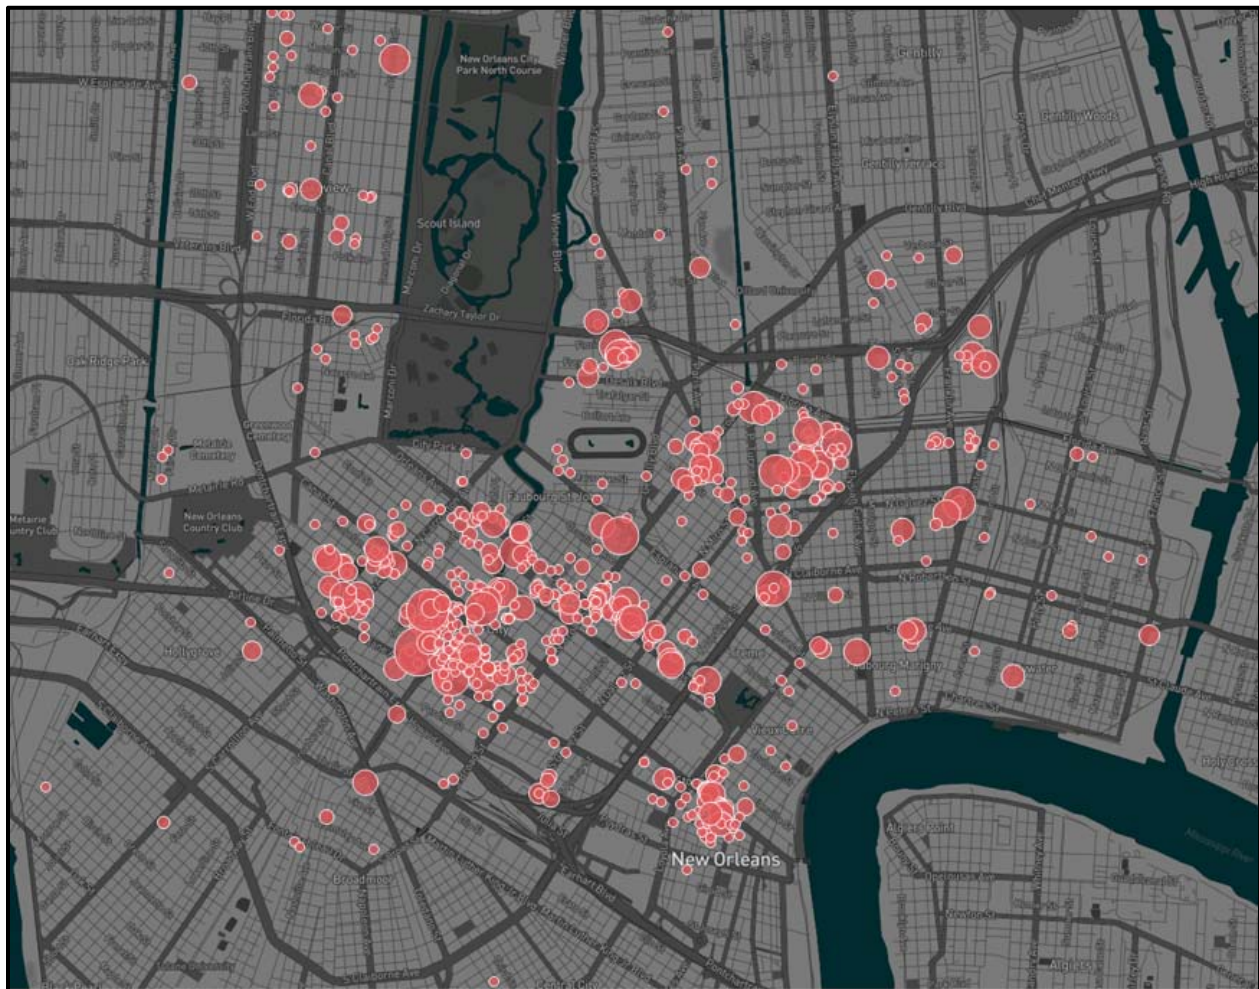
Figure 25 NFIP Claims Distribution

Participants in the National Flood Insurance Program (NFIP) who incurred flood damage filed a total of 681 claims. A total of 221 of these have been paid for a total of \$4.3 million. The number of claims by drainage basin is shown for each flood event in Table 19. A plot of NFIP claims is shown in Figure 25.

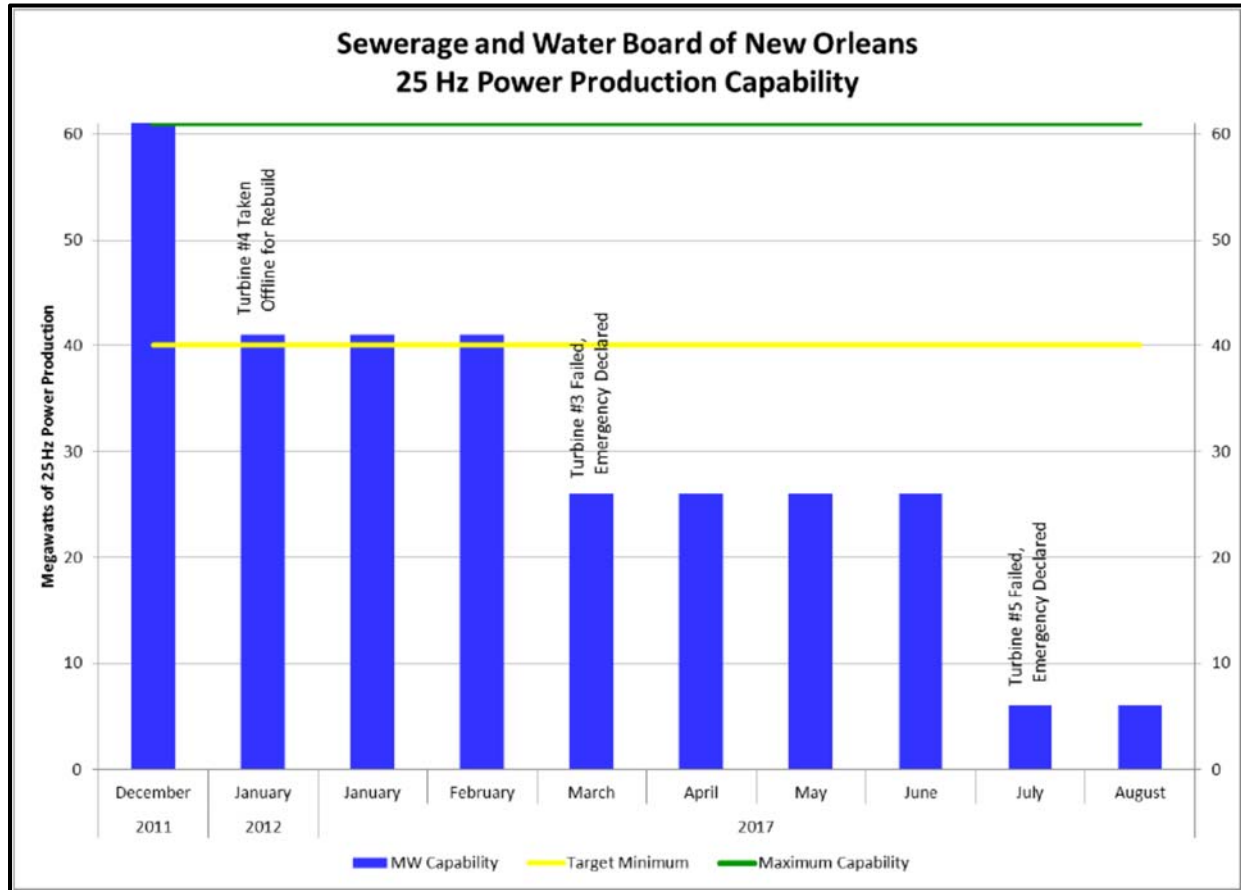
**Figure 29 25 Hz Power Production From S&WB Turbine Generators 2011-2017**

After Katrina, Turbine 4 was the only turbine used to power the drainage pumps. The only option available to power the turbine was dirty steam because the storm destroyed the water cleaning system at the plant so the only steam available was produced by dirty water. Turbine 4 successfully powered the pumps, but the dirty steam critically damaged the turbine to the point that total reconstruction was required. Seven years later in January of 2012, Turbine 4 was removed for reconstruction.

The loss of Turbine 4 reduced the 25 Hz power from the system by 20 MW. This left the system with 41 MW of power. Other turbines had to be utilized more frequently to replace Turbine 4 while it was out of service. Operating condition of the other turbines were not adequate, and the extra utilization proved to be a problem. On March 9, 2017, Turbine 3 failed. This failure reduced the 25 Hz power by 15 MW leaving the system with 26 MW of 25 Hz power. Two days after the July 22, 2017 flood event on July 24, 2017 Turbine 5 failed. This failure reduced the 25 Hz power by 20 MW leaving the system with only Turbine 1 which produces a maximum of 6 MW of 25 Hz power. Turbine 1 was the only generator in working condition leading up to and during the August 5, 2017 event. Figure 29 is a graph created by Ch2M for an S&WB presentation on September 1, 2017 showing the change in available in power as each turbine went out of service.

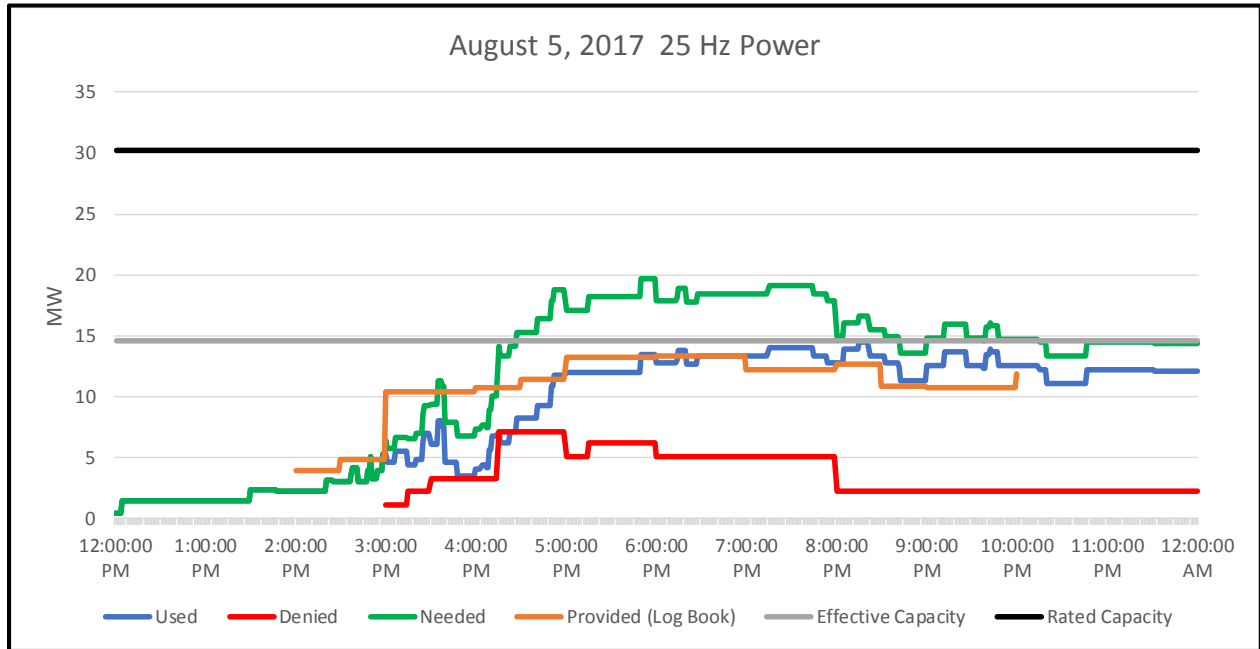
**Figure 31 25 Hz Power Demand vs Capacity**

A similar analysis was prepared by the project team for this report using logbook information for generated power. Computed power used by pumps was also determined based on horsepower and operating status (off, lite, loaded). A time-history of power used, power generated and maximum power available in the system is shown in Figure 30. Figure 31 shows the power used by pumps and the power necessary to supply pumps which were requested but denied along with a total power needed. The denied power was assumed to persist until the log book indicated the pump was started. The analysis indicates the required power exceeded the available power by more than 30%.

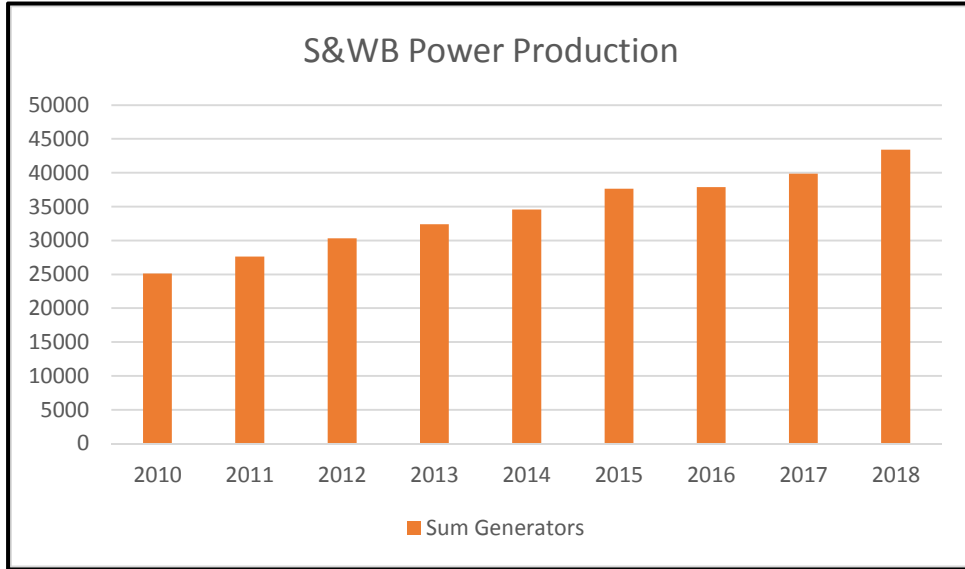
**Figure 32 Power Production by S&WB Turbine Generators(kWH)**

To assess evidence that S&WB made a policy change to use internally generated power to avoid Entergy power interruption, the power usage by S&WB drainage was evaluated and compared to power generated by the turbine generators. In Figure 32, the internal power production increased at a rate of 7-10% per year. Power purchase trends are shown in Figure 33. No clear trend is evident with regard to energy purchases. This data provides some indication of an increased reliance on internally produced power.

There is no evidence that S&WB leadership concurrently evaluated the impact of the increased use of these turbines on their overall functionality nor is there any evidence that provision was made for increased maintenance funding to minimize periods of power unreliability among these assets.

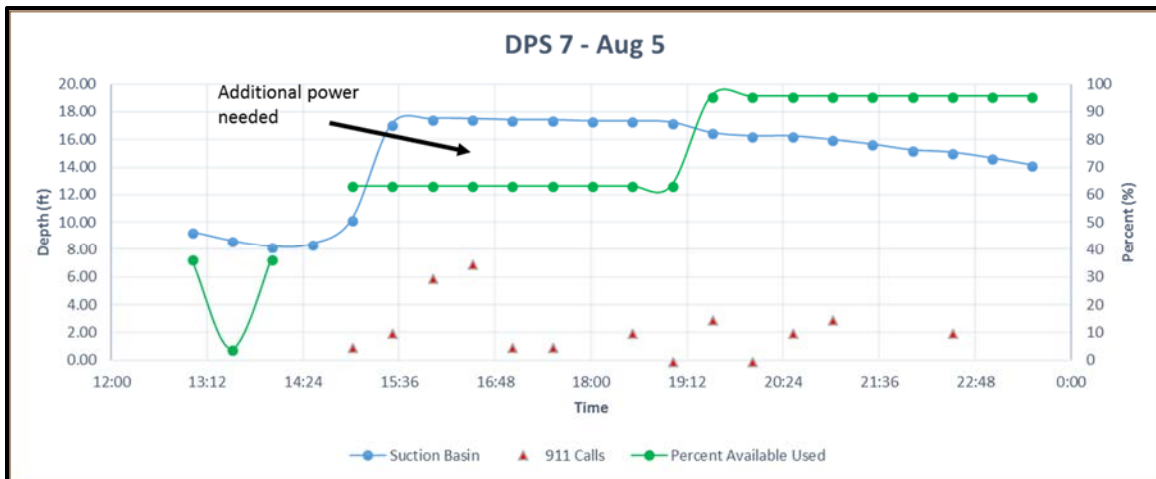
**Figure 34 DPS 7 Pumping - % of Operational Capacity**

An analysis was prepared, for each drainage pumping station, which compared the suction basin level to the pumping capacity used as a percentage of available pumping capacity. In cases where the available pumping capacity was less than the installed capacity due to inoperable pumps, the comparison with installed capacity is also shown. Figures are provided below for each drainage basin along with an evaluation of performance. An example comparison for DPS 7 is shown in Figure 34 and Figure 35. Even though up to 100% of the available pumping was used, it was only 60% of the installed capacity. These figures also show that substantial decrease in suction basin levels did not occur until all available pumps were running.

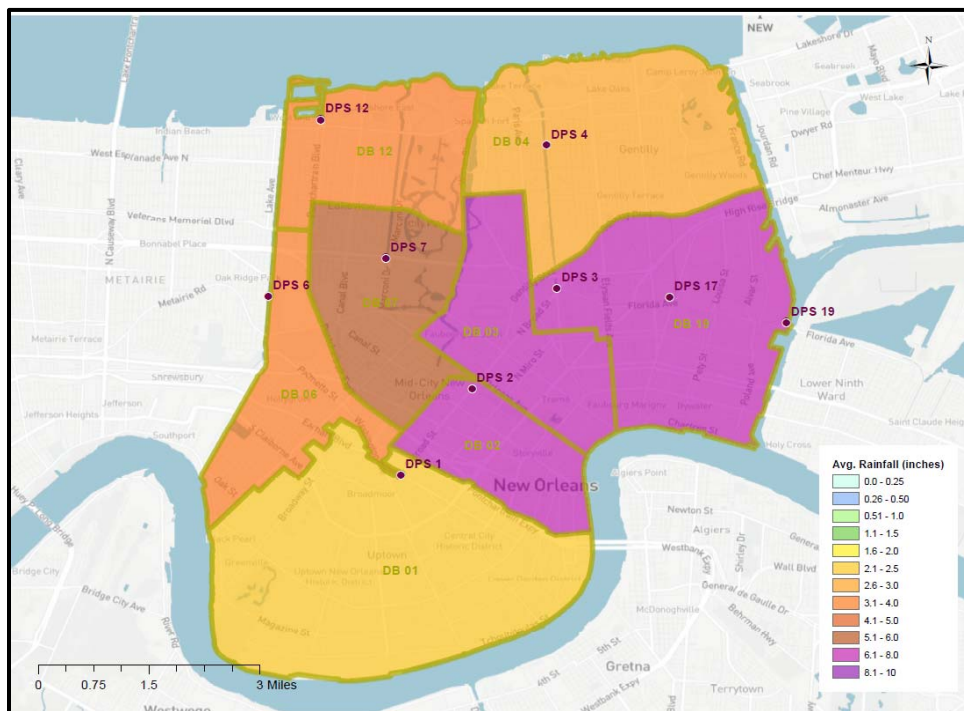
**Figure 36 Drainage Basin Boundaries and Average Rainfall**

In most of the drainage basins on August 5, suction basins were cleared to pre-event levels and pumping was stopped after midnight. Suction levels then rose again as additional storm water flowed in from farther reaches of the drainage basins. The time to clear the suction basin after reloading was 2-9 hours depending on the drainage pumping station. A summary of the drainage pumping station performance for each drainage basin is provided below for the August 5, 2017 event. A description of drainage basin boundaries and average rainfall for each basin is shown in Figure 36 for reference.

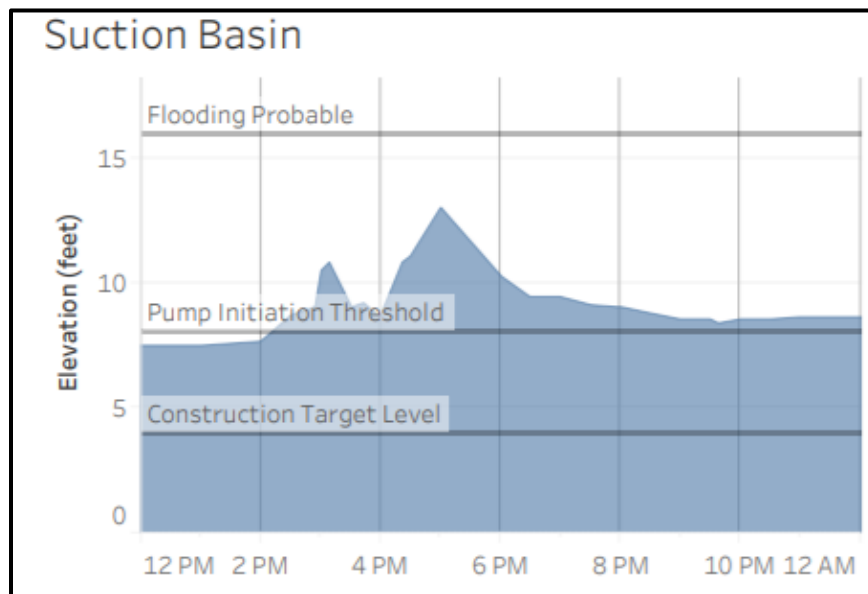
**Figure 37 DPS 1 Suction Basin Levels August 5**

**Conclusion.** The drainage basin experienced much less intense rainfall than other drainage basins. DPS1 exhibited capacity capable of providing an adequate LOS within its drainage basin during the event, with the result that there was little flooding in DB 1. Evaluation of the suction basin levels confirms that minimal flooding would be expected as shown in Figure 37.

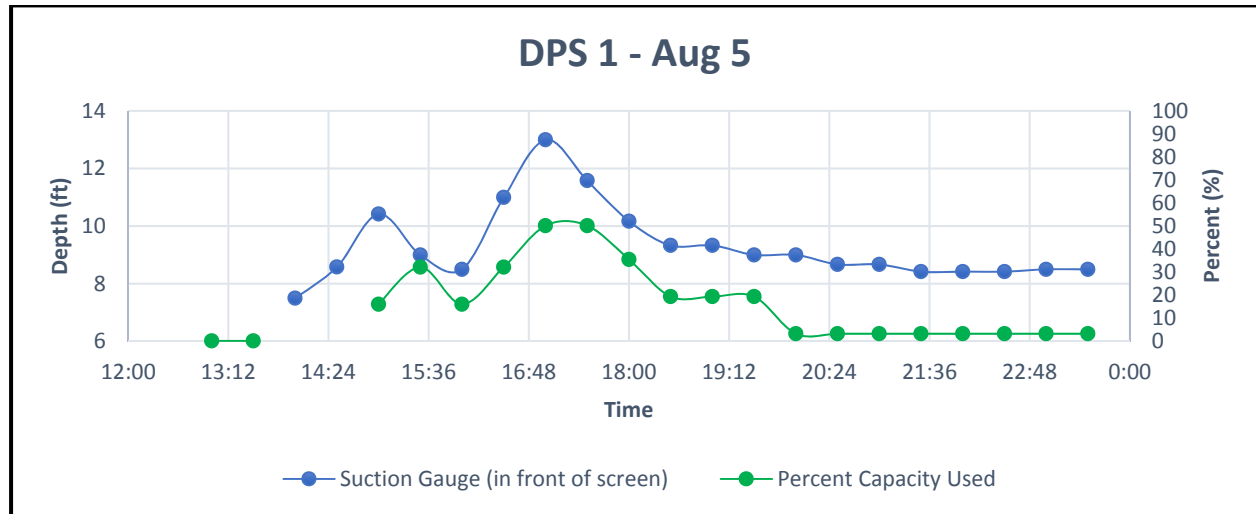
Figure 38 DPS 1 Pumping Performance August 5

Pumping commenced at 2:55 PM and continued for approximately 15 hours in the initial period. The suction basin took approximately 16 hours to clear. Maximum pumping at the station used approximately 50% of the available capacity. Pumping started approximately 30 minutes after the suction basin began to rise and was able to keep pace with the suction basin level and shown in Figure 38. Power interruptions and loss of pump load were noted in the logbook.

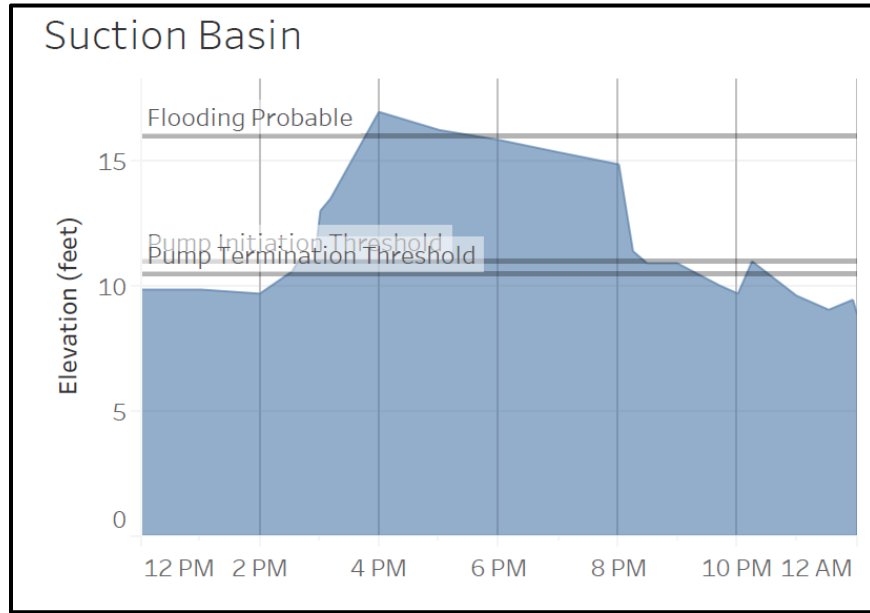
Figure 39 DPS 2 Suction Basin Levels August 5

Pumping commenced at 2:30 PM and continued for approximately 9-1/2 hours in the initial period. The suction basin took approximately 9 hours to clear initially. Suction levels rose again after midnight until 11 AM. Pumping did not restart until 7 AM. Suction basin elevations were consistent with flooding in the drainage basin as shown in Figure 39.

**Conclusion.** DPS2 functioned at current design during the event with few technical issues. However, there was significant flooding in DB 2. Despite the highest degree of pumping capacity redundancy in the S&WB drainage system, DPS 2 and system capacity is inadequate to handle intense rainfall events such as were experienced in most of DB 2 on August 5. Current pumping capacity in DPS 2 is limited by the capacity of the St. Louis Avenue Canal and possibly the Broad St. Canal. Capacity is also limited by the real-time functional capacity of outfall stations DPS 7 and DPS 3. While flooding would inevitably have occurred under such severe precipitation conditions, it is likely that flood depth and duration during the event could have been reduced if substantial improvement in DB 2 drainage pipe capacity occurred and DPS 2 discharge capacity was increased. It is also likely that flooding depth and duration would have been reduced if DPW drainage network cleaning, maintenance and repair had been accelerated.

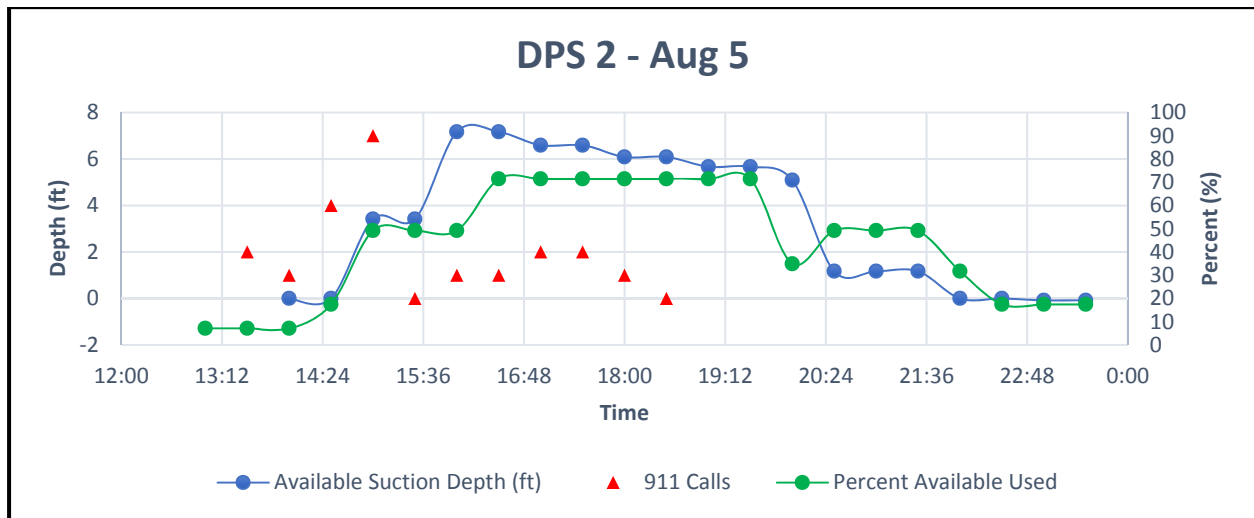
Figure 40 DPS 2 Pumping System Performance August 5

Pumping started as the suction basin began to rise and kept pace with the suction basin level as shown in Figure 40. Maximum pumping at the station used approximately 70% of the available and installed capacity. Two requests to start pumps were denied at 3:11 and 4:00 PM. An additional request was denied at 7:48 AM on 8/6. Loss of pump load was noted in the logbook.

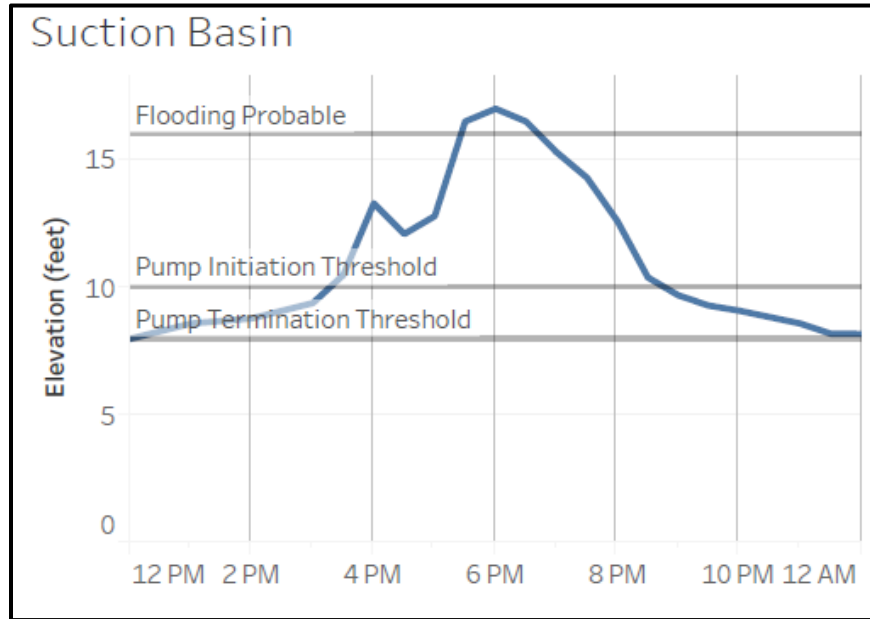
Figure 45 DPS 6 Suction Basin Levels August 5

DB 6 did not receive intense rainfall with the drainage basin experiencing an average rainfall of 3.2 inches (<1-yr 6-hr event). Suction basin elevations were consistent with flooding in the drainage basin as shown in Figure 45. DPS 6 target capacity is high due to requirement to discharge water drained from DB 1 and from 2500 acres in Jefferson parish. DPS 6 did not substantially meet the target pumping capacity even though all available pumps were run. Pumping commenced at 3:30 PM and continued for approximately 10-1/2 hours in the initial period. Pumping started well after the suction basin began to rise but did not keep pace until 90% of the available capacity was used. The suction basin took approximately 8 hours to clear initially and 10 hours to clear after rising on August 6 AM.

**Conclusion.** DPS 6, even with reduced pump capacity, exhibited capacity capable of providing an adequate LOS within its drainage basin during the event, with the result that there was little flooding in DB 6. However, DB 6 experienced significantly less intense rainfall than other drainage basins. The decision to drain DB 12 for an extended period through DB 6, with the relatively limited drainage effect, rather than running D Pump at DPS 12, could have contributed to flooding depth and duration in DB 12. Had 25 Hz power been diverted from G Pump at DPS 6 to D Pump at DPS 12 at an earlier point in time, it is likely that flood depth and duration in DB 12 would have been reduced. If this had been done, there could simultaneously have been greater flood depth and duration in DB 6, although overall precipitation intensity was similar in both drainage basins. DB 12, as discussed below, was likely contending with run off from DB 7, which experienced significant flooding.

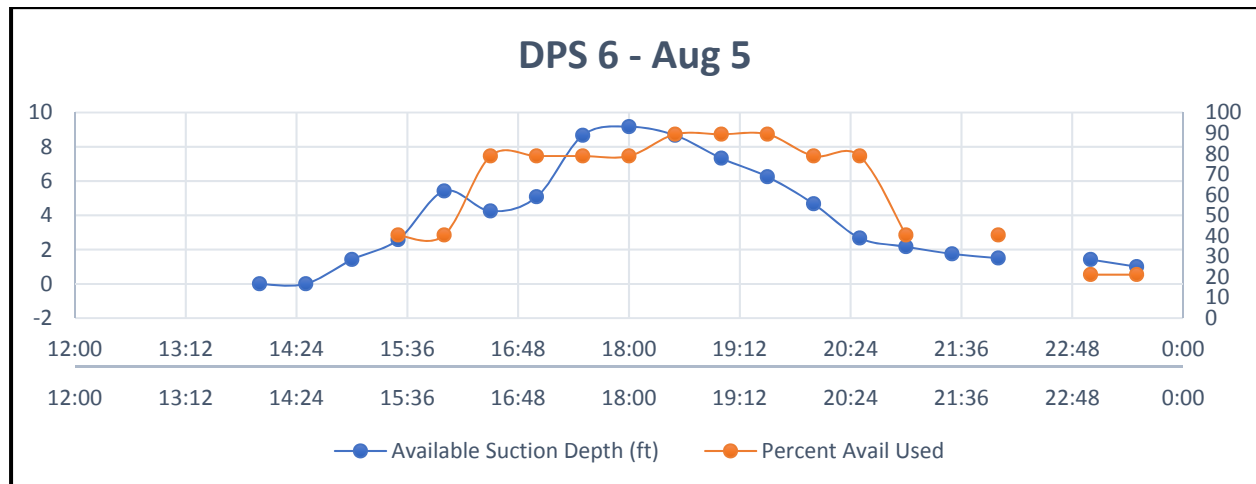
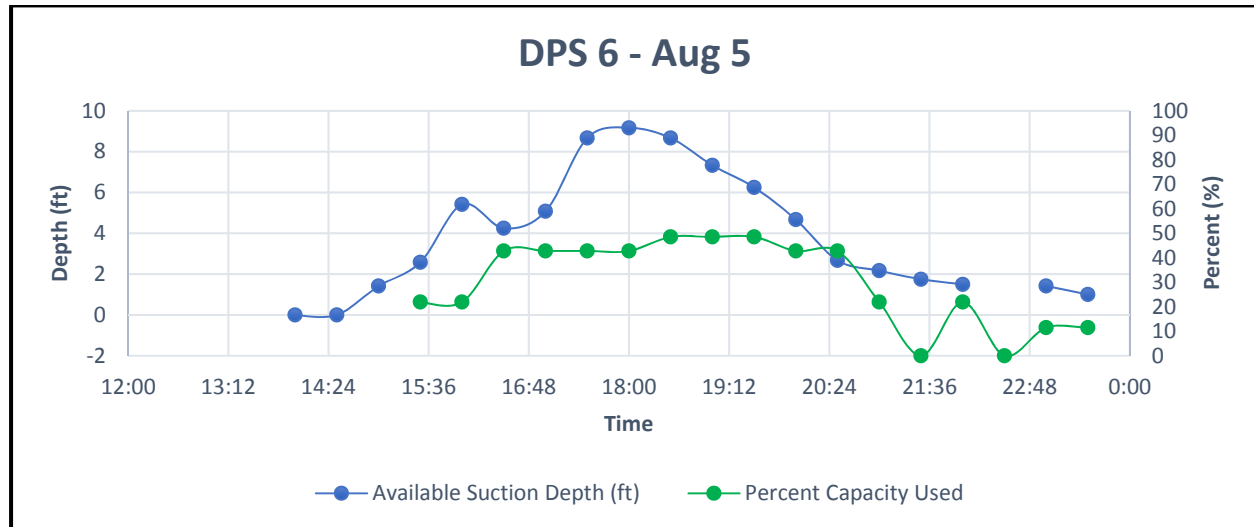
Maximum pumping at the station used approximately 90% of the available capacity but only 50% of installed capacity as shown in Figure 46 and Figure 47. Six pumps were out of service for a total not in service of 5300 cfs, half of station design capacity.

Multiple feeder voltage losses and pump load losses were noted in the logbook. A request for additional pump starts at 5:11 pm was denied. This request represented approximately 11% of the operable capacity. A decision was made to power the 25 Hz G Pump at DPS 6 rather than 25 Hz D Pump at DPS 12 for critical period of event.

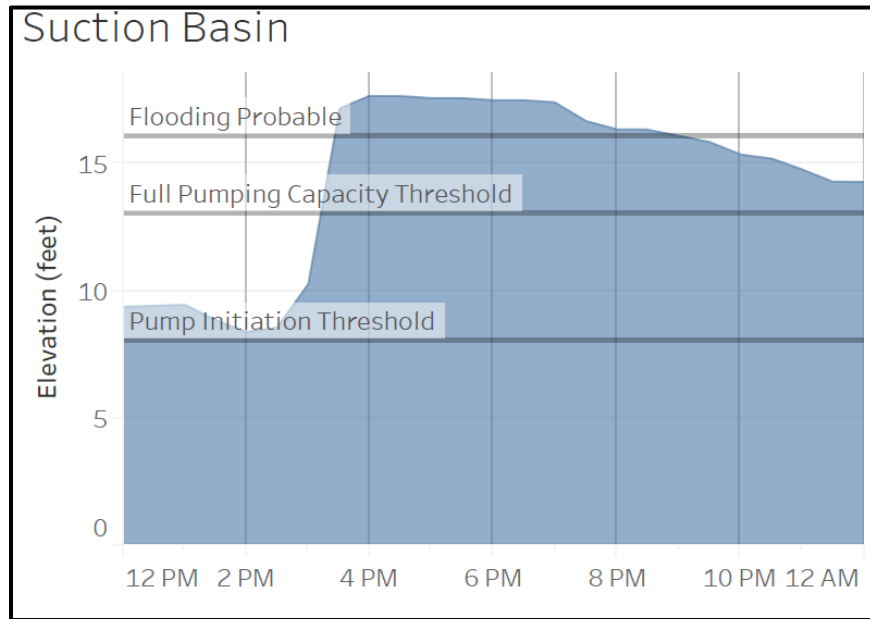
Figure 48 DPS 7 Suction Basin Levels August 5

Suction basin elevations were consistent with flooding in the drainage basin as shown in Figure 48.

**Conclusion.** DPS 7 has among the lowest pumping capacity redundancy of any drainage pumping station surpassing only the single-pump DPS 12. Together, these two stations drain approximately 5,340 acres with 145% of target drainage pumping capacity, lower than any other basins. On August 5, capacity of DPS 7 was significantly reduced such that at midnight the suction basin remained significantly elevated above pre-event level. Pumping capacity was clearly inadequate in that DPS 7 not only did not meet its target pumping capacity, but it was incapable of doing so. It is likely that significant runoff from DB 7 flowed into DB 12, which although it did not receive relatively intense rainfall, experienced significant flooding. C Pump at DPS 7 had been out of service since March 2016 and this failure of maintenance and repair management left not only DB 7 at risk for unnecessary flood impacts, but increased risk in DB 12 as well. It is also likely that flooding depth and duration would have been reduced if DPW drainage network cleaning, maintenance and repair had been accelerated.

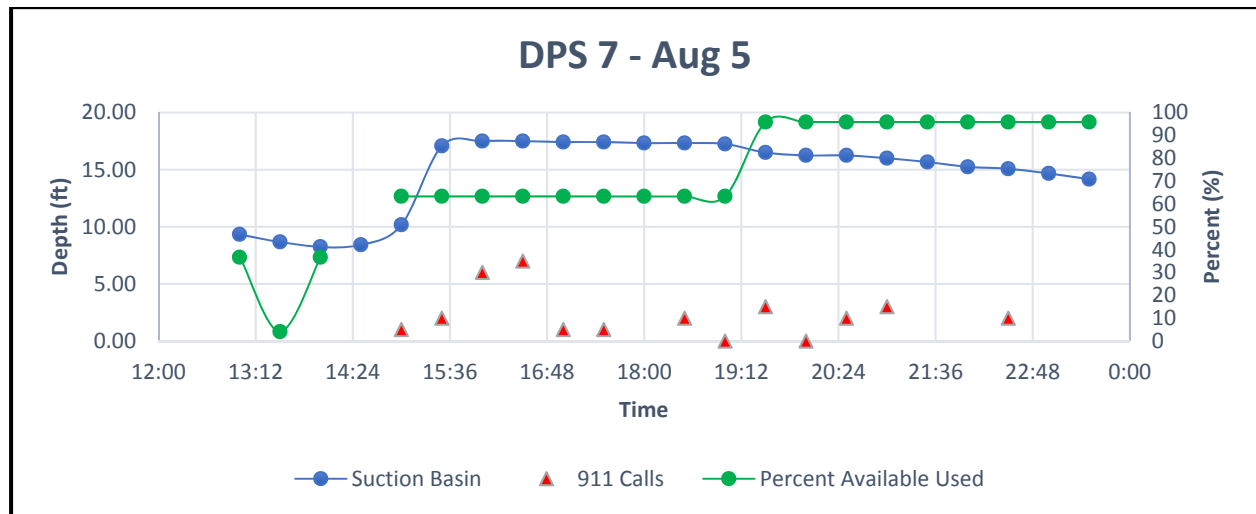
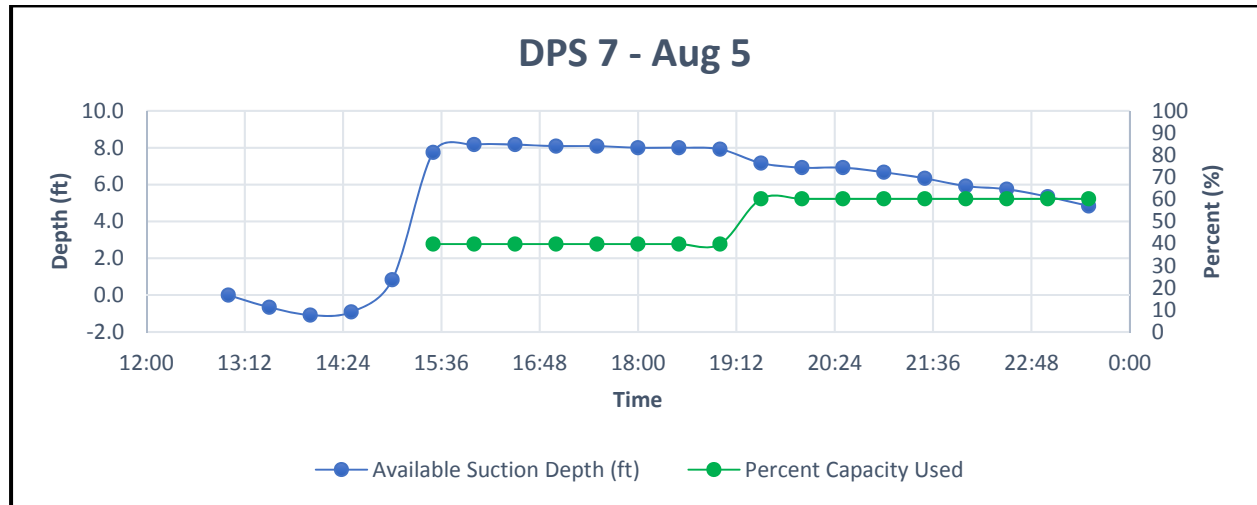
DPS 7 did not substantially meet target pumping capacity, with three large drainage pumps not in service and experienced significant flooding. Maximum pumping at the station used approximately 100% of the available capacity but only 60% of installed capacity as shown in Figure 49 and Figure 50. Three requests for pump start between 3:00-3:30 pm were denied and pump load loss was noted in the logbook.
