# CITY OF NEW ORLEANS STORMWATER DRAINAGE SYSTEM ROOT CAUSE ANALYSIS FINAL REPORT

Contract: K18-111

ROOT CAUSE ANALYSIS

FINAL REPORT

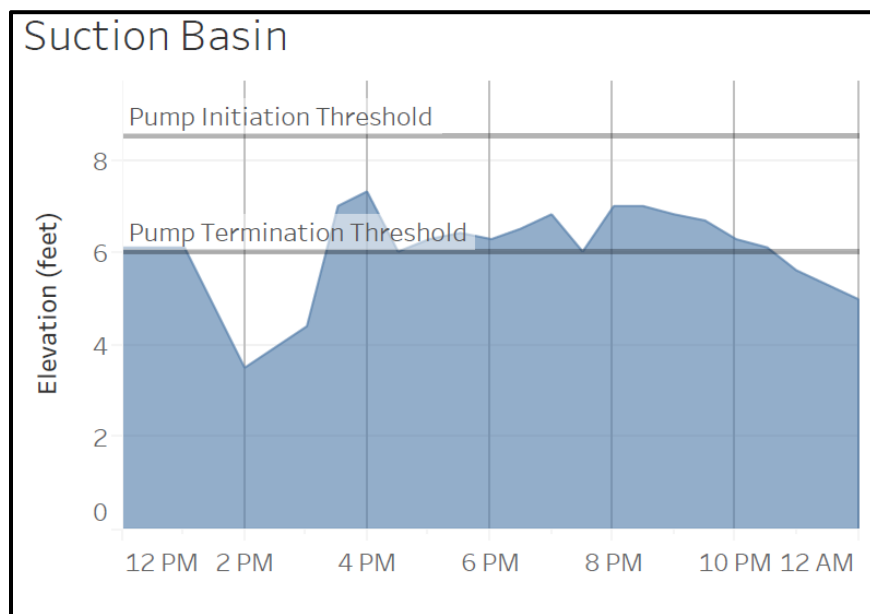
**Figure 53 DPS 19 Suction Basin Levels August 5**

**Conclusion.** DPS 19 largely functioned at current design capacity during the event with few technical issues. The station is entirely 60 Hz and had no power supply issues. However, there was significant flooding in DB 19. Despite a moderate level of pumping redundancy, DPS 17 and 19 and system capacity is inadequate to handle intense rainfall events such as were experienced in most of the drainage basin. While flooding would inevitably have occurred under such severe precipitation conditions, it is likely that flood depth and duration during the event could have been reduced had the Florida Avenue Canal Enlargement SELA project been completed and most probably also reduced if DPS 17 and DPS 19 discharge capacities were increased. Flooding would also likely have been reduced if DPW drainage network cleaning, maintenance and repair had been accelerated.

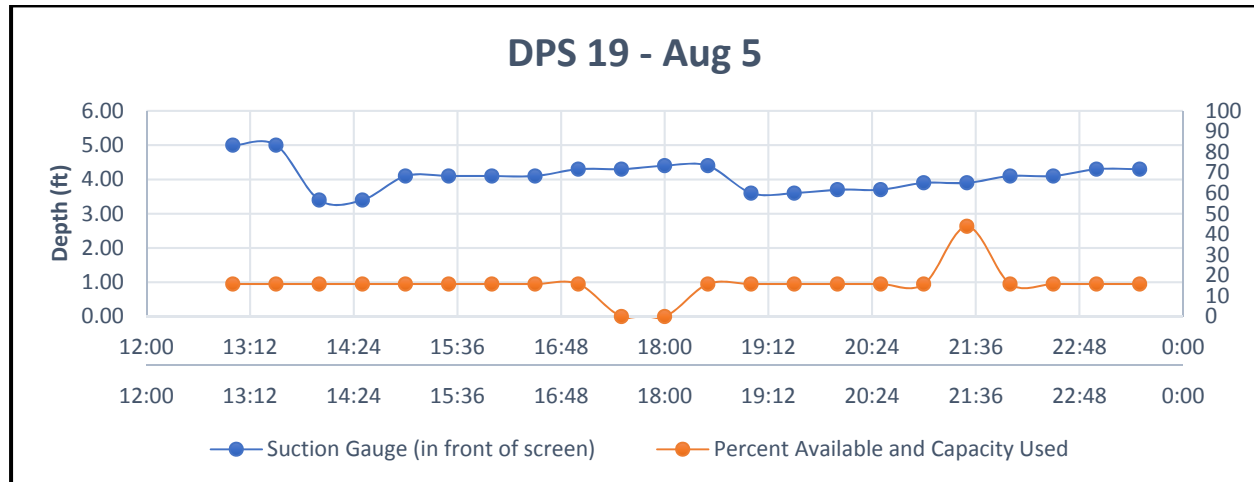
Figure 54 DPS 19 Pumping System Performance August 5

DB 19 experienced intense rainfall. Average rainfall over the drainage basin was 6.0 inches (>10-yr 6-hr event). Pumping commenced at 4:30 PM and continued for approximately 14 hours in the initial period. Maximum pumping at the station used approximately 20% of the available capacity for most of the pumping period rising to 40% for a brief time as shown in Figure 53 and Figure 54. DPS 19 did substantially meet target pumping capacity; however, significant flooding occurred.

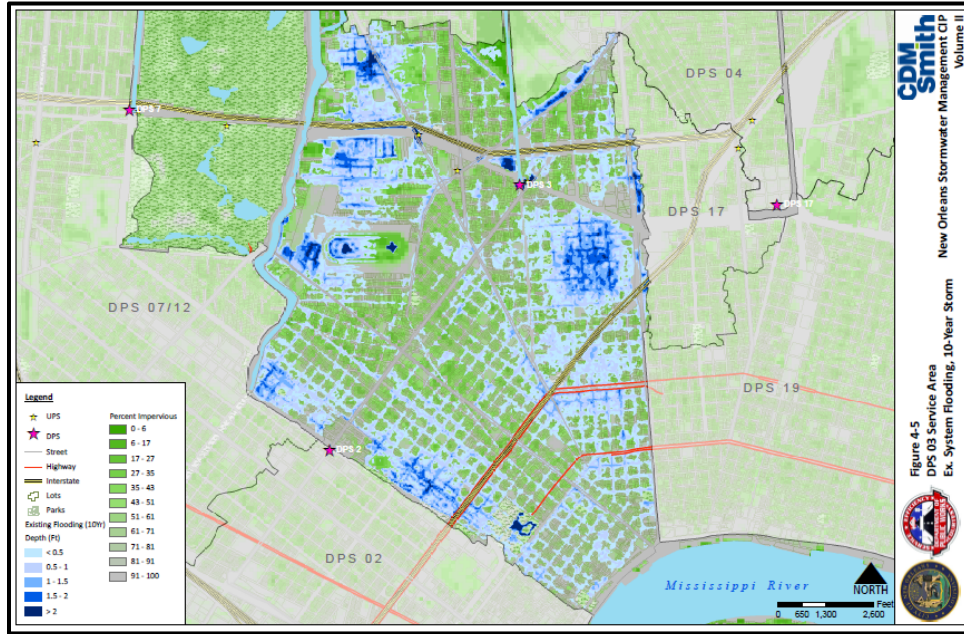
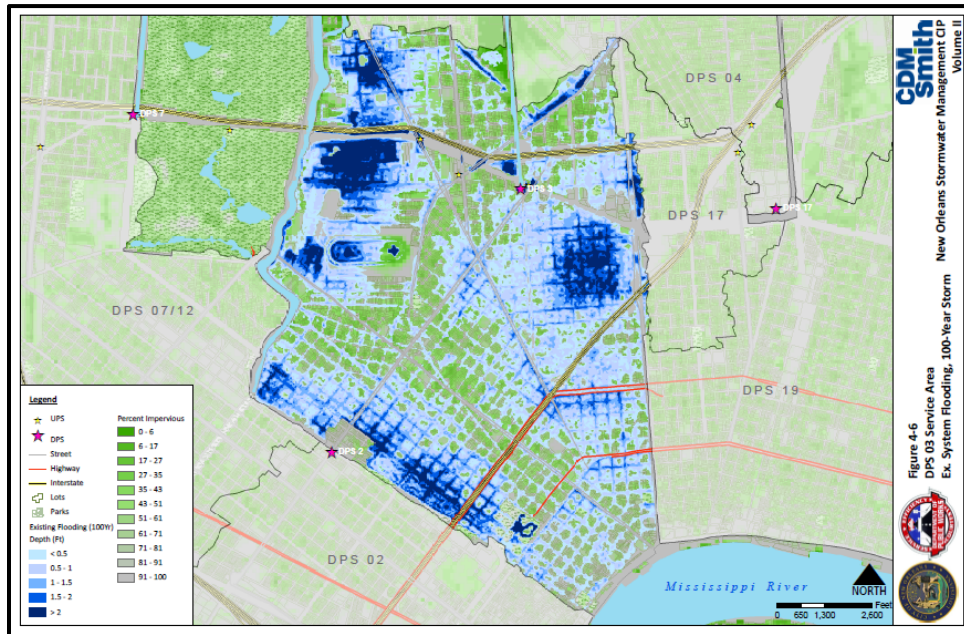
CDM Smith provided studies of system flooding by drainage basin for various storm recurrence intervals. These were evaluated to see water depths that would be predicted for a fully functioning, unobstructed system for storm frequencies which were observed on August 5. In drainage basin 3, where significant flooding was observed, rainfall with storm frequency equivalents between 10 and 100 years. Plots from the CDM Smith report for these frequencies are shown in these compare favorably with observed depths from the NOHSEP damage assessment shown in Figure 55 and Figure 56.

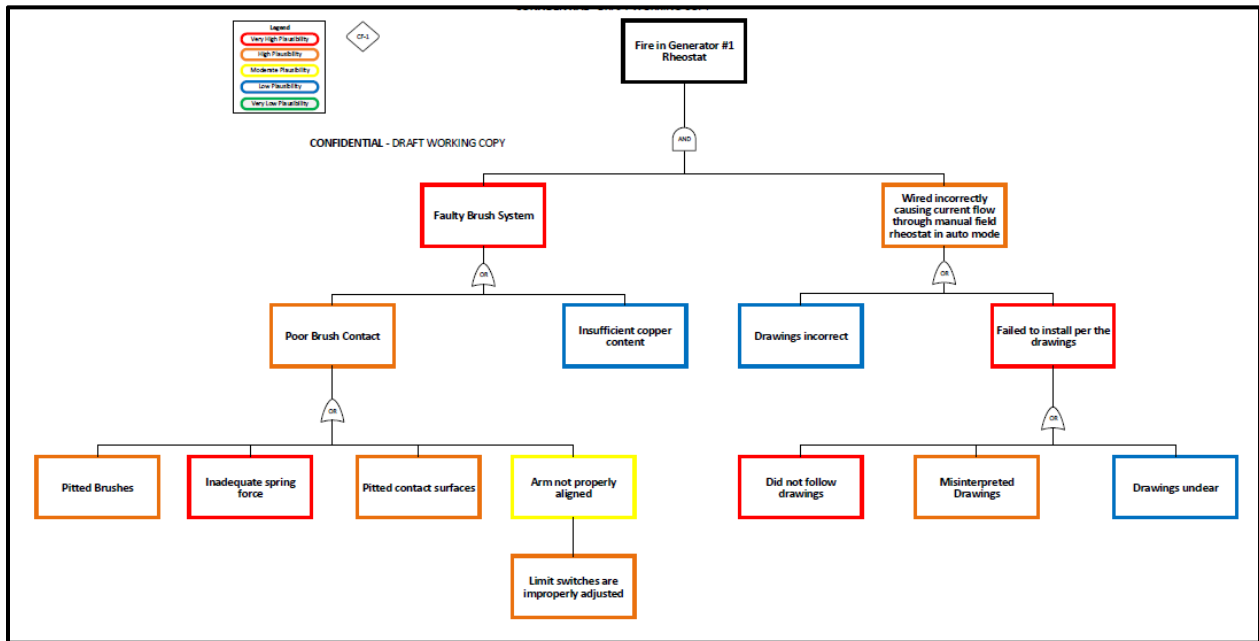
**Figure 60 Cause and Effect Tree for Turbine Generator 1 Electrical Fault**

Potential causes of the arcing and resulting fire were developed by the ABS Group team. These were identified as potential causal factors and incorporated into a CAET in Figure 60. For arcing to occur, there must be current passing through the rotating arm. In the manual mode, current flows through the arm but this mode is only used in emergencies so there is a short period of time current would be flowing in the correct wiring configuration. Since current was flowing through the manual rheostat even in automatic field control mode, potential for brush contact arcing was significantly increased.

Arcing can occur when there is pitting in the contact surfaces. Any arcing will increase pitting and continue a cycle of increased damage to the contact surfaces. Another potential cause of arcing is low or uneven spring force on the brushes. This allows for poor contact between the brush and switching segments giving rise to arcing. Since there are two brushes different spring tensions can cause one brush to conduct more current than the other. This would increase the temperature rise of the brush carrying more current. Increased spring temperature caused by brush current imbalance can weaken the springs and reduce the force holding the brushes against the contact surfaces.
